TOWNSHIP OF HAVELOCK-BELMONT-METHUEN

To: Mayor Martin and Members of Council
From: Bob Angione, Chief Administrative Officer/Clerk
Meeting Date: March 4, 2025
Subject: Repairs to Old Town Hall (1 Mathison Street West)

Building Envelope Condition Assessment (BECA) Report

RE: Building Envelope & Roof Condition Assessment for Old Town Hall, 1 Mathison Street West, Havelock ON

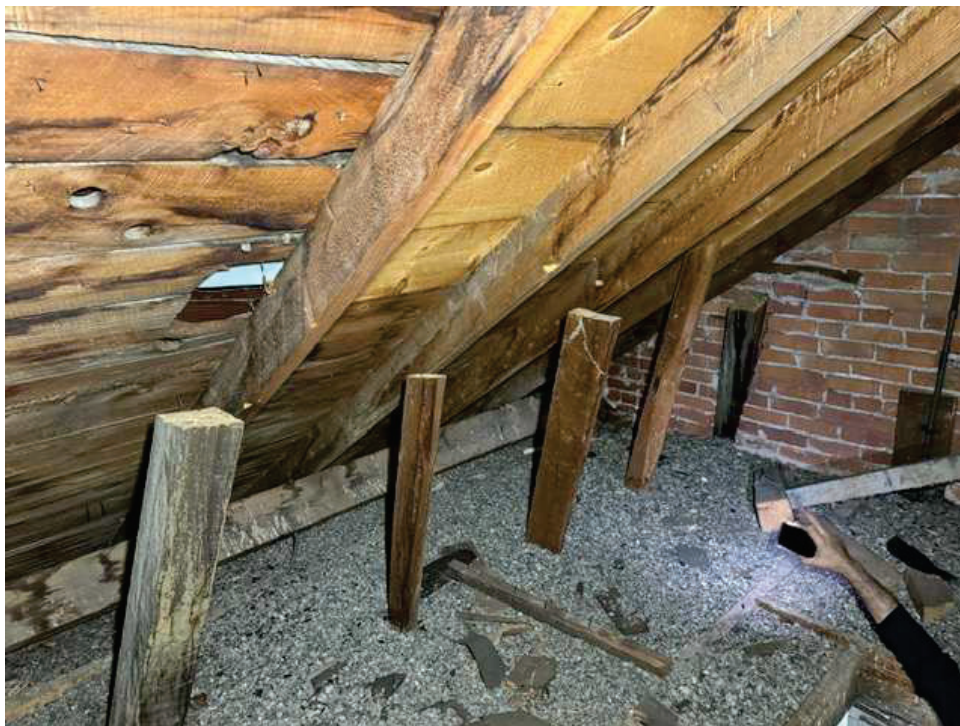
Photo #5

General View of the Attic Looking South – Scattered Debris, Deteriorated Materials, and Aged Rafters with Inadequate Bracing

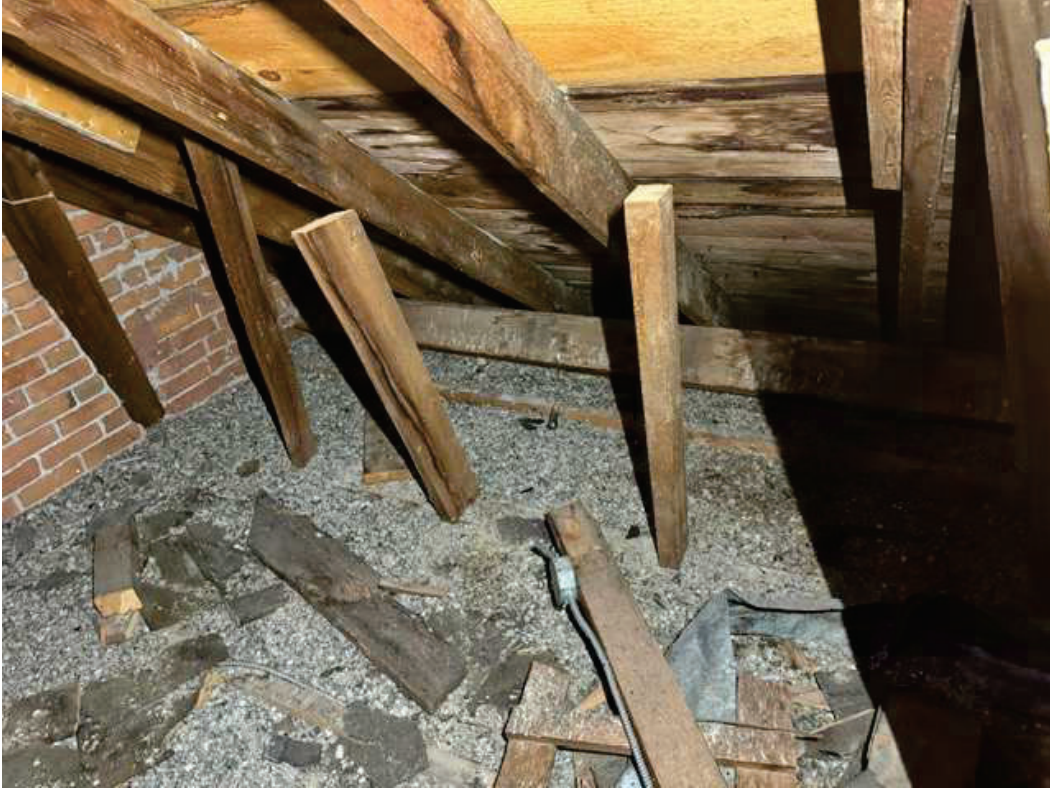
Photo #6

Northwest Attic Corner Looking Northwest – Deteriorating Wooden Rafters with Visible Damage, Including Missing Sections, Signs of Decay, and Inadequate Load Transfer Mechanisms

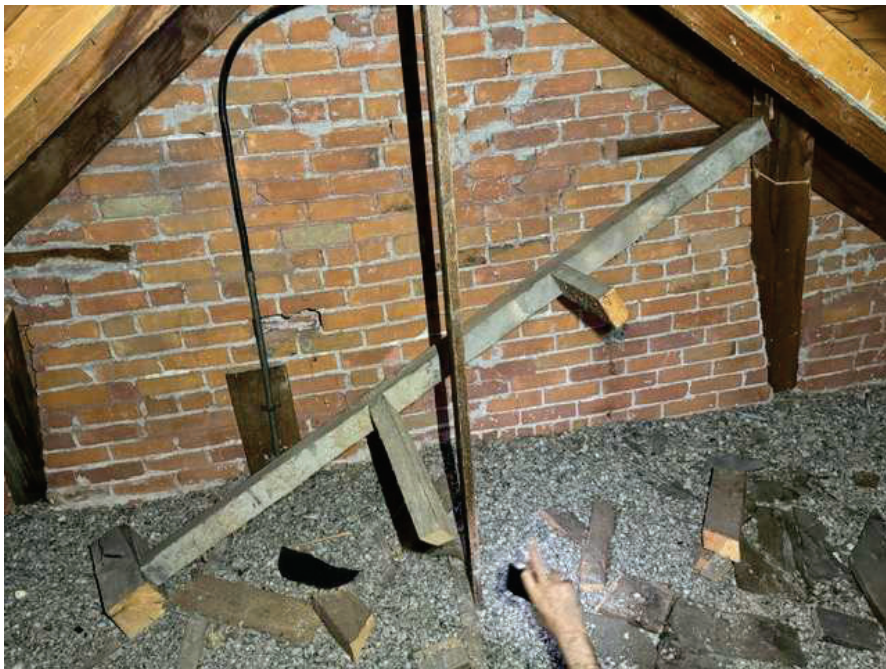
Photo #7

Northeast Attic Corner Looking Northeast – Deteriorating Wooden Rafters with Visible Damage, Including Missing Sections, Signs of Decay, and Inadequate Load Transfer Mechanisms

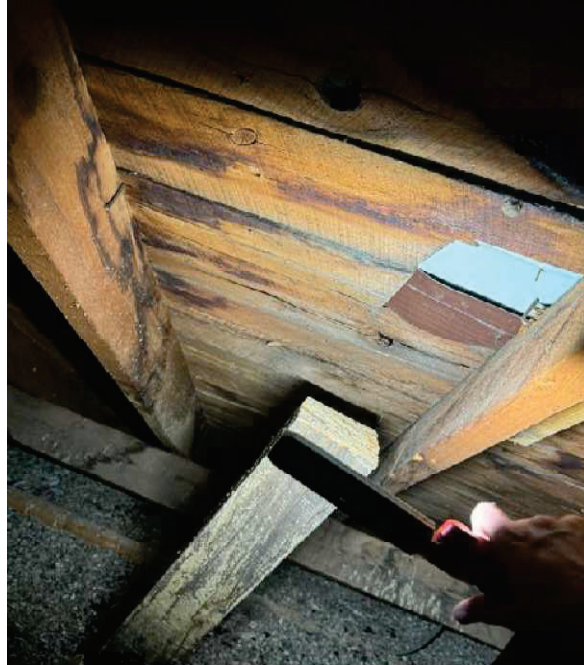
Photo #8

North Side Wall in the Attic Looking North – Irregular Bracing, Deteriorated Wood, Cavities in the Brick Wall, and Irregular Anchoring Requiring Further Detailed Assessment

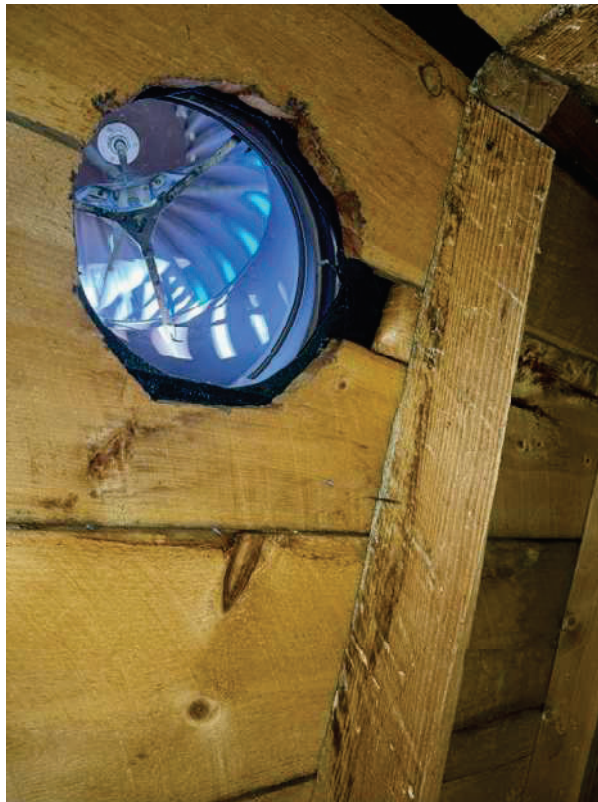
Photo #9

Close View of Ventilation Opening – Deteriorated Wood, Cut Bracing, and Cavities in Roof Boards.

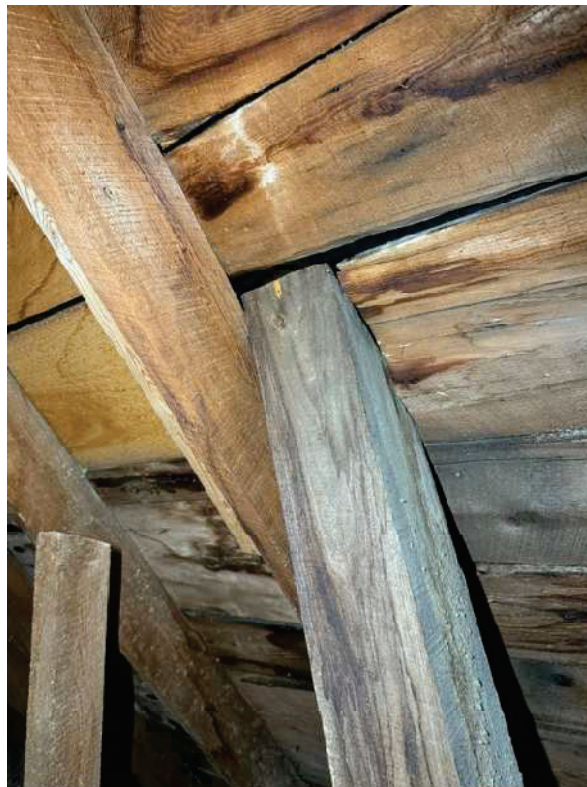
Photo #11

Close View of Roof-to-Wall Connection in Northwest Corner – Highlighting Misaligned Masonry, Deteriorated Wooden Elements, and Inadequate Anchoring.

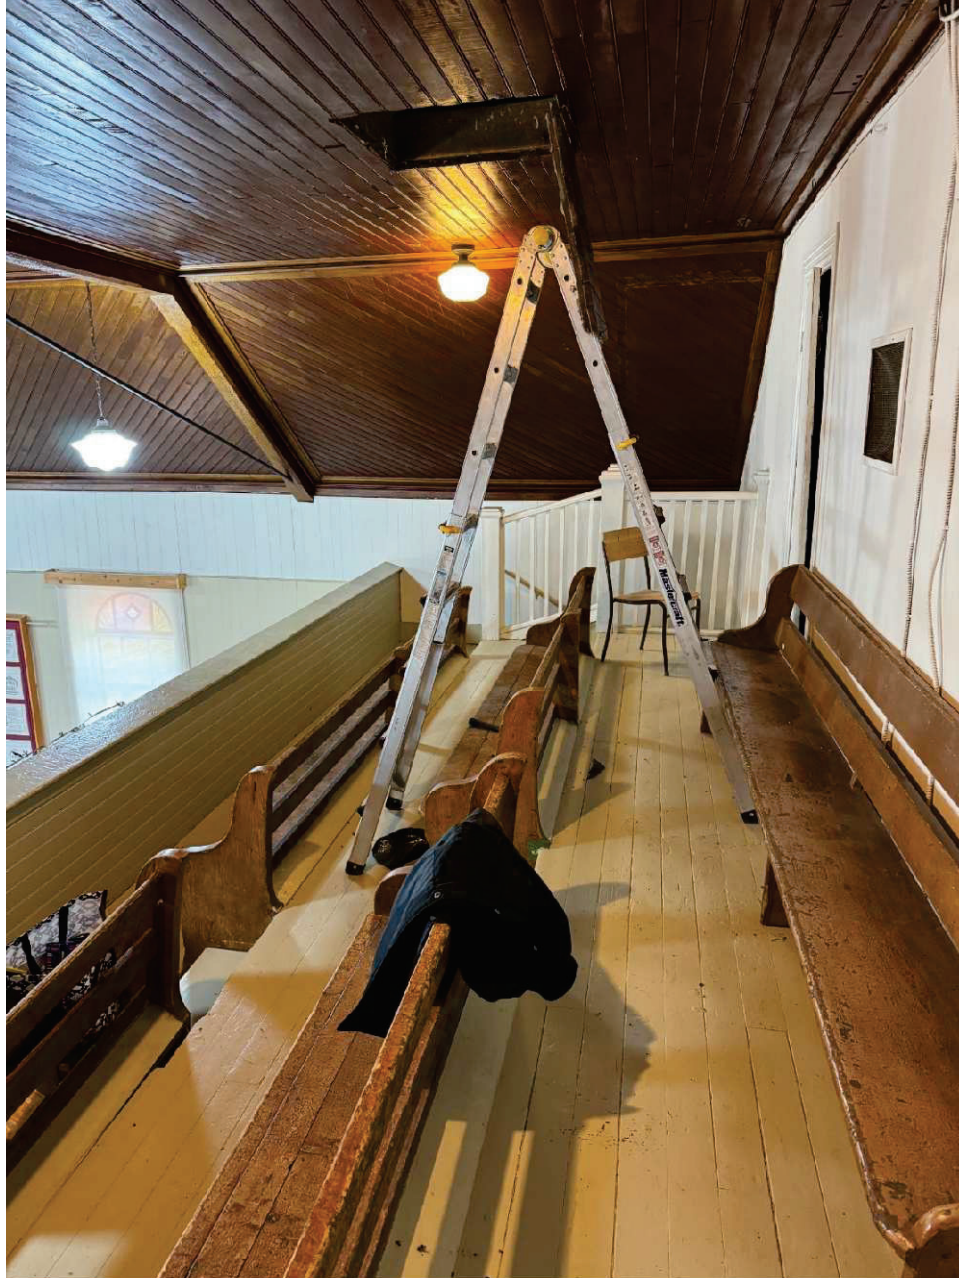
Photo #17

View of Bleacher/Viewing Balcony on Mezzanine Level – No Signs of Distress, Deflection, or Misalignments Observed in Walls, Floor, or Over Door to Mechanical Room. Attic Access Opening Shown in Ceiling Overhead with Ladder Used for Attic Entry, Looking East.

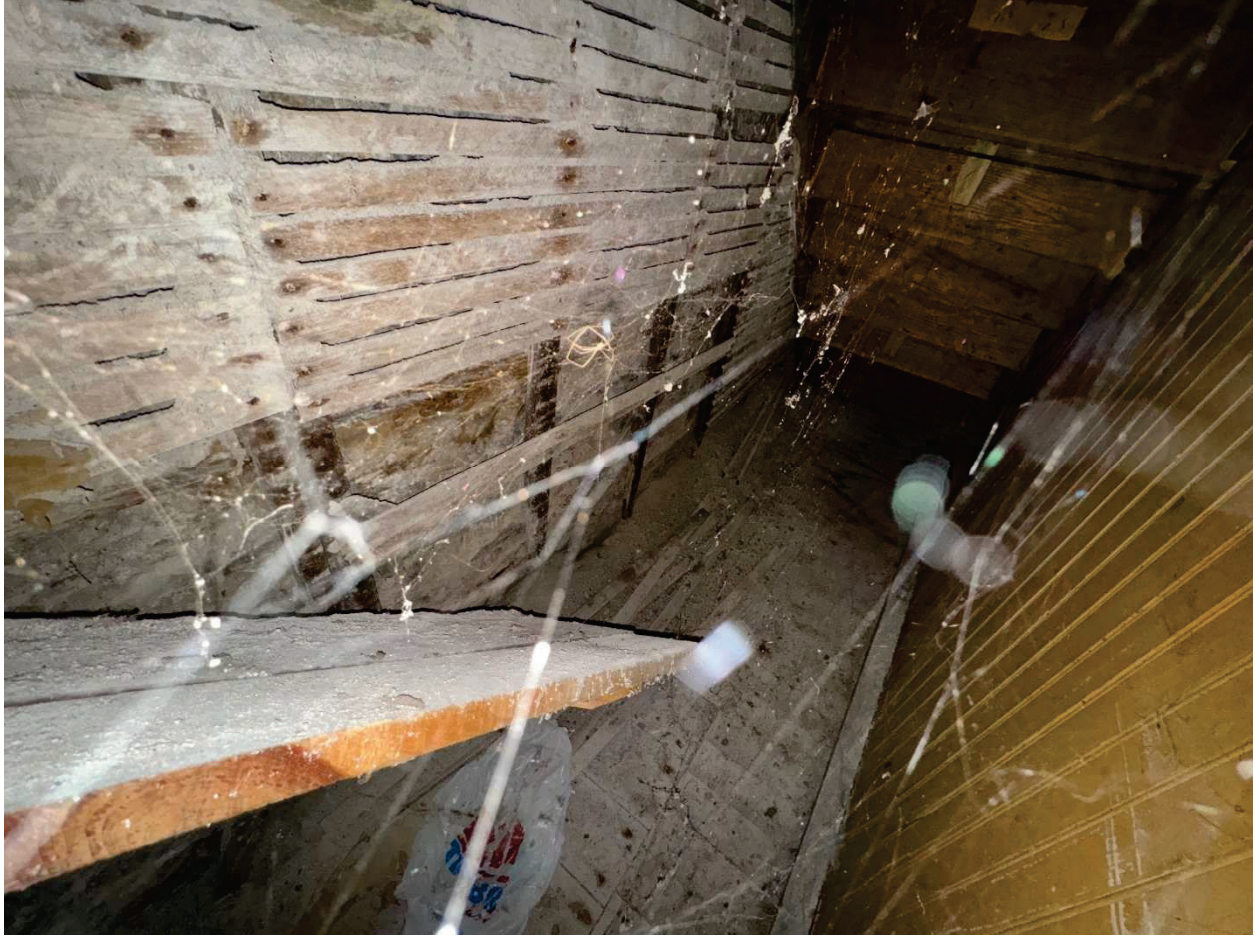
Photo #46

Storage Room Below North Basement Stairs at Northeast Corner, Looking North. Interior wall finishes are deteriorated, exposing the wooden lath beneath.

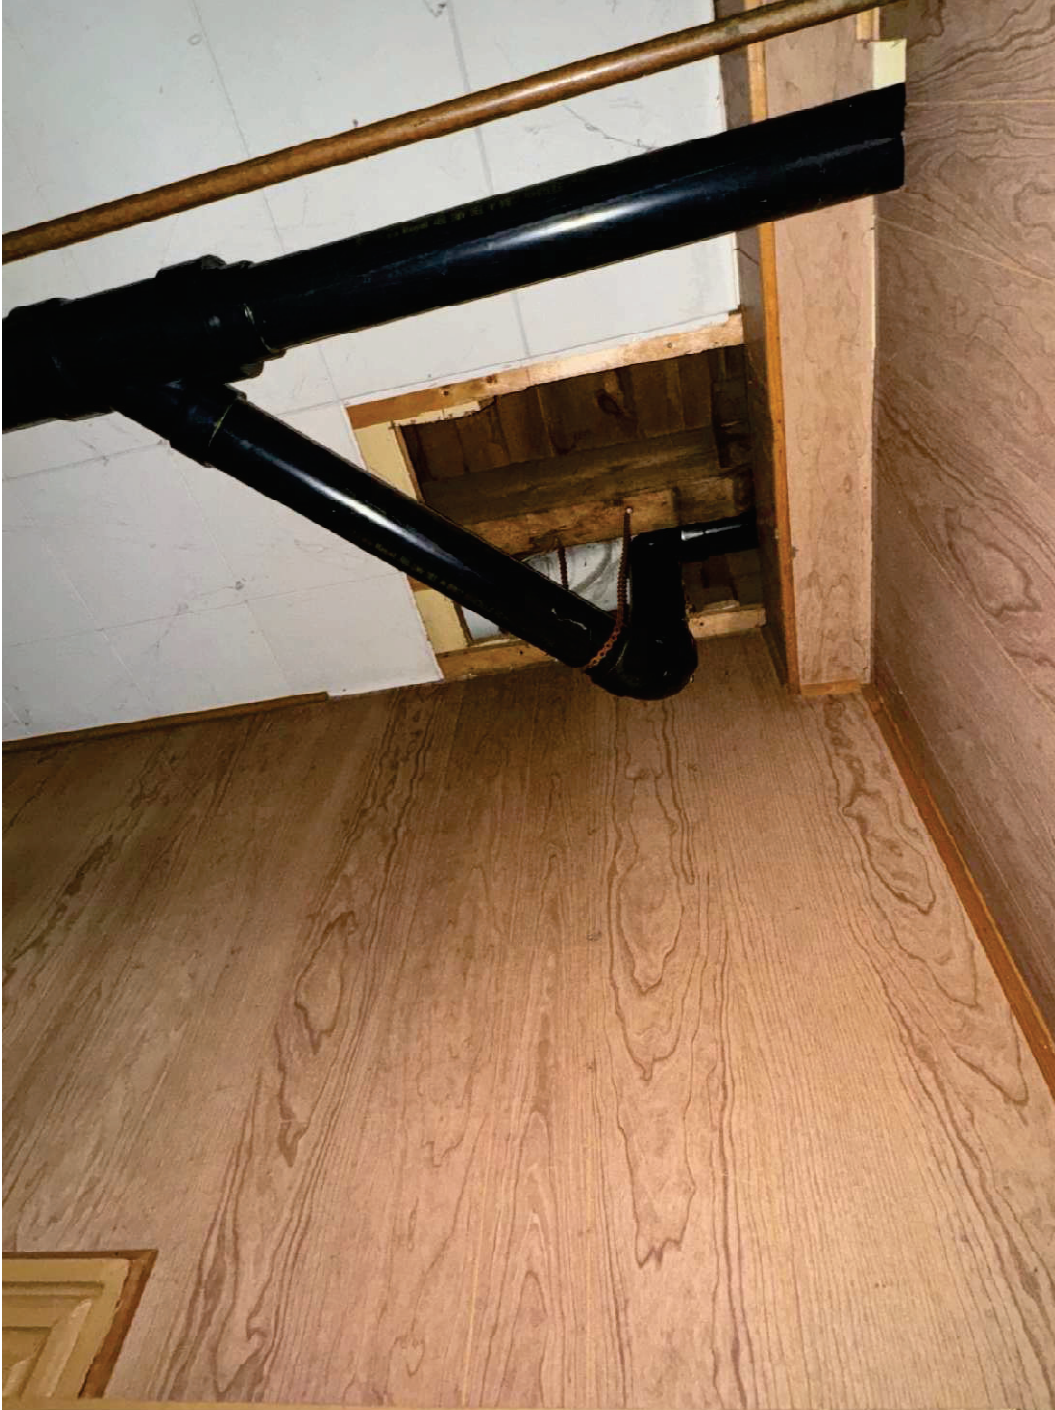
Photo #47

View of Storage Room Located Below North Basement Stairs, Facing East.
Interior wall finishes are deteriorated, exposing the wooden lath beneath.

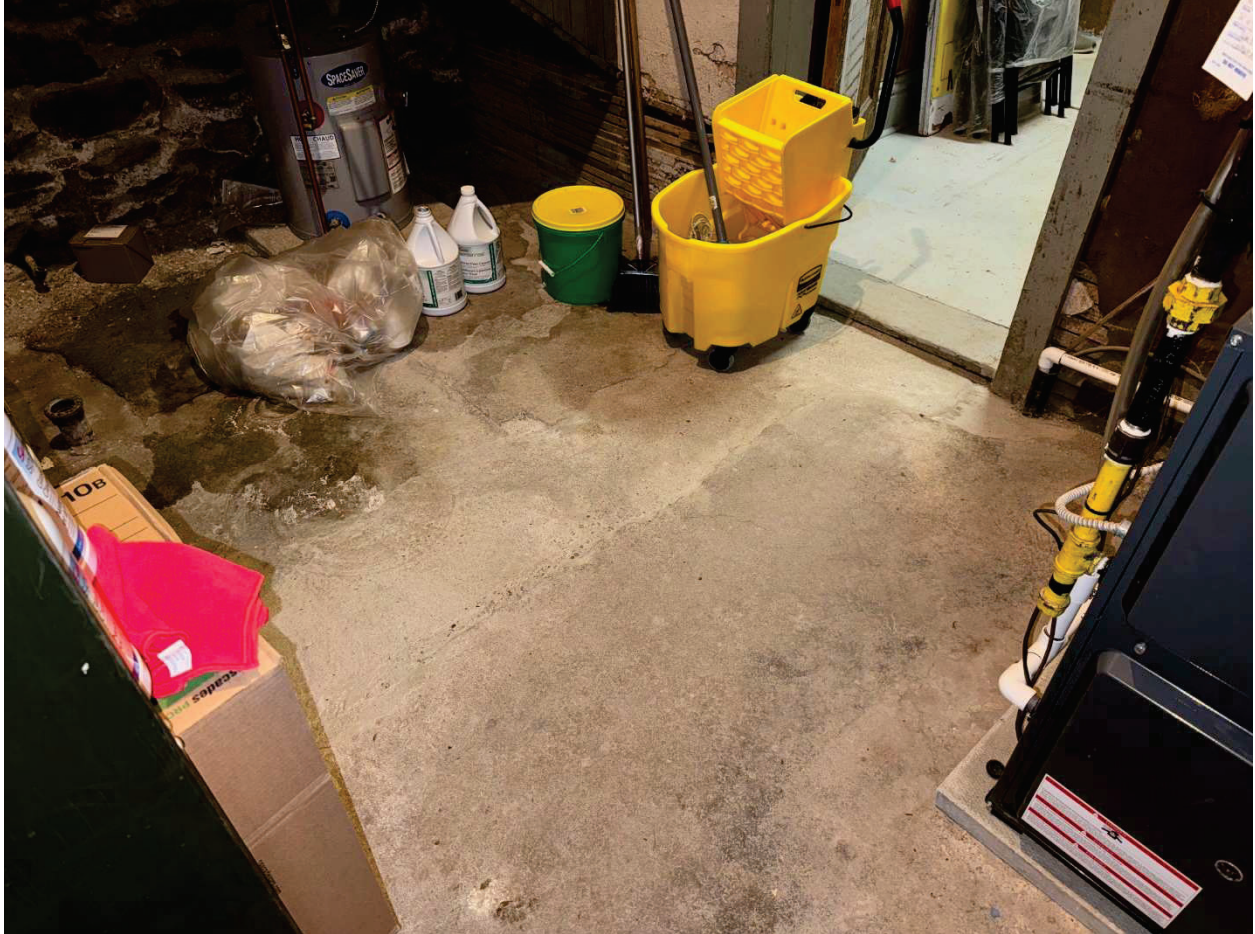
Photo #53

Basement mechanical room, looking west. The south side features a new partition to the police office. The concrete slab on grade appears to be in generally fair condition, with no visible signs of significant cracking, settlement, or heaving

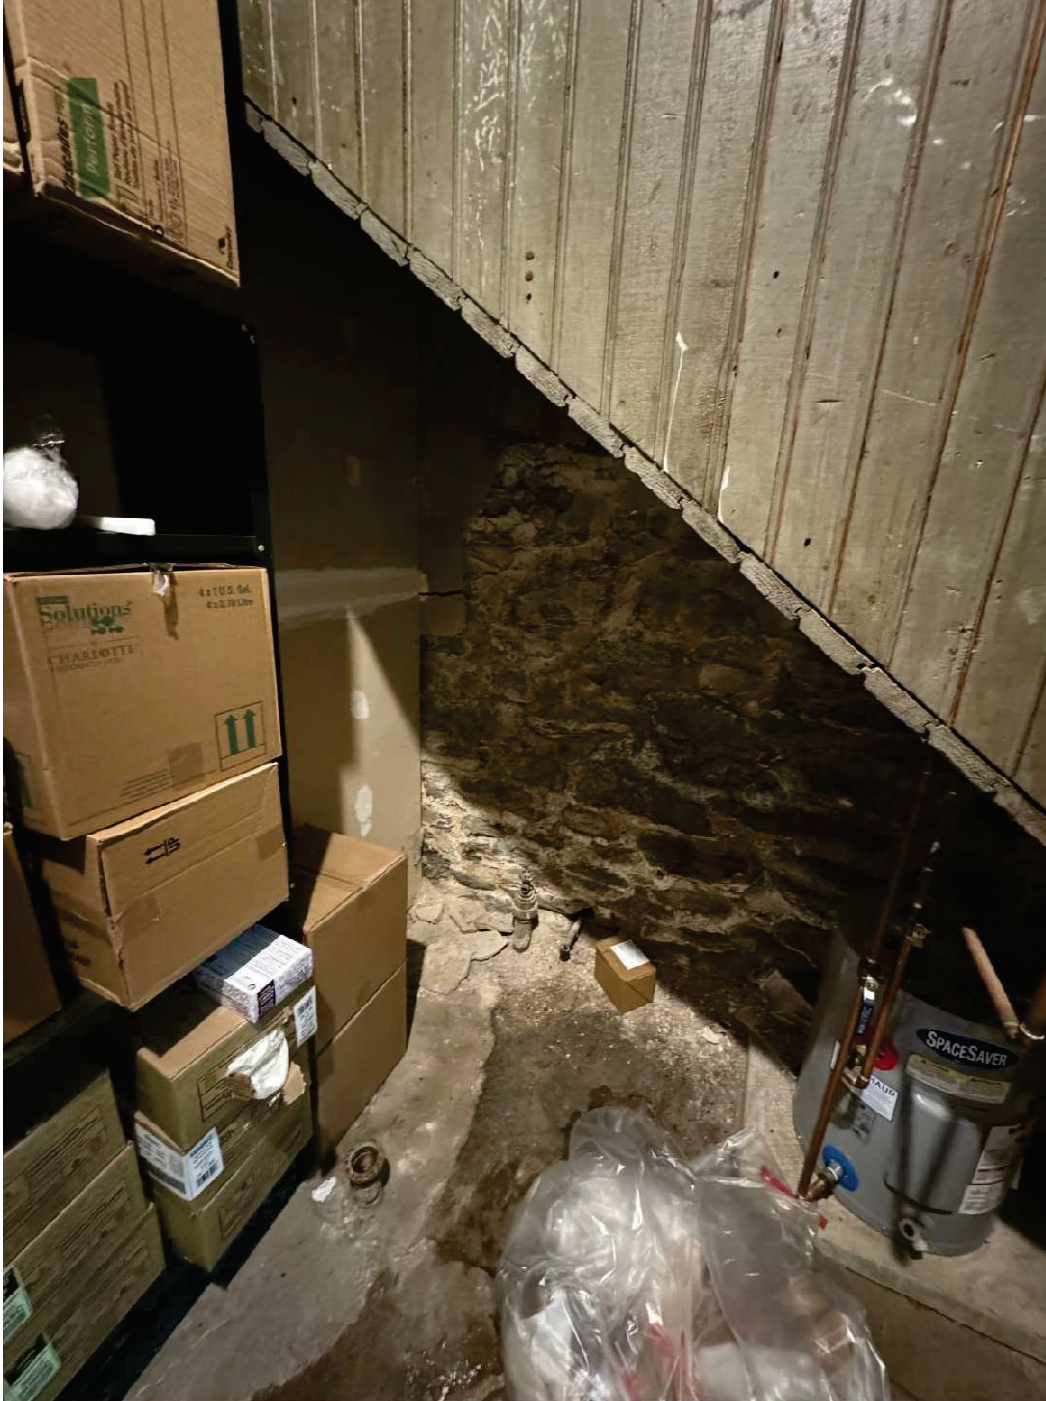
Photo #54

Basement mechanical room slab on grade and the east foundation wall below the south stairs. Local damage to the slab-on-grade has been observed and should be repaired promptly. The stone masonry foundation wall shows signs of mortar joint erosion and surface degradation, which may reduce its lateral support capacity and resistance to hydrostatic pressure. Repointing and sealing the joints are recommended to enhance stability and durability.

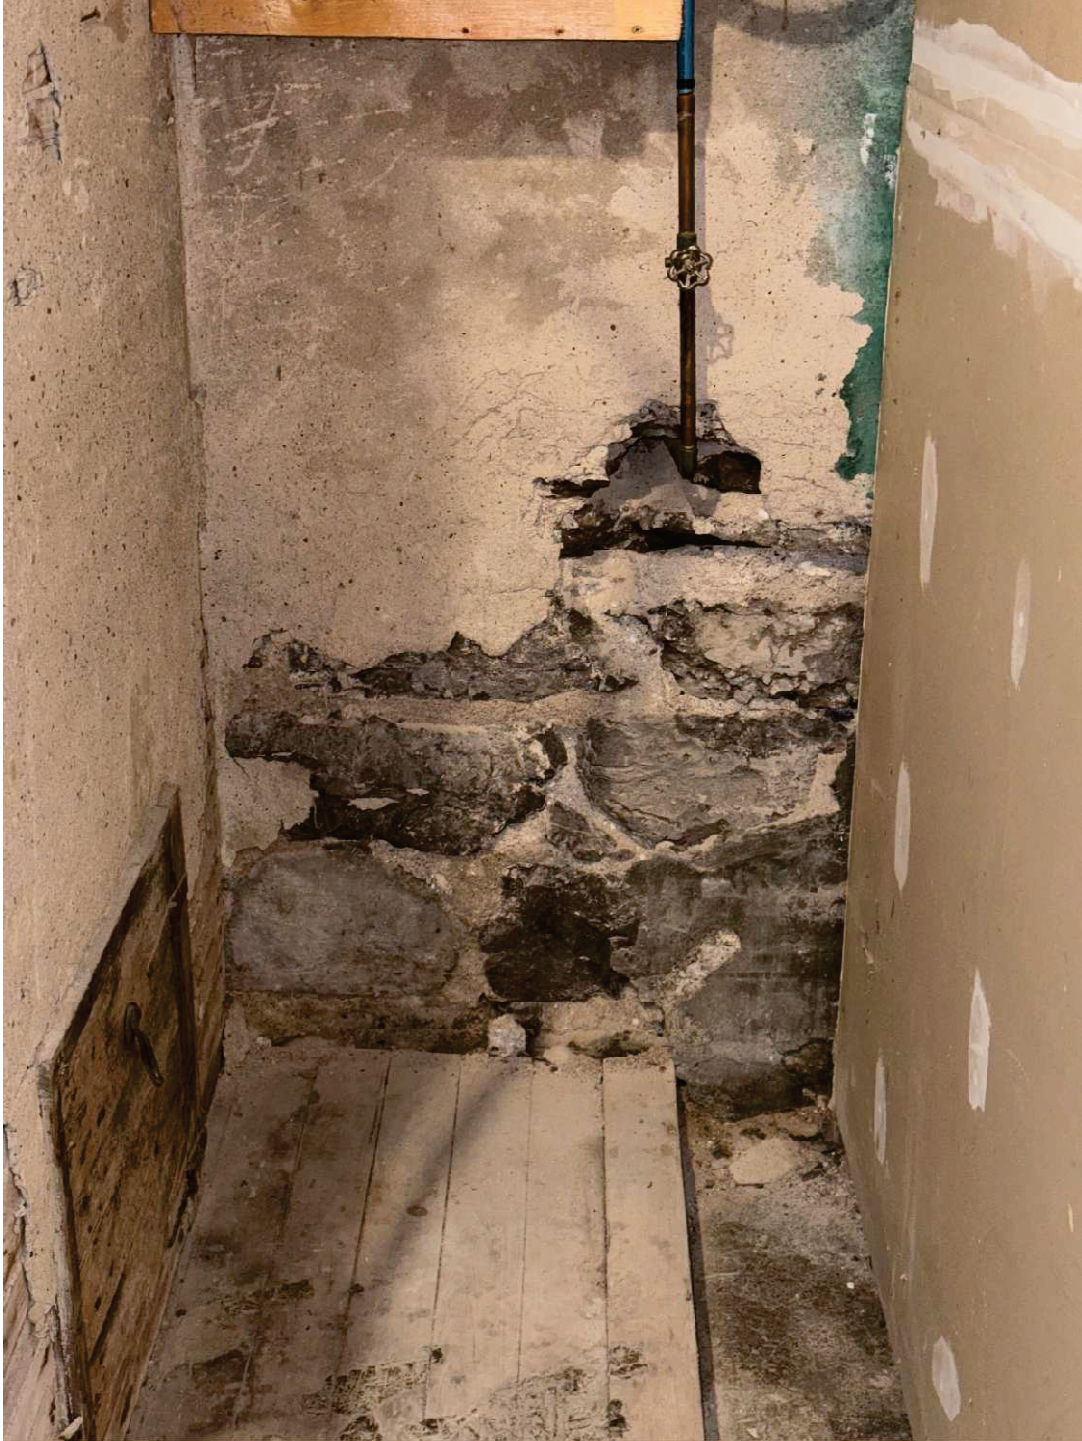
Photo #55

Closer view of the east foundation wall below the stairs, looking east. Local damage to the slab-on-grade has been observed and should be repaired promptly. The stone masonry foundation wall shows signs of mortar joint erosion and surface degradation, which may reduce its lateral support capacity and resistance to hydrostatic pressure. Repointing and sealing the joints are recommended to enhance stability and durability.

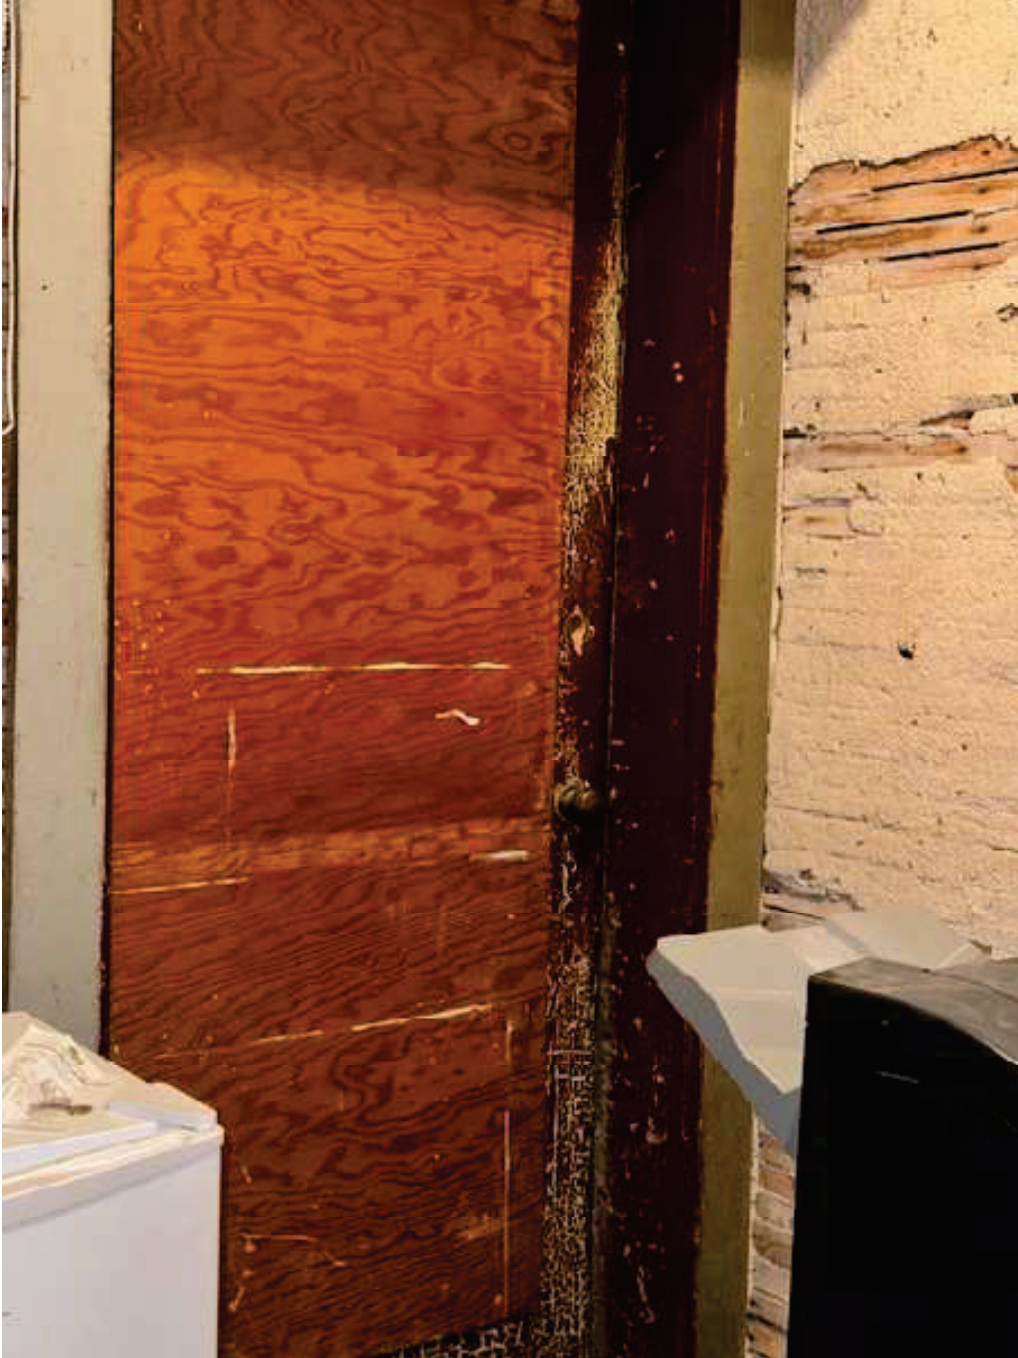
Photo #56

Basement mechanical room, part of the east building foundation wall, looking east. Cracking and gaps around utility pipe penetrations compromise the wall's load-bearing capacity and water resistance.

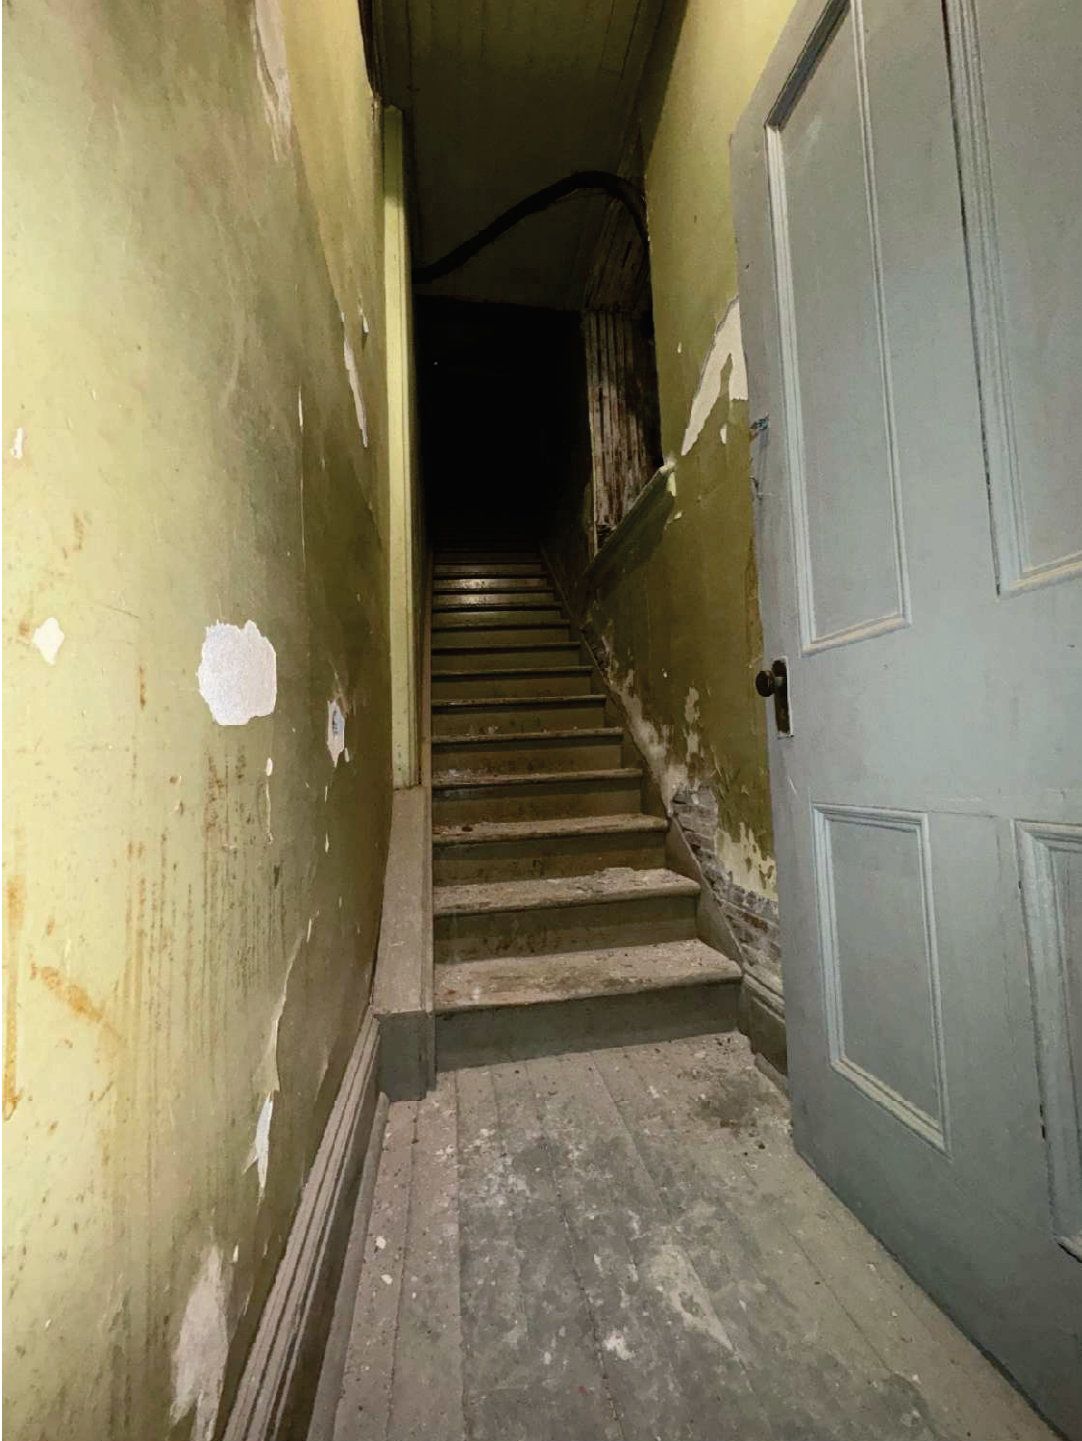
Photo #57

Door to the stairs leading to the stage area.
The interior layer of the east foundation wall on the right side of the photo appears to consist of lath and plaster. This layer has experienced surface wear and degradation.

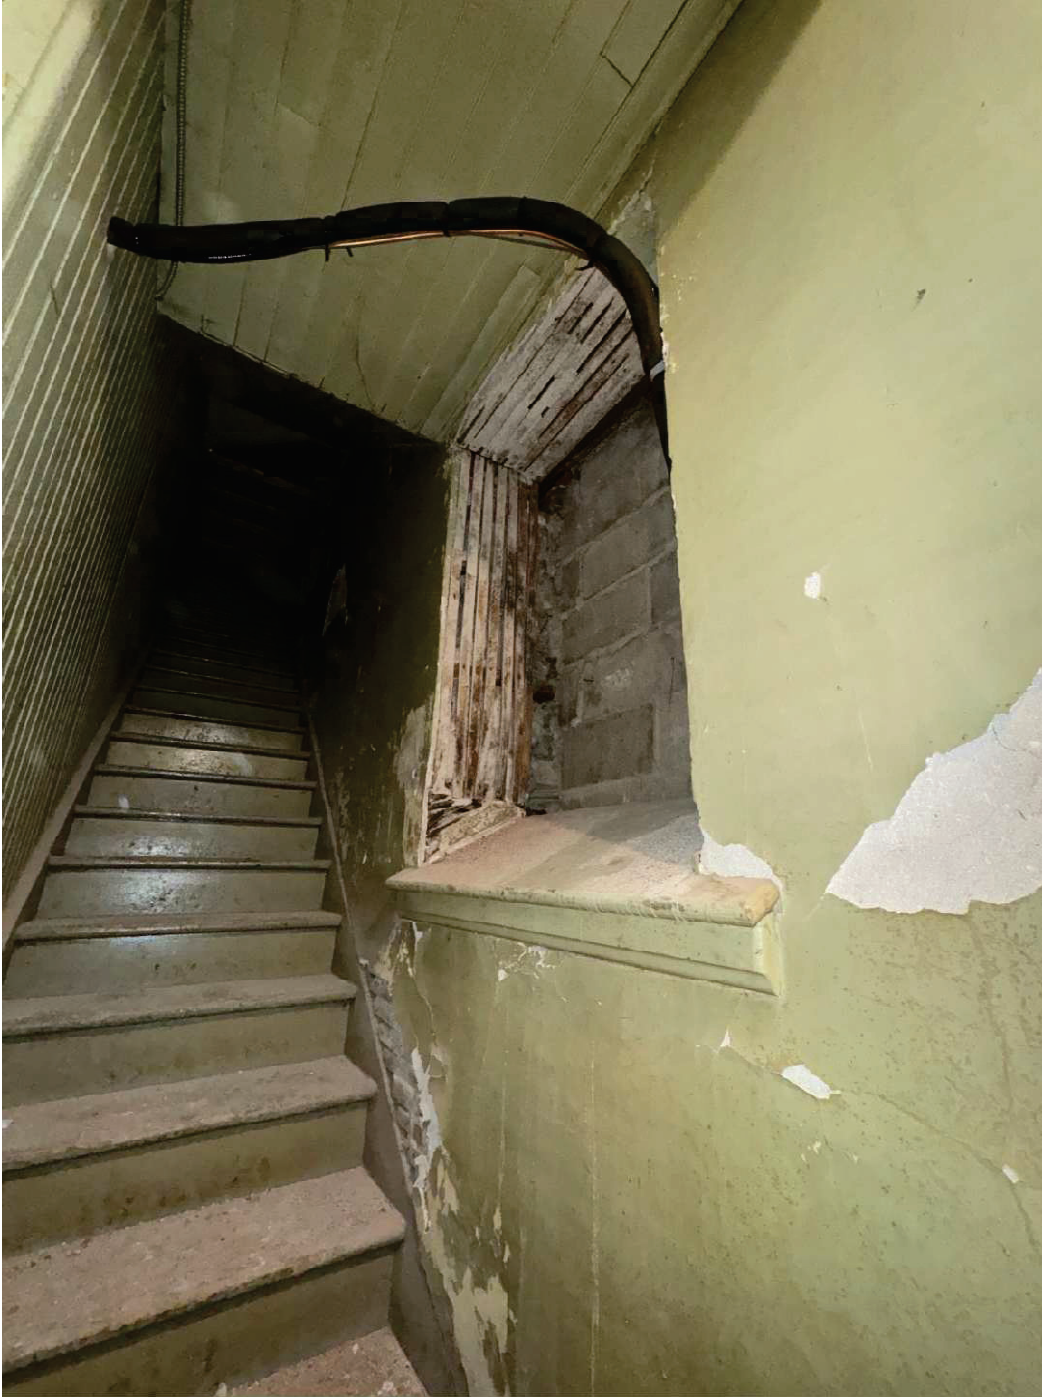
The interior finishing of the east foundation stone masonry wall under the stairs shows some deterioration, with missing mortar and signs of spalling.

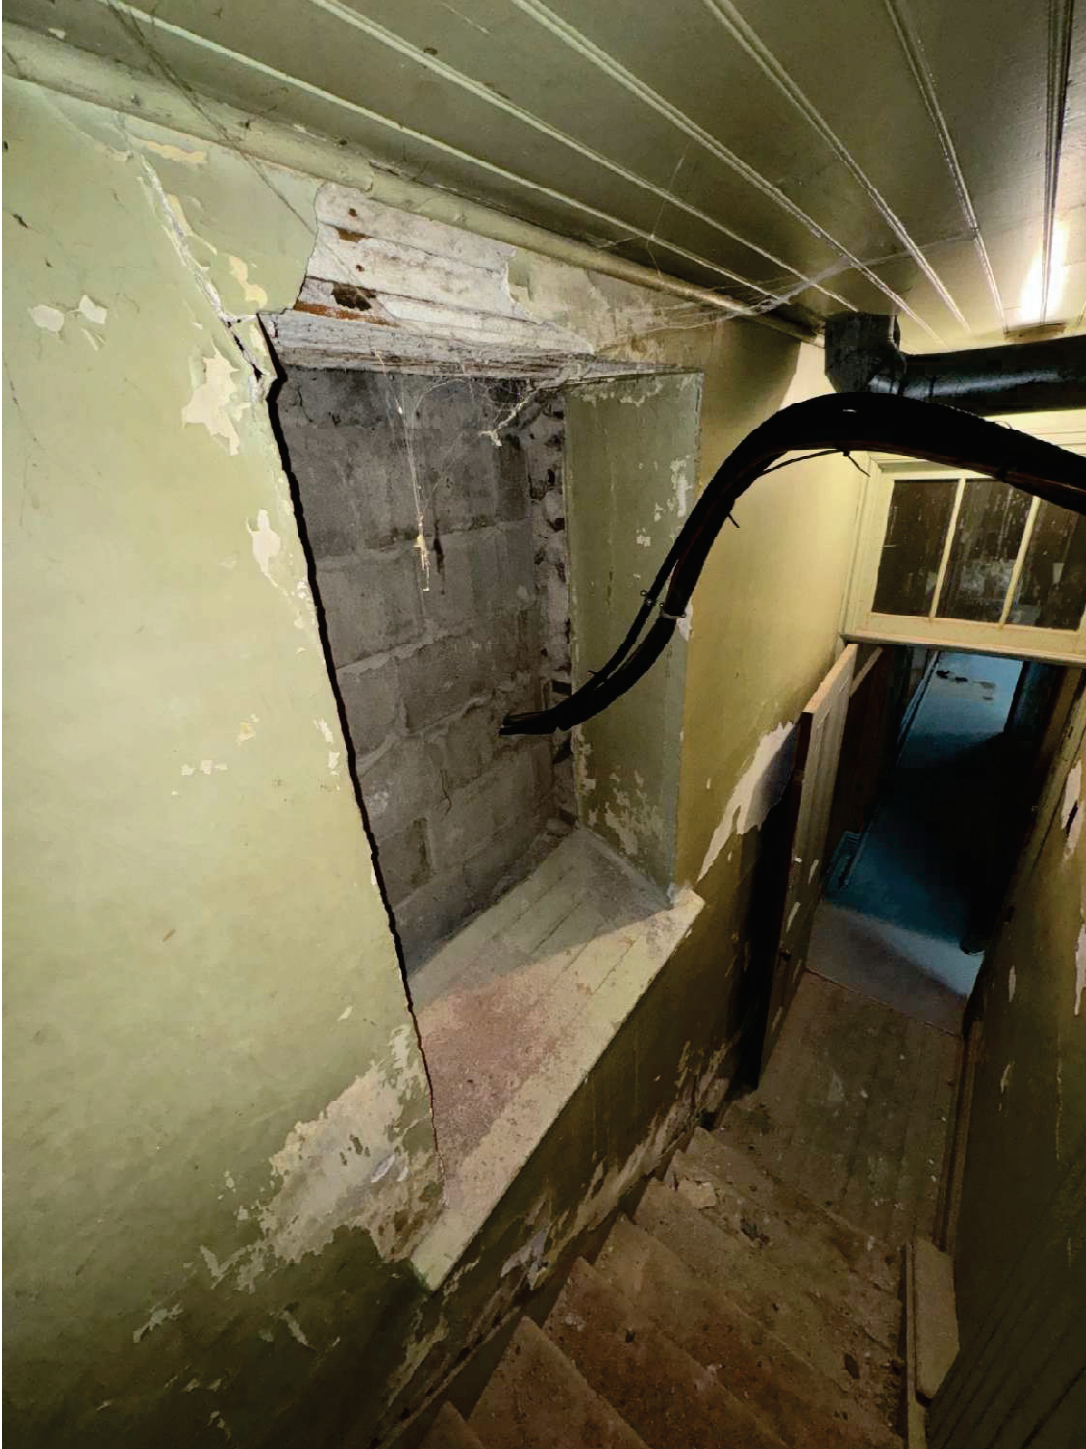
Photo #59

Closer view of the east foundation wall and a poorly closed window infilled with concrete blocks, looking south. The peeling paint and deteriorating surfaces in the area highlight the need for the cosmetic restoration.

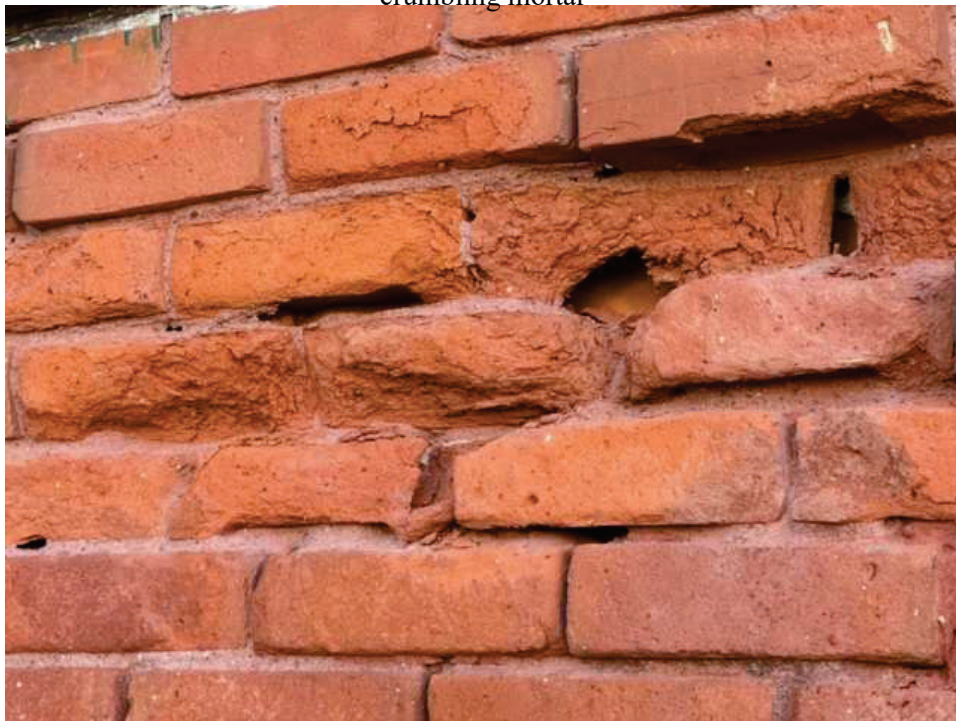
Photo #74

The brick wall near the stair entrance shows deterioration, with visible gaps, crumbling mortar

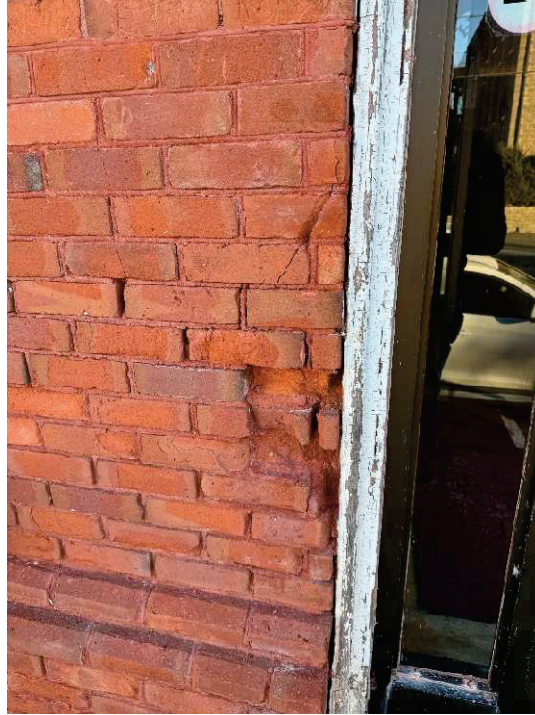
Photo #75

North brick wall near the stair entrance shows deterioration, with visible gaps, crumbling mortar, and brick damages

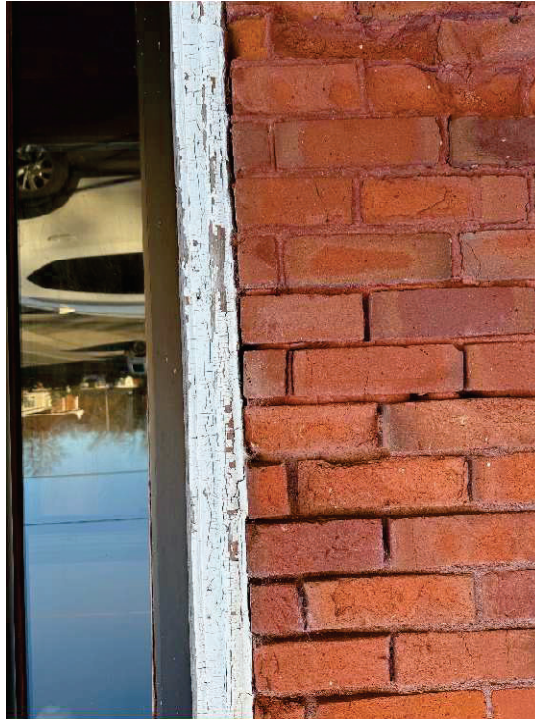
Photo #76

North Bick Wall near to the entrance door exhibits severe localized deterioration, including spalling, cracking, and material loss, with some bricks entirely damaged.

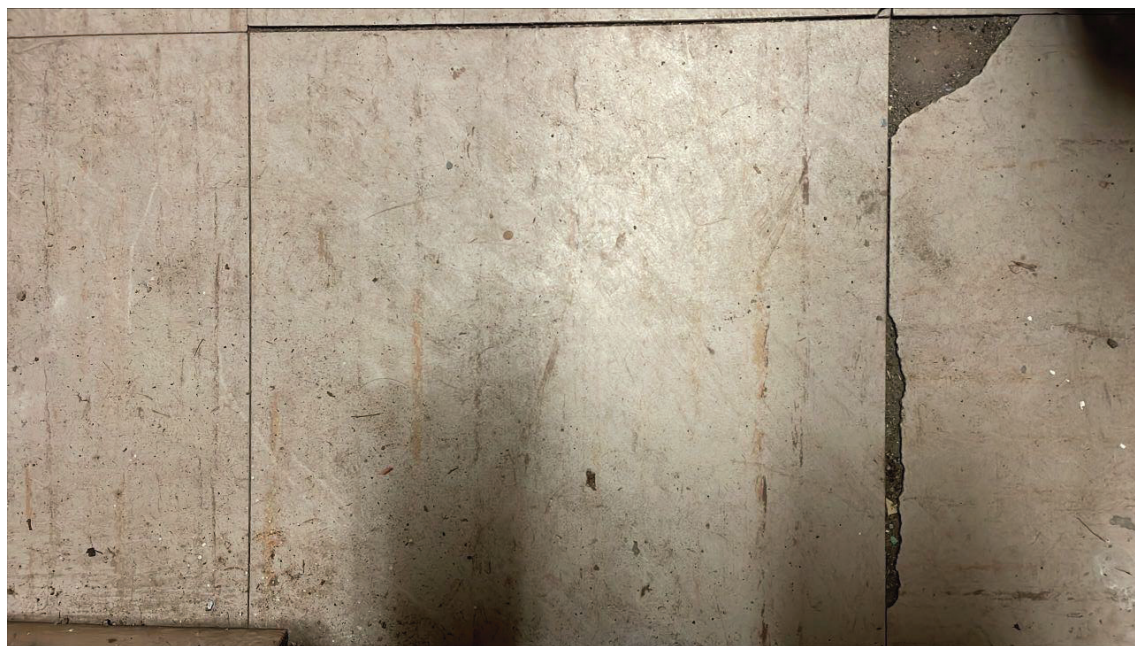
Figure 1: Asbestos-containing 12"x 12" vinyl tile from Basement

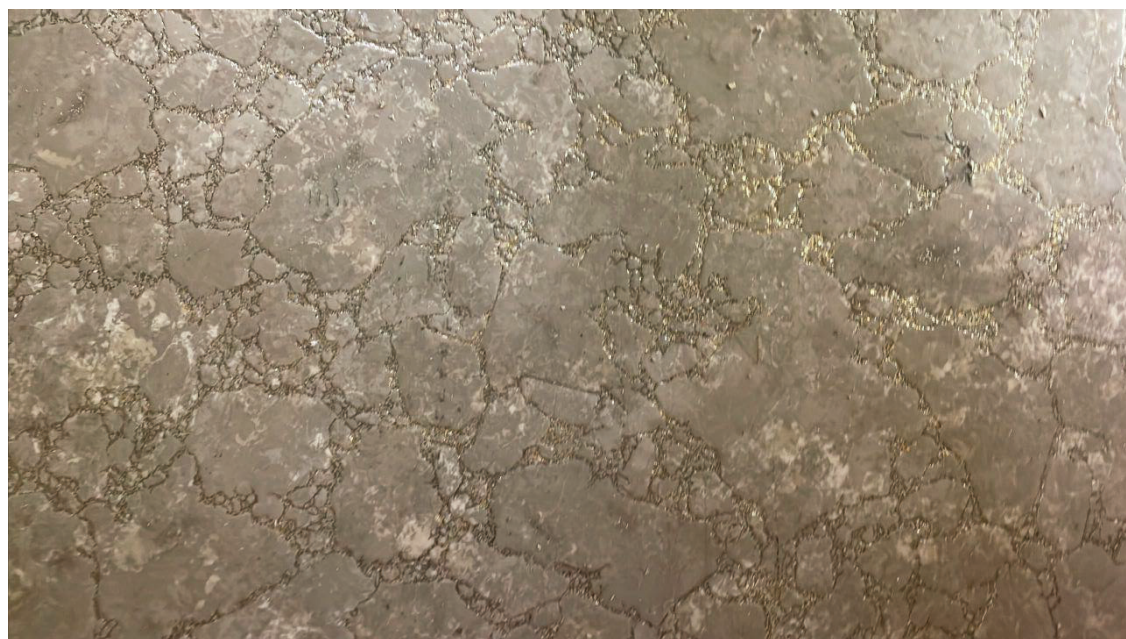
Grey vinyl sheet flooring is present in the Carpentry Shop. This material was sampled (Sample 8-1 to 8-3) and found to contain chrysotile asbestos. Vinyl sheet flooring is a non-friable material and is in good condition.

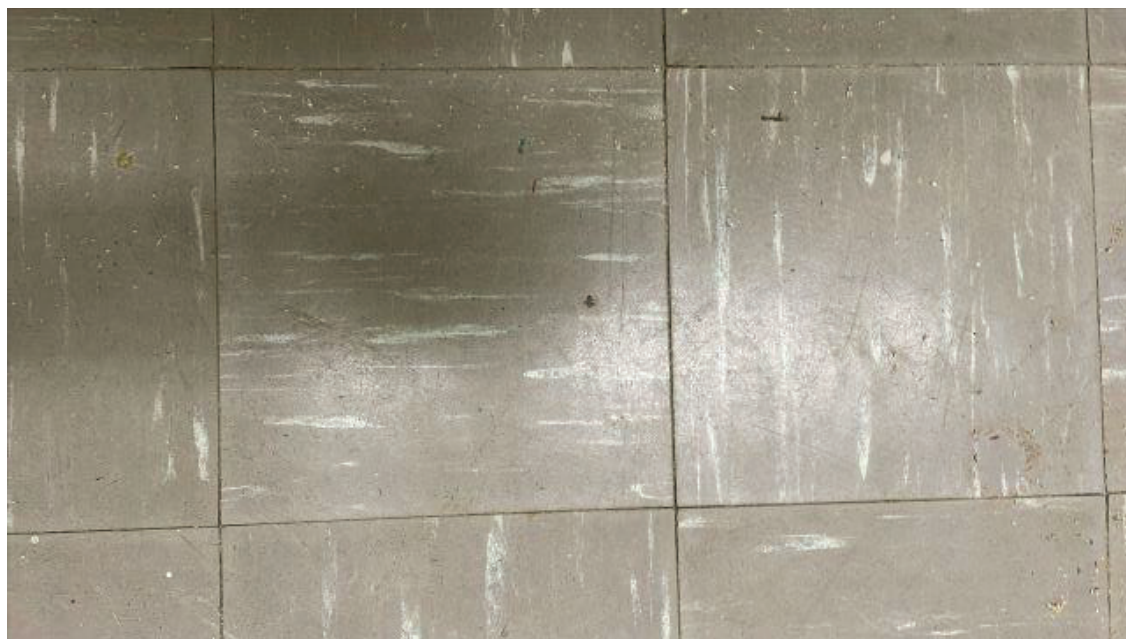
9"x 9" grey floor tile with beige fleck is present in the Carpentry Shop. This material was sampled (Sample 9-1 to 9-3) and found to contain chrysotile asbestos. Vinyl floor tile is a non-friable material and is in good condition. There are approximately 150 square feet present.
