TOWNSHIP OF HAVELOCK-BELMONT-METHUEN

To: Mayor Martin and Members of Council
From: Bob Angione, Chief Administrative Officer/Clerk
Meeting Date: March 4, 2025
Subject: Repairs to Old Town Hall (1 Mathison Street West)

Building Envelope Condition Assessment (BECA) Report

RE: Building Envelope & Roof Condition Assessment for Old Town Hall, 1 Mathison Street West, Havelock ON

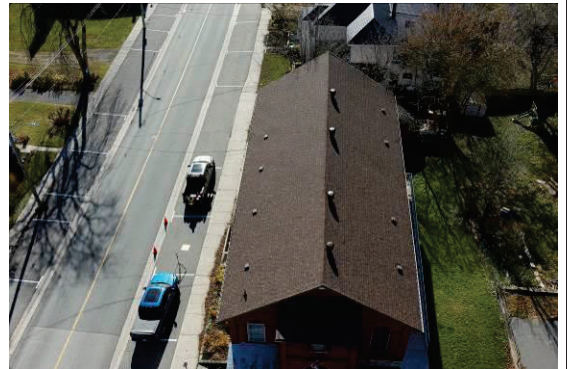
Description:
General view of the slope asphalt shingle roof on the Main Building.

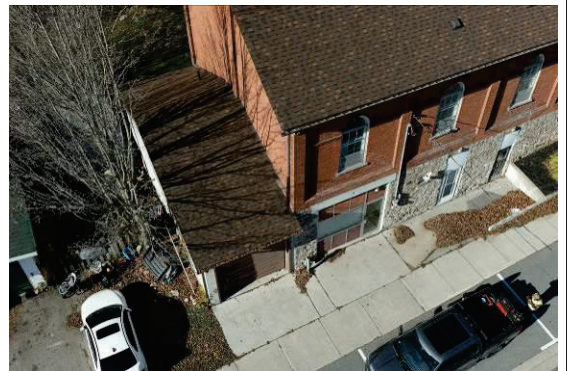
Description:
General view of the slope asphalt shingle roof on the South Addition.

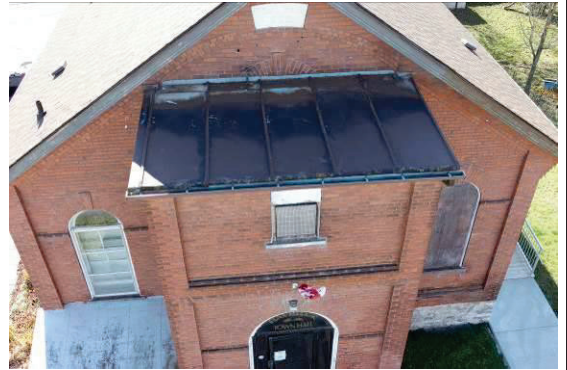
Description:
General view of the slope metal roof on the North Front Entry.

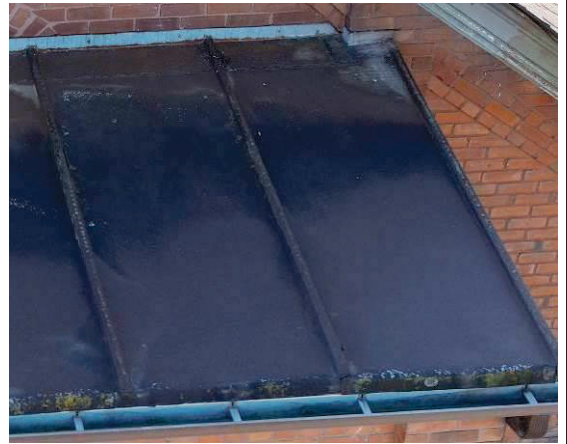
- Corrosion was noted on the entire surface of the standing seam metal roof panels.

Description:
Closeup view of corroded standing seam metal roof panels.

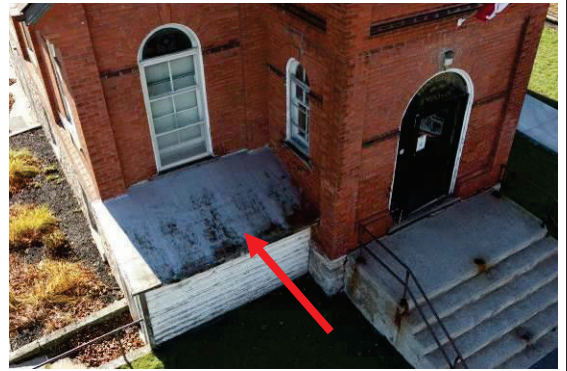
Description:
General view of the slope metal roof on the North Front Entry.

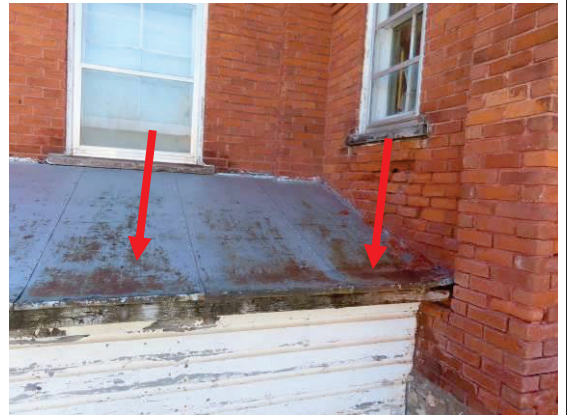
- Corrosion was noted on the surface of the metal roof panels.

Description:
Closeup view of surface corrosion on metal roof.

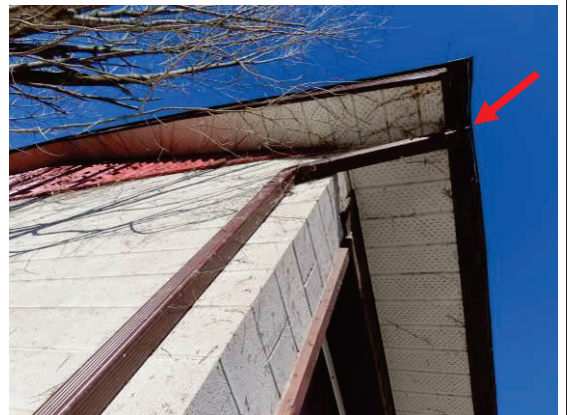
Description:
View of damaged eavestrough on the west side of the Main Building.

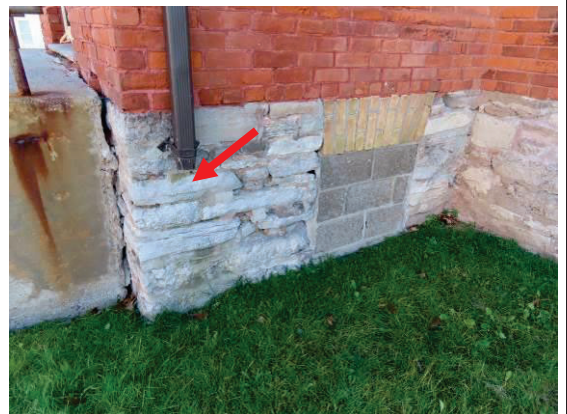
Description:
View of missing downpipe on the Main Building, located on the northwest corner.

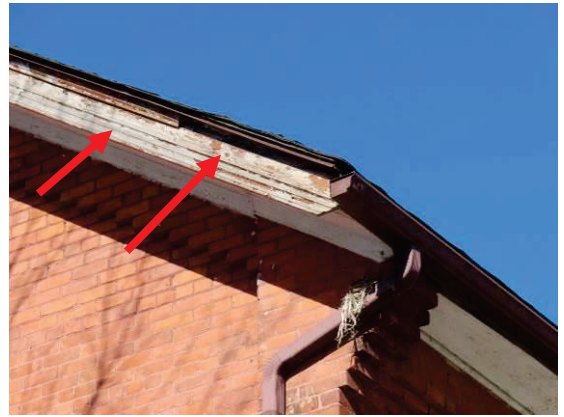
View of poor condition of the wooden fascia. Note that a section of the top fascia trim is missing.

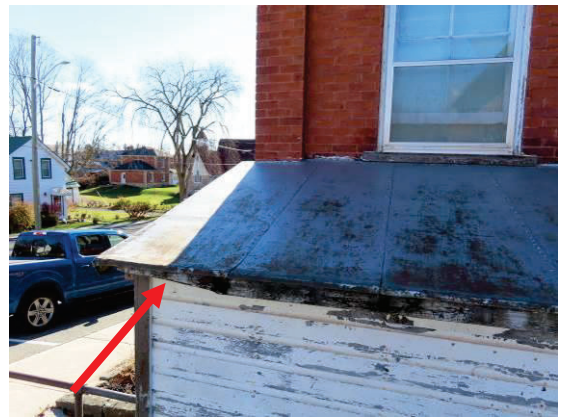
View of missing wooden fascia board.

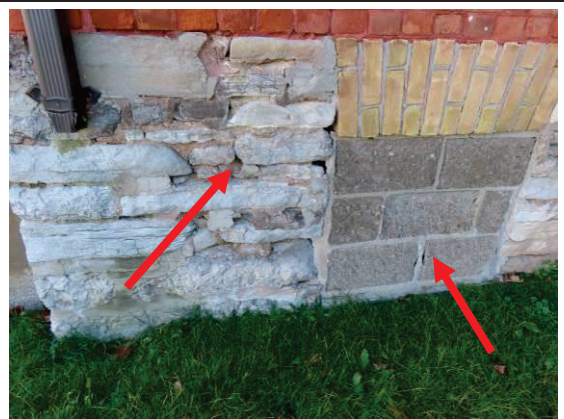
View of typical poor mortar joints on the stone foundation wall. Additionally, the concrete block in-fill was also noted to be deteriorated.

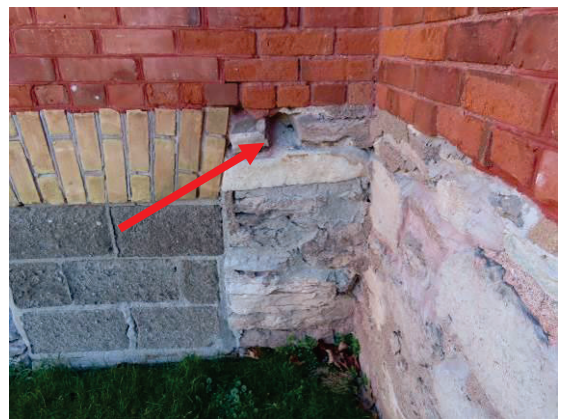
Typical hole encountered on the stone foundation wall.

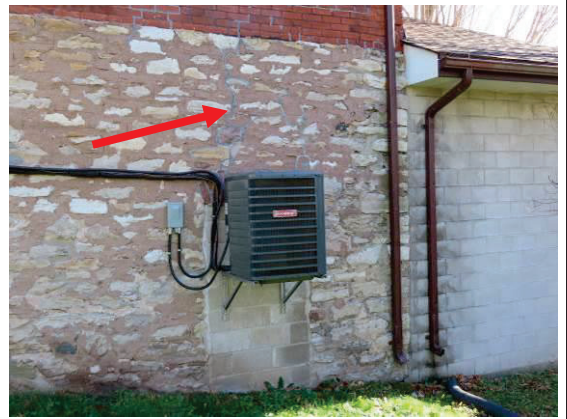
Description:
Vertical crack on the stone foundation wall. Additionally, the general condition of the mortar between stone units were found to be in poor condition.

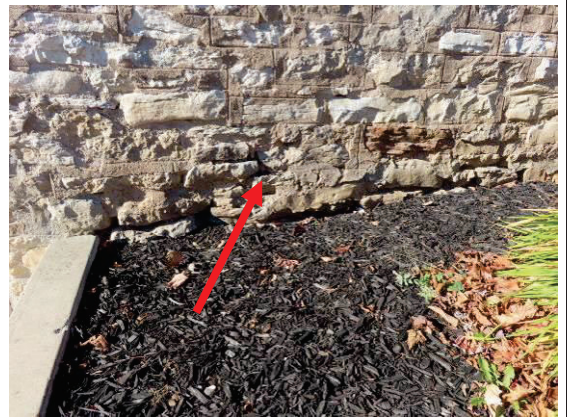
Description:
View of typical poor condition of stone foundation wall at grade level.

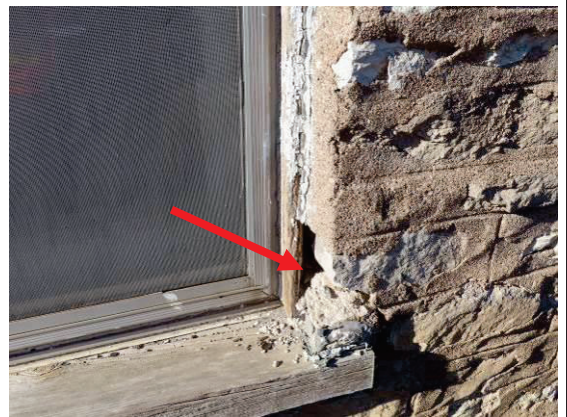
Description:
View of opening into the stone wall at exterior window.

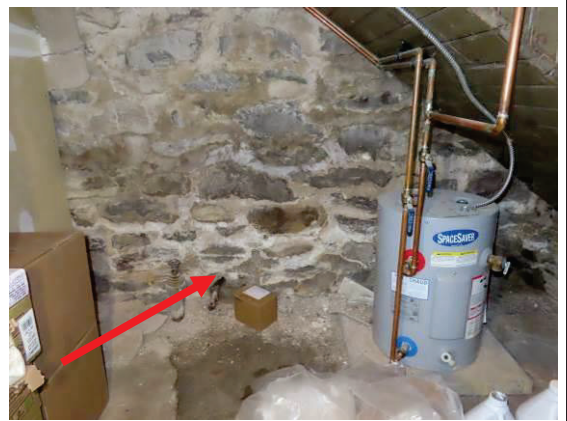
Description:
View of the interior side of foundation walls within the lower level basement. Past and/or active leakage from stone foundation wall is evident.

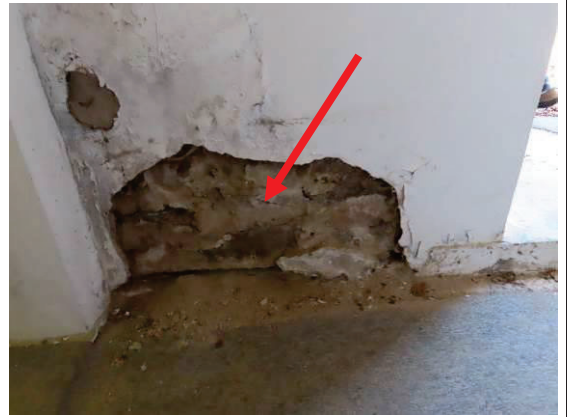
View of damaged plaster finish at the bottom of the interior side of foundation walls within the lower level basement. Damage appeared to be the result of leaks from stone foundation walls.

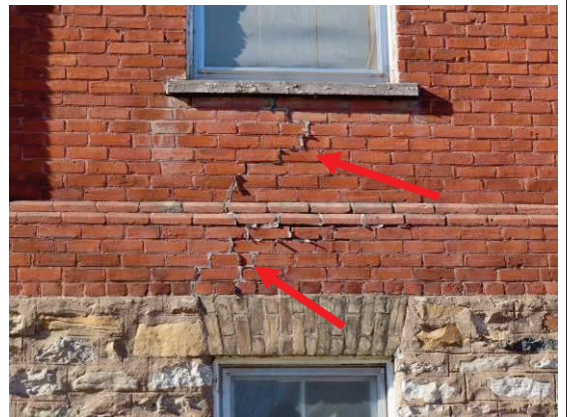
View of typical poor and failed mortar between masonry brick units at the bottom of a typical exterior window.

Note that poorly applied caulking has been incorrectly applied to failed mortar of masonry brick wall.

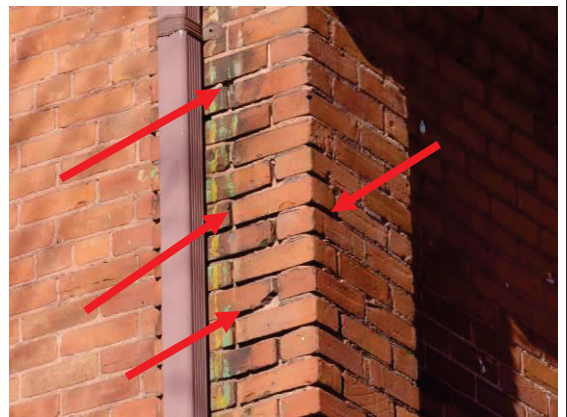
Closeup view of severely deteriorated and missing mortar between masonry brick units at an outside exterior wall corner. This defect is suspected to be the result of water leakage from a past leaking roof eavestrough and/or downpipe at this location.

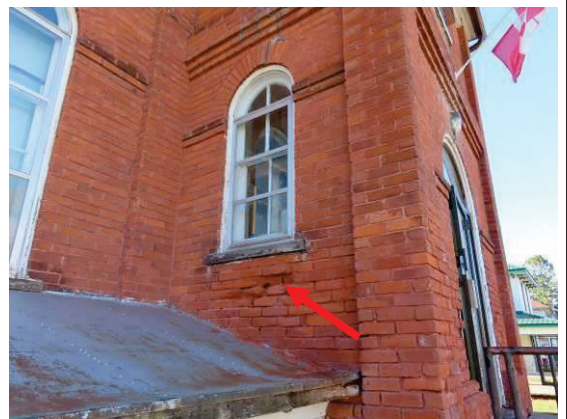
The existing masonry bricks at the base of the exterior window were found to be severely deteriorated, extensively damaged, and partially missing.

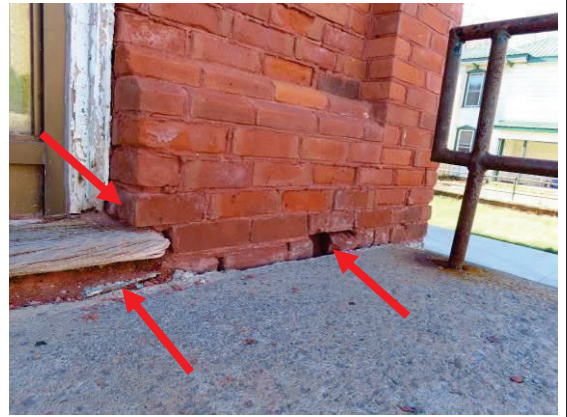
The existing masonry bricks at the base of the exterior front entrance door were found to be severely deteriorated, extensively damaged, and partially missing.

This defect is suspected to be the result of prolonged exposure to salt applied on the concrete landing in this area.

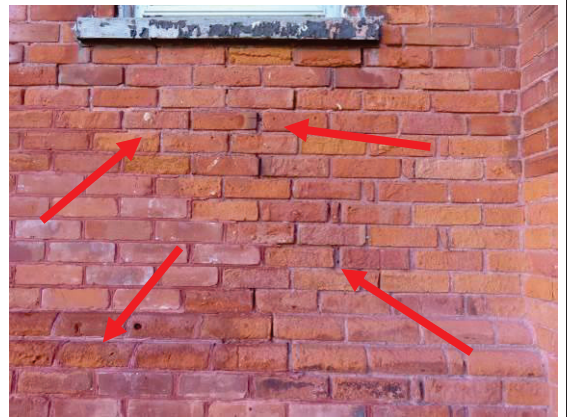
A typical view of a large, damaged section of the exterior masonry brick wall, featuring spalled bricks and deteriorated mortar located beneath an exterior window.

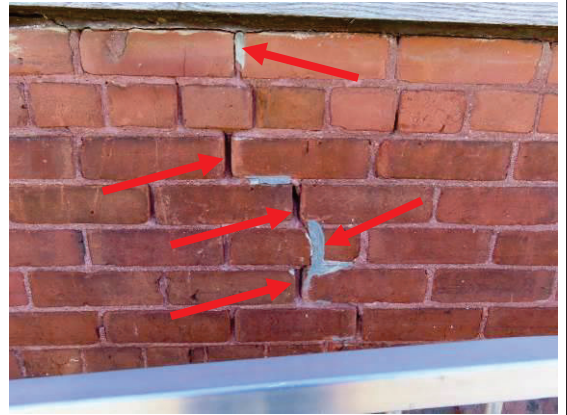
Closeup view of severely deteriorated mortar joints.

Note that poorly applied caulking has been incorrectly applied to failed mortar of masonry brick wall.

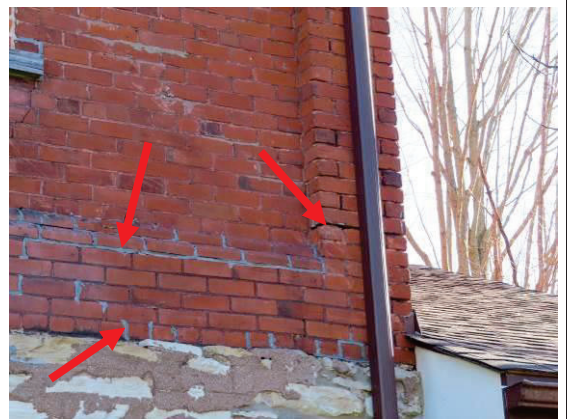
View of severely deteriorated outside wall corner with failed mortar joints.

Note that poorly applied caulking has been incorrectly applied to failed mortar of masonry brick wall.

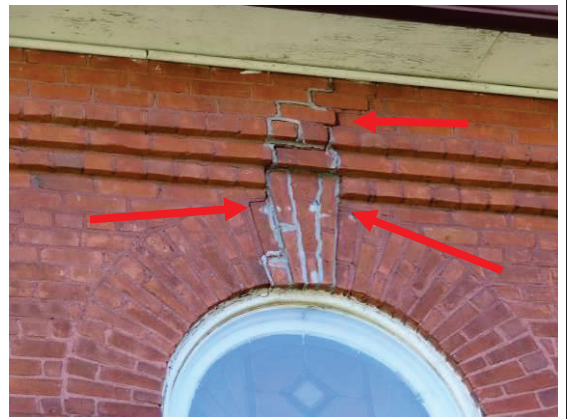
Description:
Damaged bricks and failed mortar were observed at the tops of all masonry arch lintels above the exterior windows.

Note that poorly applied caulking has been incorrectly applied to failed mortar of masonry brick wall.

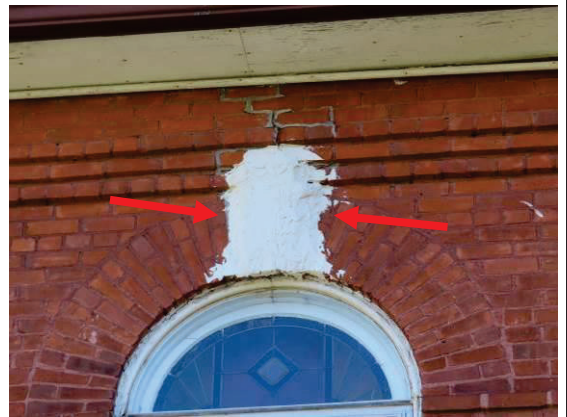
Description:
View of a poor repair performed at the masonry wall above the exterior window.

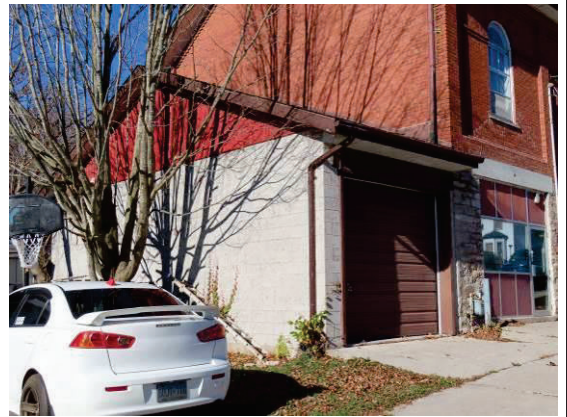
Description:
View of the existing Concrete Masonry Unit (CMU) Block walls of the South Addition Garage in good condition.

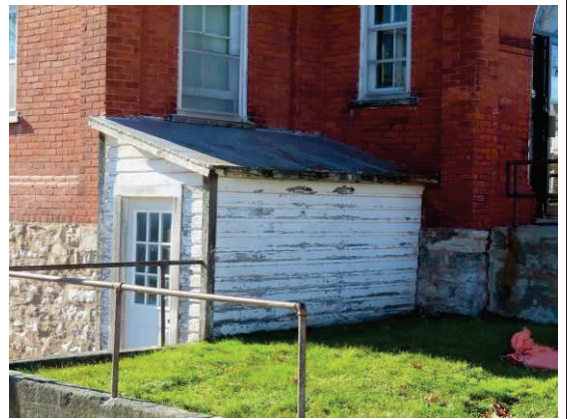
Description:
General view of the Northeast Lower-Level Entry Enclosure with wood siding wall board. The paint finish of the wall is deteriorated and in poor condition.

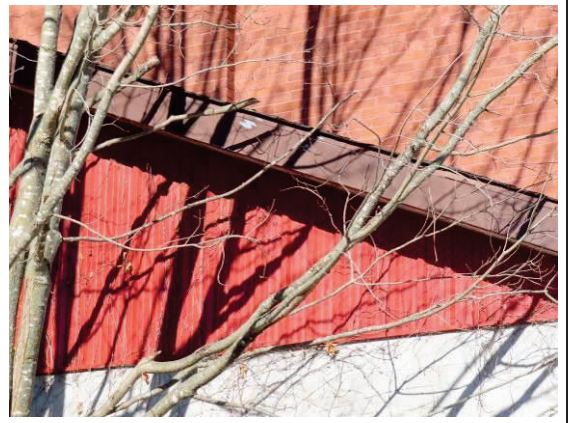
Description:
View of the existing metal clad wall assembly on the south elevation in good condition.

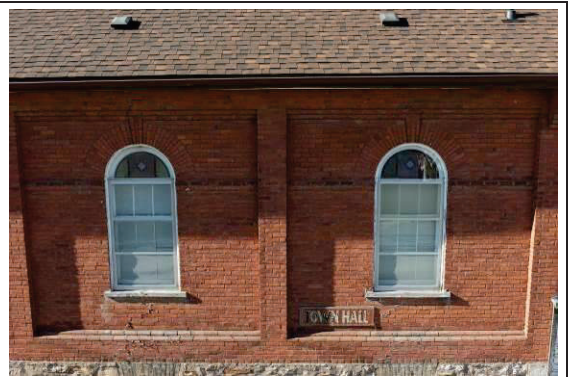
Description:
General typical view of exterior wooden windows on the east elevation of the building.

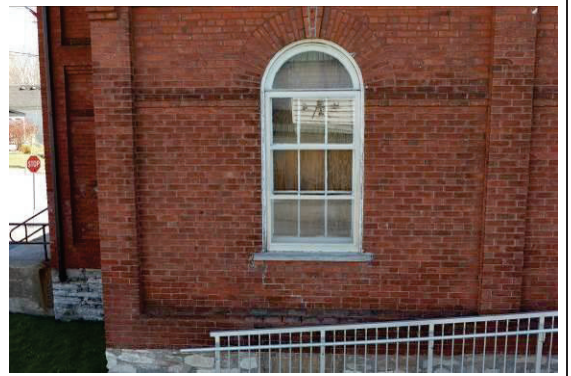
Description:
General view of a typical exterior wooden windows on the west elevation wall.

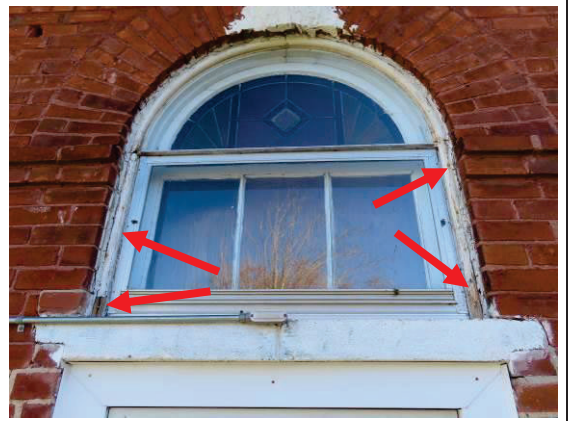
Description:
Closeup view of deteriorated wooden frames around a typical arched window.

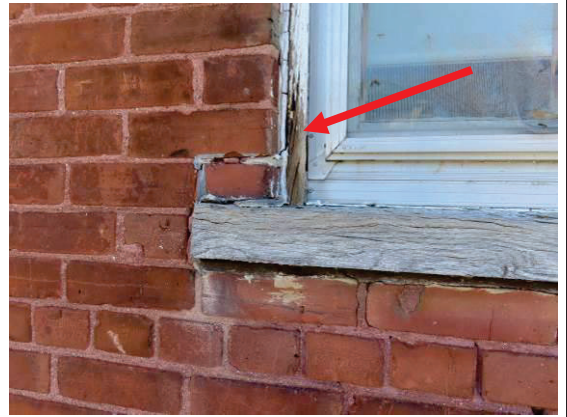
Description:
Rotted and damaged window frame.

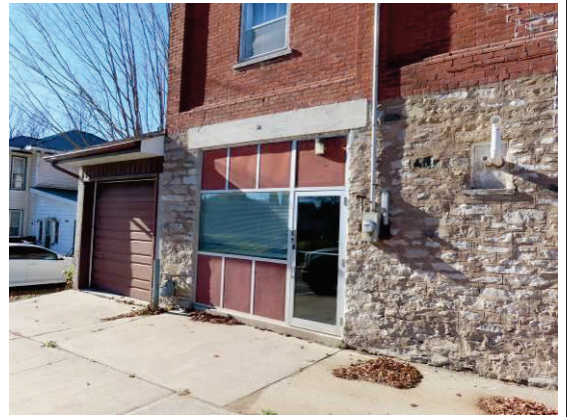
Description:
View of storefront aluminum combination windows and door located on the east elevation of the building at the OPP office in fair condition.

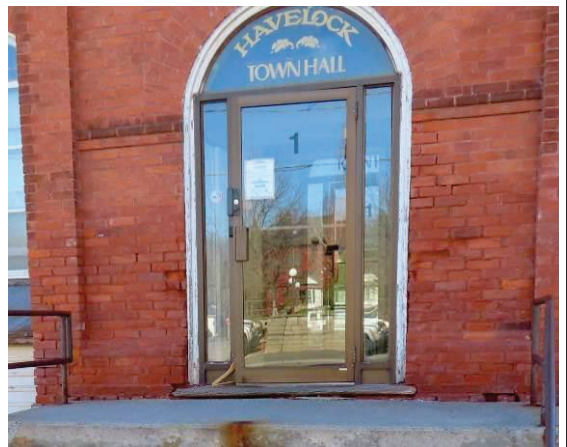
Description:
View of front entrance aluminum door assembly in poor condition.

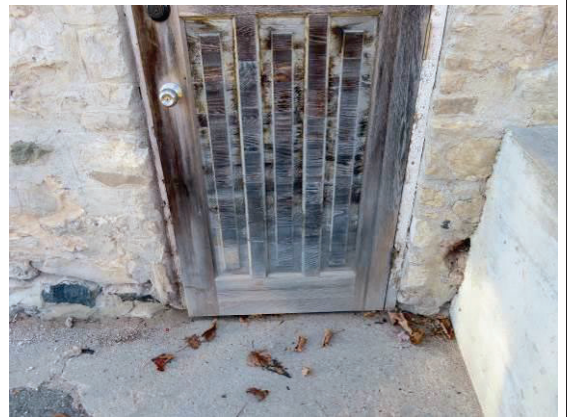
Description:
View of poor condition of the exterior wooden door located on the west side of the building.

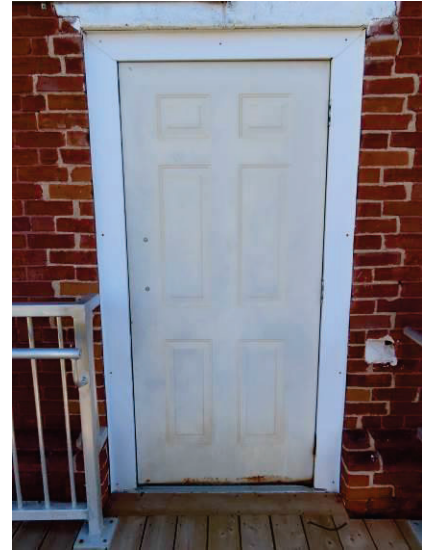
Description:
View of the metal door located on the west side of the building, top of the accessible wooden ramp.

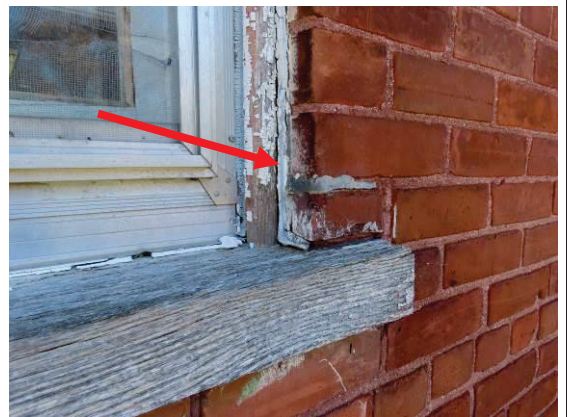
Description:
Typical view of severely deteriorated sealant around exterior window

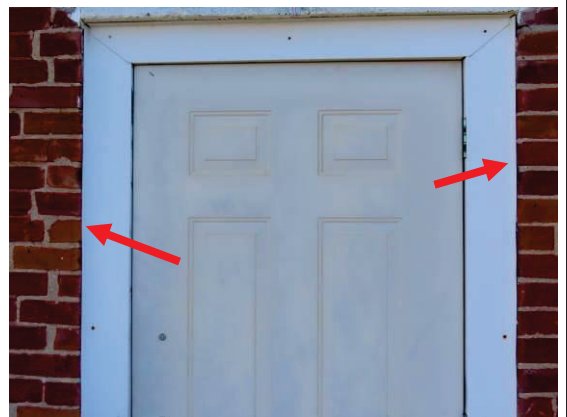
Description:
Lack of sealant around exterior metal doorframe on the west side of the building

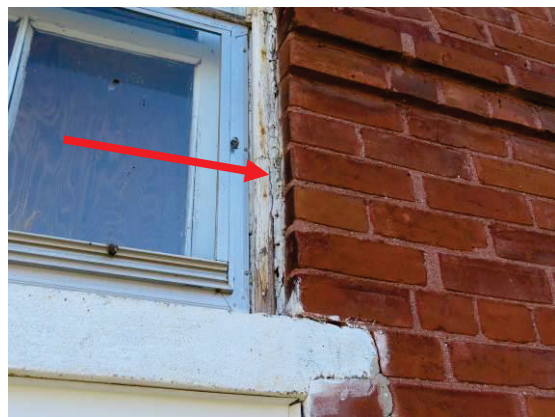
Description:

Typical view of severely deteriorated sealant around exterior windows and door.

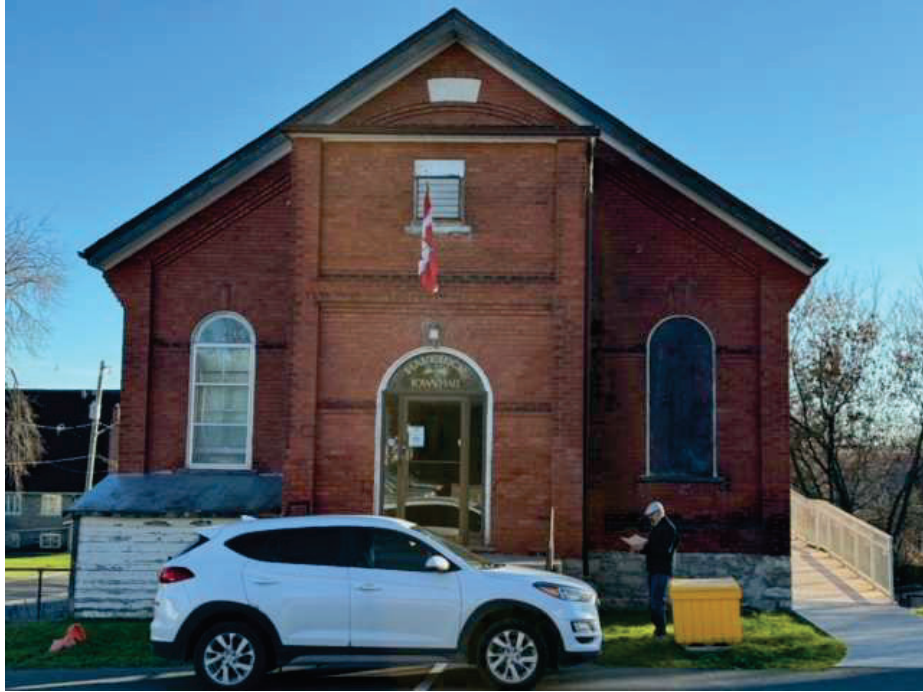
Photo #1
General View of the North Elevation

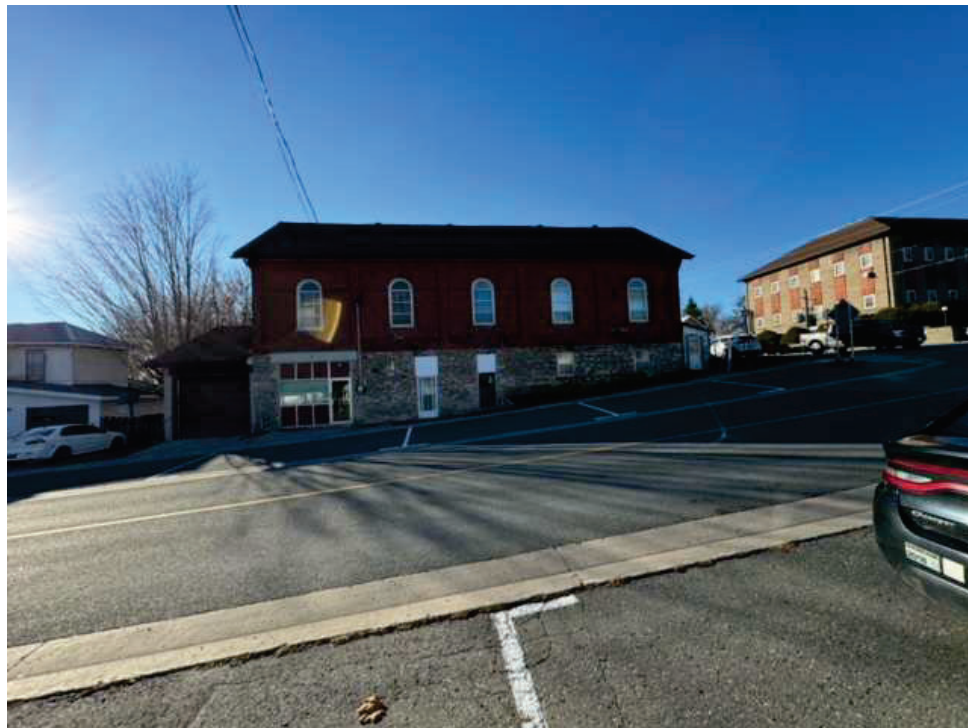
Photo #2
General View of the East Elevation

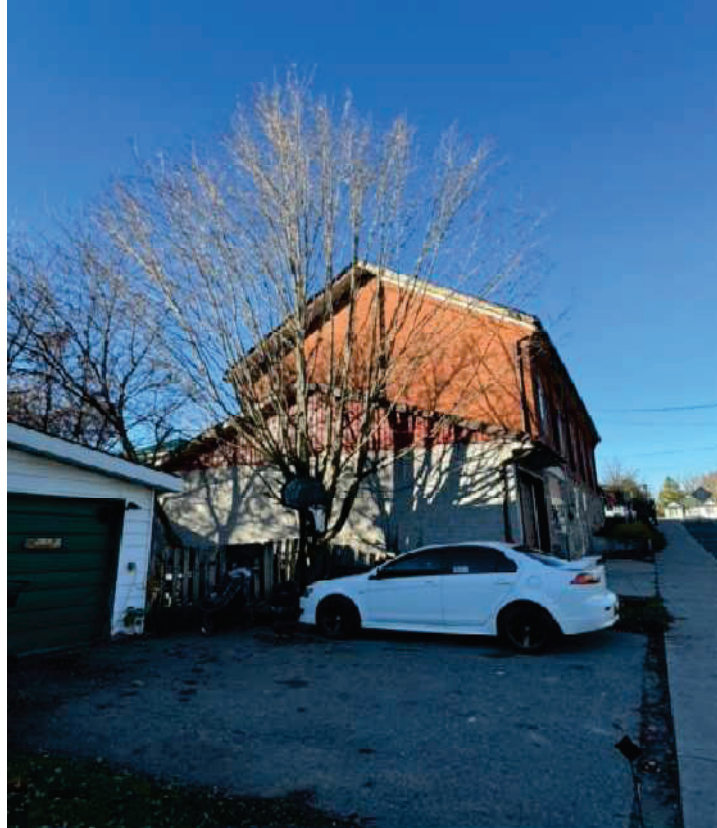
Photo #3
General View of the South Elevation

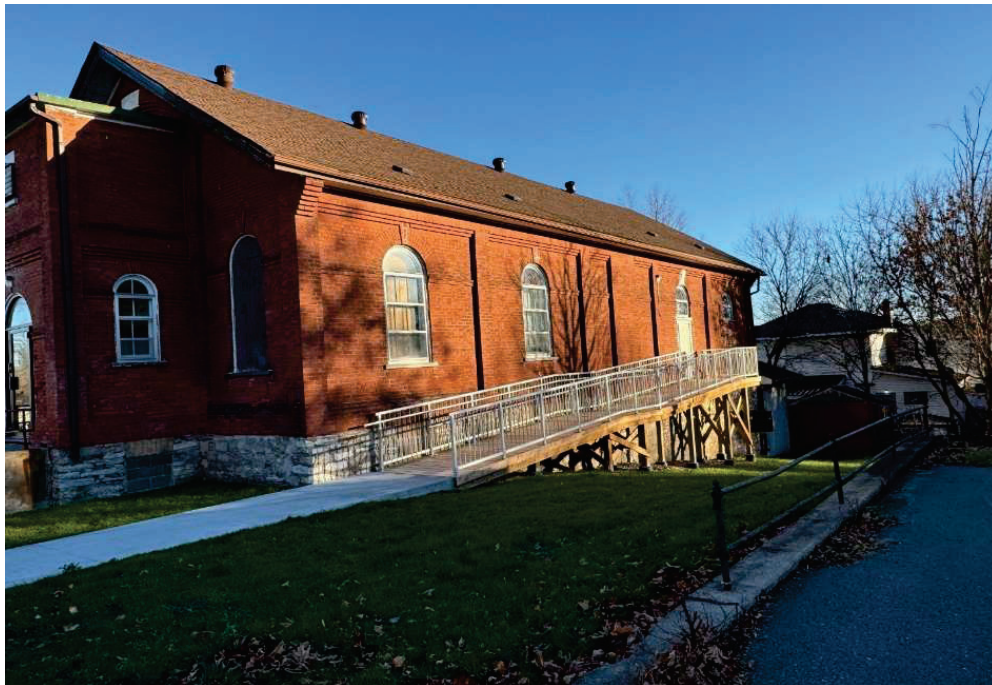
Photo #4
General View of the West-North Elevations

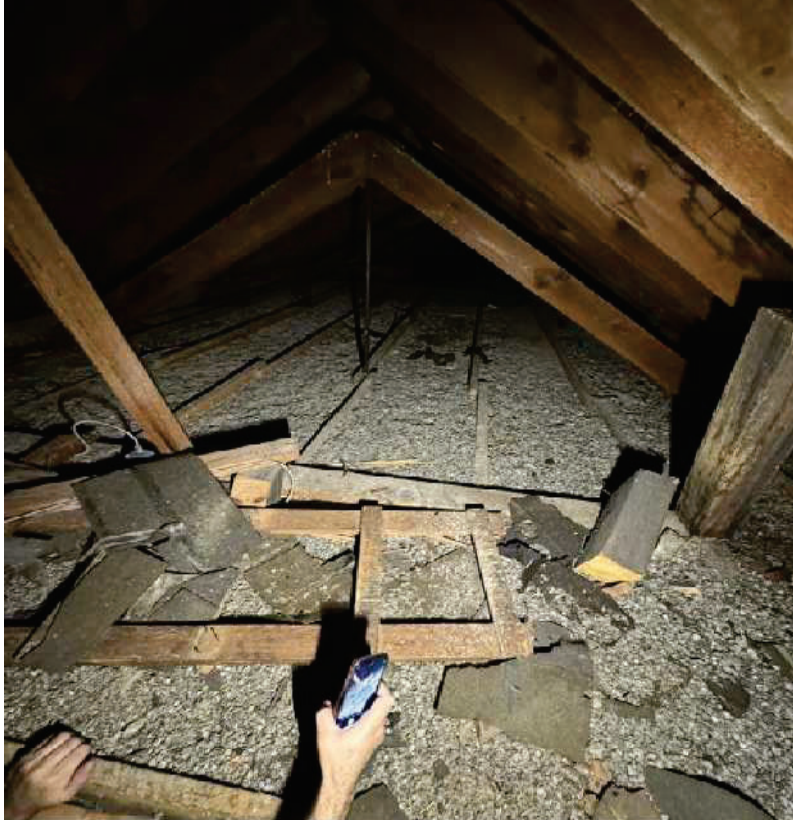
Photo #5

Photograph #5 provides a general view of the attic, showing the roof framing as seen from the north side, looking south. The image reveals extensive debris scattered across the attic floor, including broken wooden elements and deteriorated roofing materials. The structural members, such as rafters and floor elements, appear aged and may show signs of wear, including potential deficiencies in bracing and stability.

General View of the Attic Looking South – Scattered Debris, Deteriorated Materials, and Aged Rafters with Inadequate Bracing

Address deficiencies in connections and bracing to meet modern standards.

Reinforce or replace deteriorated wooden elements to ensure stability.

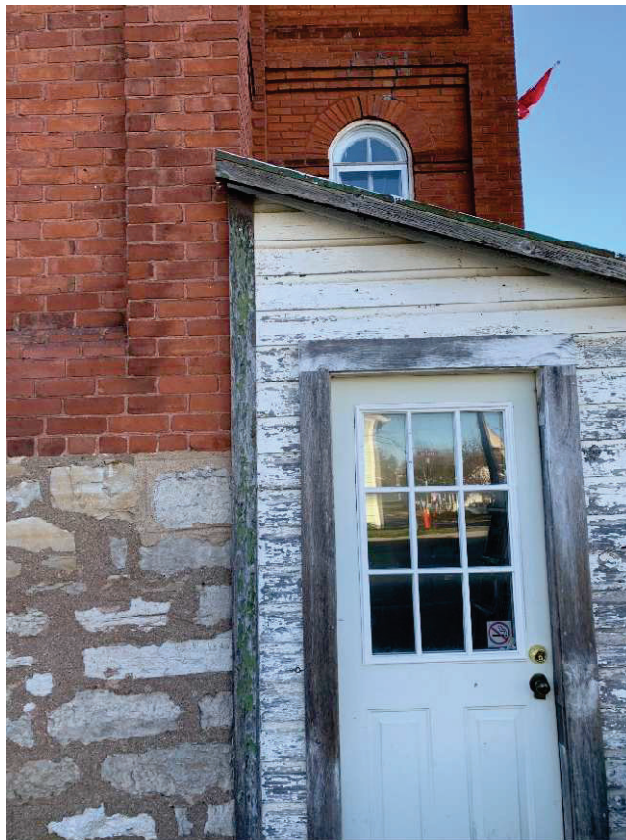
Photo #15

Photograph #14 shows the flat roof over the building entrance, as well as a portion of the gabled roof over the main building. Photograph #15 highlights the sloped roof over the basement access way. Photograph #16 displays the gabled roof over the garage.

View Highlighting the Sloped Roof Over the Basement Access Door, Looking West West

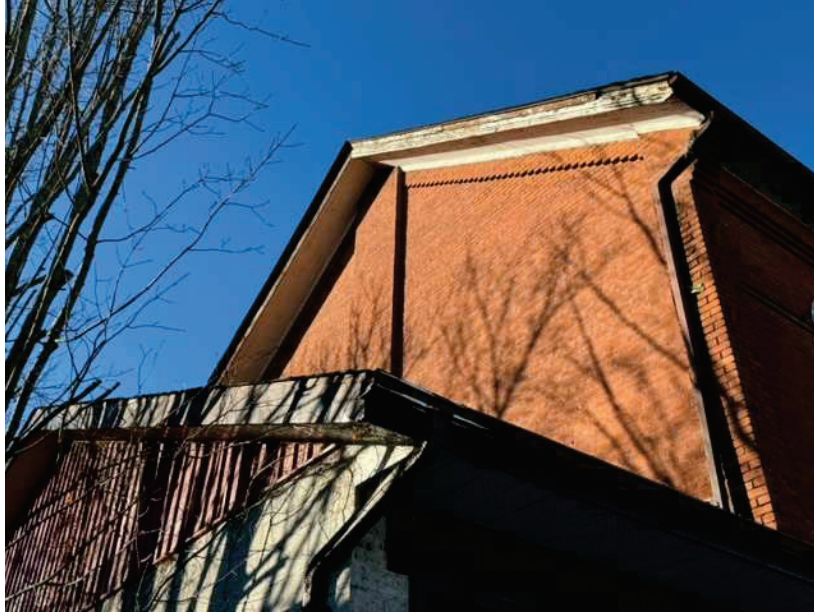
Photo #16

View of Gabled Roofs Over the Garage Addition and the Main Building – Highlighting Eaves and Supporting Structure, Looking Northwest

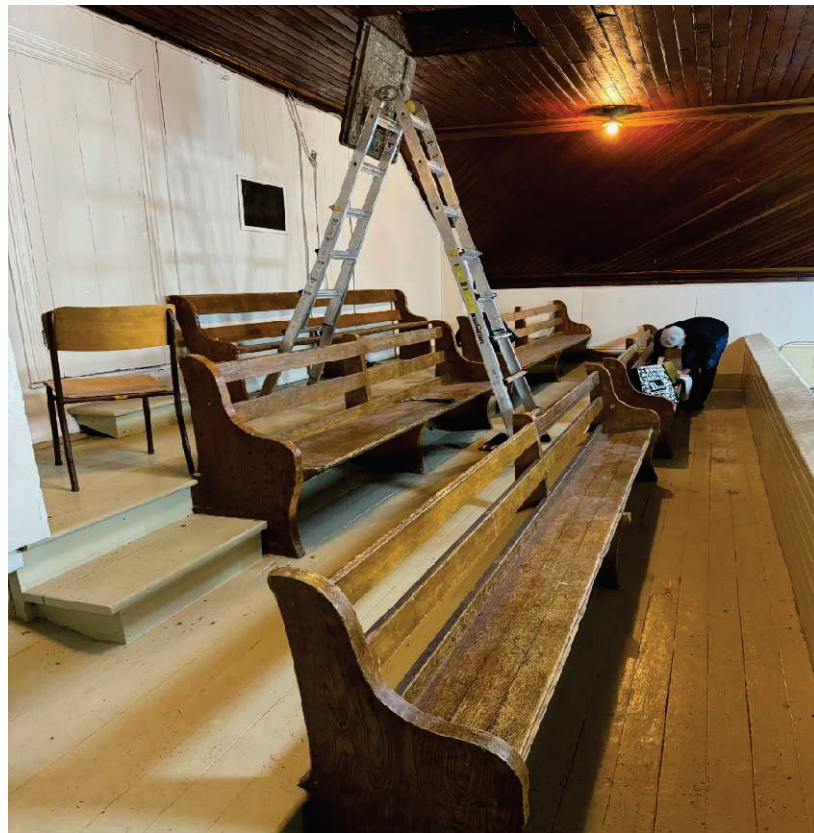
Photo #17

No visible indications of structural issues, stresses, misalignments, or movements were observed in the bleacher/ balcony area.

View of Bleacher/Viewing Balcony on Mezzanine Level – No Signs of Distress, Deflection, or Misalignments Observed in Walls, Floor, or Over Door to Mechanical Room. Attic Access Opening Shown in Ceiling Overhead with Ladder Used for Attic Entry, Looking East.

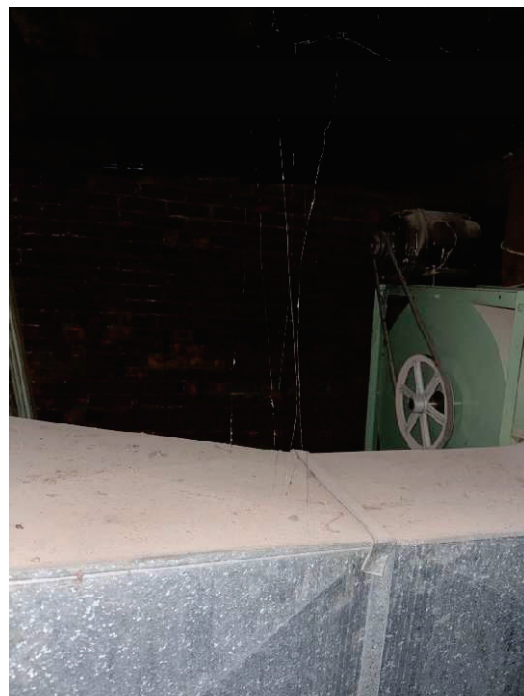
Photo #20

Photograph #20 shows the mechanical room with exposed exterior brick walls, a dusty metal duct, and visible cobwebs. The space contains a green mechanical unit with a pulley system, indicating ventilation or other machinery. The area appears to be poorly maintained and cluttered.

View of Mechanical Room – Featuring a Mechanical Duct, Black-Colored Brick Walls, and a Black-Painted Ceiling. Looking East.

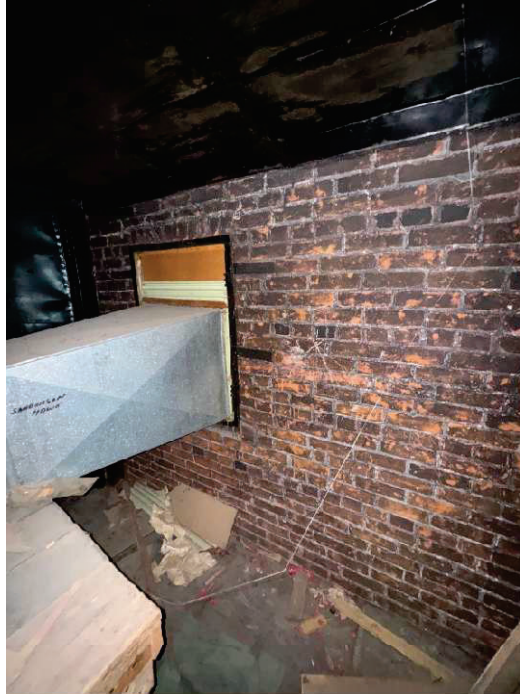
Photo #21

Mechanical Bleacher Room – Featuring Exposed Brick Walls with Worn Joints, a Black-Painted Ceiling, Cobwebs, a Mounted Metal Duct, and Scattered Debris, Indicating Poor Maintenance. Looking Southeast.

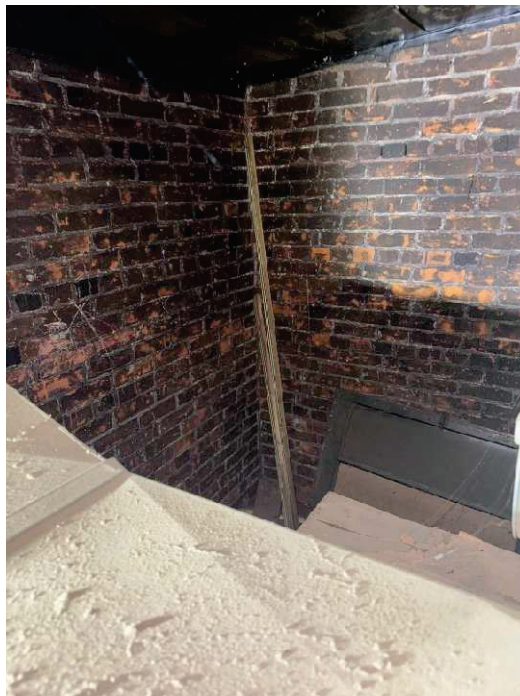
Photo #22

Mechanical Bleacher Room – Featuring Exposed Brick Walls with Worn Joints, a Metallic, Black-Painted Ceiling, Cobwebs, Scattered Debris, and Signs of Poor Maintenance. Looking Southeast.

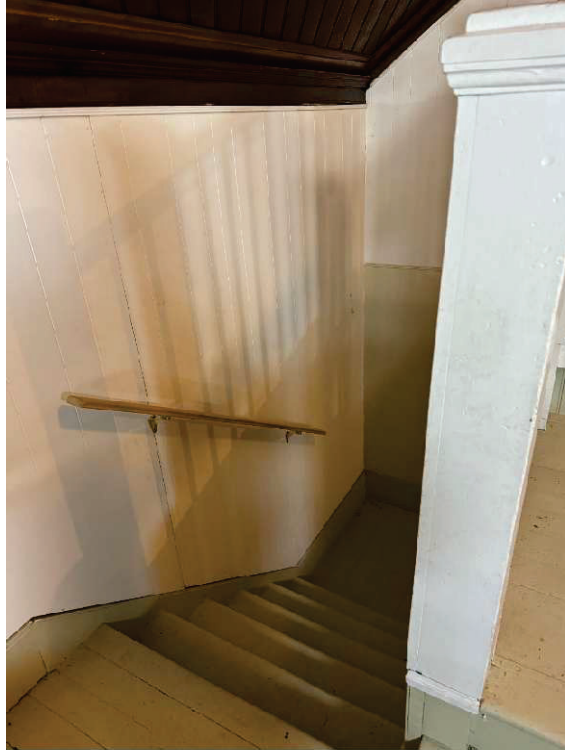
Photo #23

Wooden Staircase from Bleacher to Landing –
Featuring a Railing on One Side, Viewed from the Top.

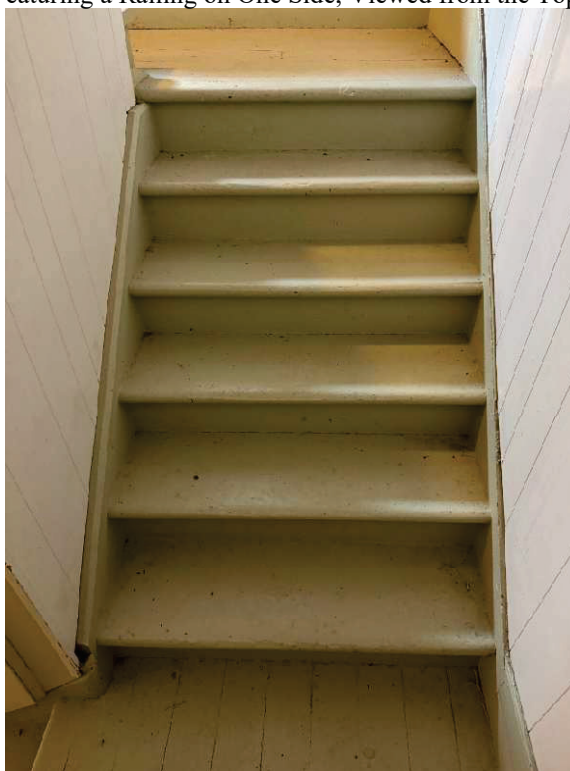
Photo #24

Wooden Staircase from the Landing to the Bleacher
Area – No Railing Present. No Structural Irregularities
Such as Cracks, Deflections, or Movements Observed.
Looking South.

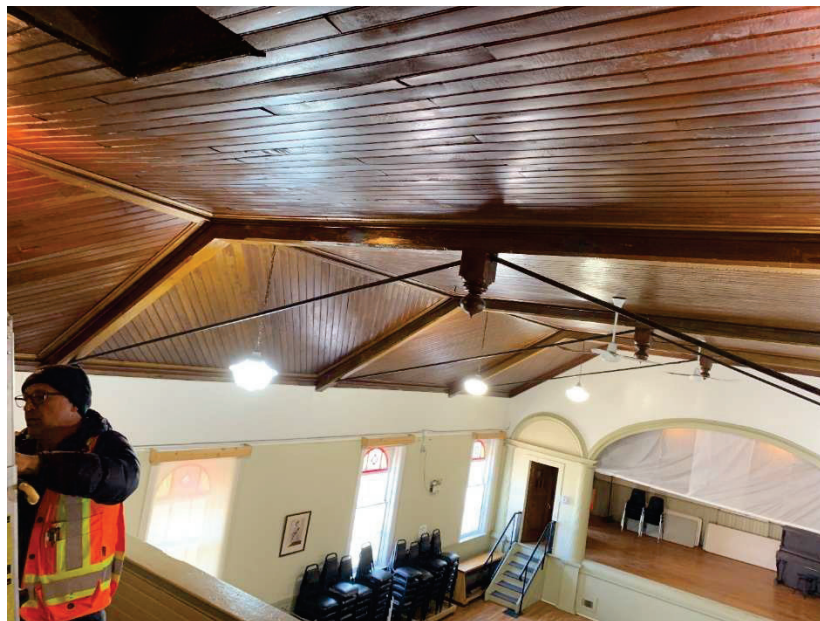
Photo #26

View of the Town Hall from Bleacher Looking Southeast – Featuring a Wooden Vaulted Ceiling with Visible Wood Roof Trusses and Steel (~35mm Diameter) Tension Ties/Cables. The Two Sloped Steel Tension Cables/Ties Are Connected to the Main Tension Tie/Cable/Hang-Up Shown in Attic Photo #13, Providing Structural Support Against Thrust Forces Generated by the Roof Rafters. The Photo Also Shows the Performance Stage, Stairs to the Stage, Windows with Stained Glass, and the Main Hall Below.

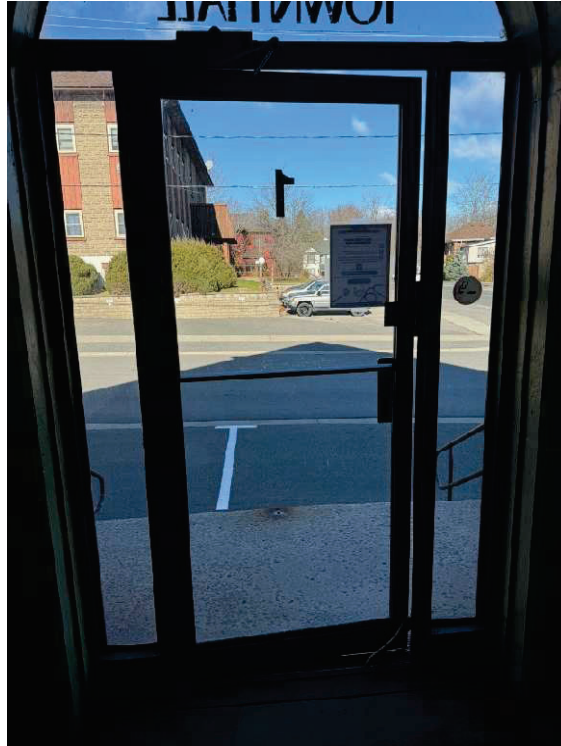
Photo #27

Main Entrance door (Photographs #27) is a glass-paneled, metal-framed unit set within the original arched brick masonry opening, supported structurally by the surrounding load-bearing brick wall.

Main Entrance Door – View Looking North from Inside the Building.

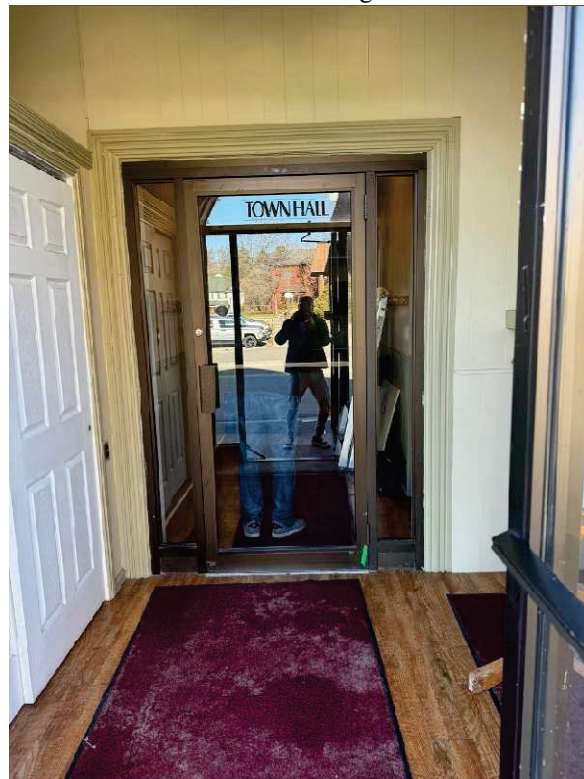
Photo #28

Second Interior Entrance Door – View Looking South Towards the Town Hall Entrance Door.

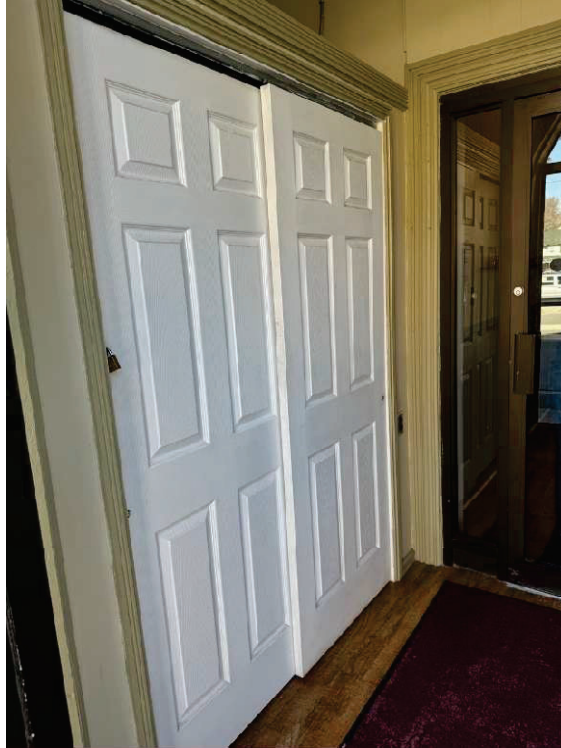
Photo #29

East Closet in Entrance Corridor – View Looking Southeast.

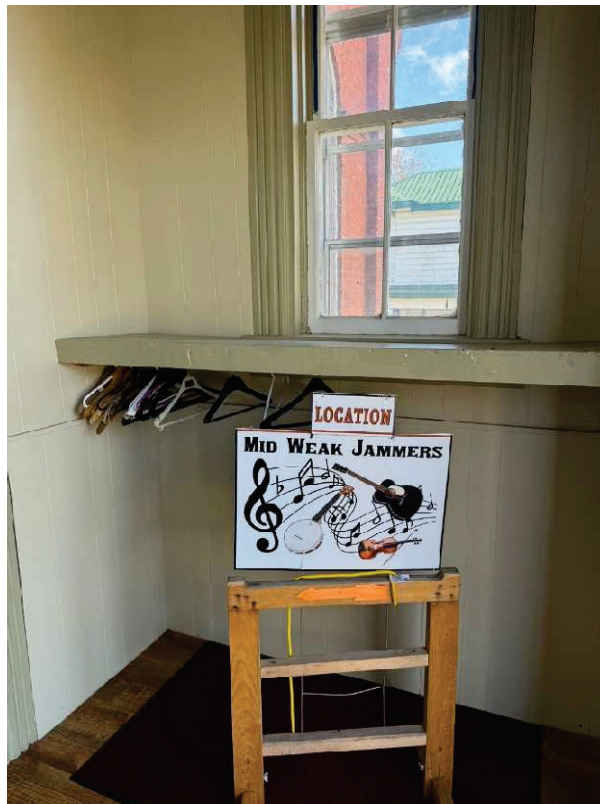
Photo #30

West Closet in Entrance Corridor – View Looking Southwest.

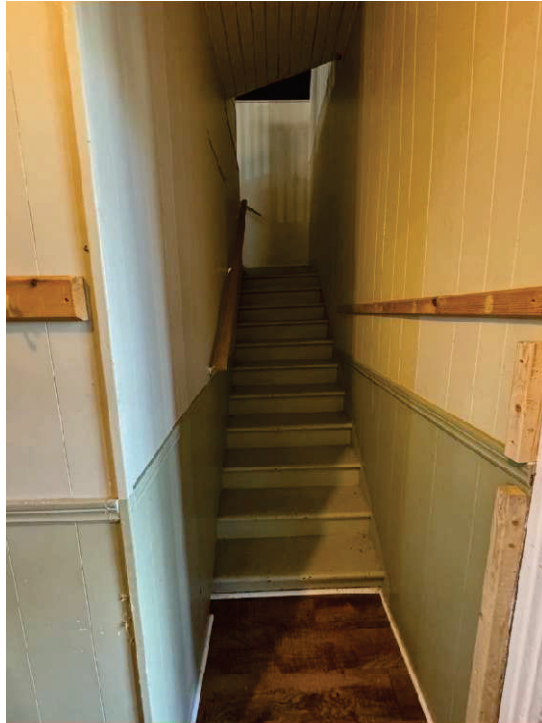
Photo #31

Stairs to the Bleacher – View Looking West. These Stairs Were Previously Closed Before the Inspection. No Signs of Structural Irregularities Were Observed During the Inspection.

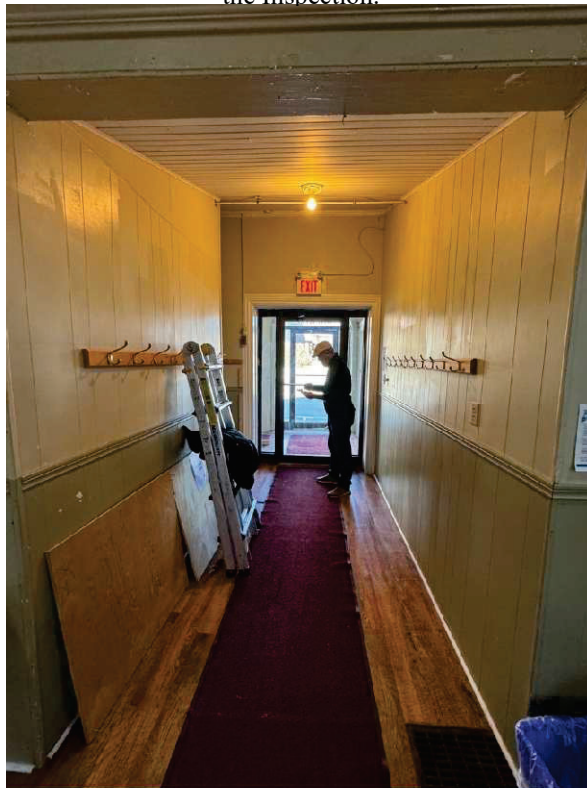
Photo #32

The corridor connects the Town hall to the building's entrance and is characterized by wooden flooring and paneled walls (see photograph #32). The structural layout appears consistent, with no visible irregularities.

Corridor Leading to the Town/ Banquet Hall
View Looking North

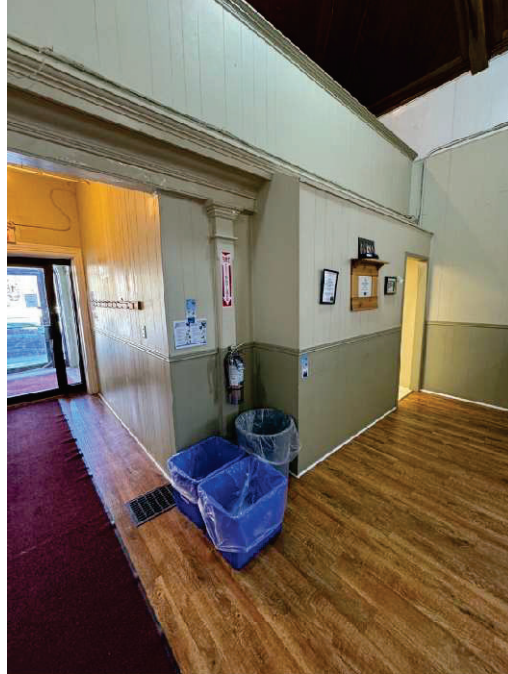
Photo #33

Washroom Area – Featuring a Structural Column with a Capital. No Signs of Structural Irregularities Were Observed During the Inspection of Any Structural Member.
