TOWNSHIP OF HAVELOCK-BELMONT-METHUEN

To: Mayor Martin and Members of Council
From: Bob Angione, Chief Administrative Officer/Clerk
Meeting Date: March 4, 2025
Subject: Repairs to Old Town Hall (1 Mathison Street West)

Building Envelope Condition Assessment (BECA) Report

RE: Building Envelope & Roof Condition Assessment for Old Town Hall, 1 Mathison Street West, Havelock ON

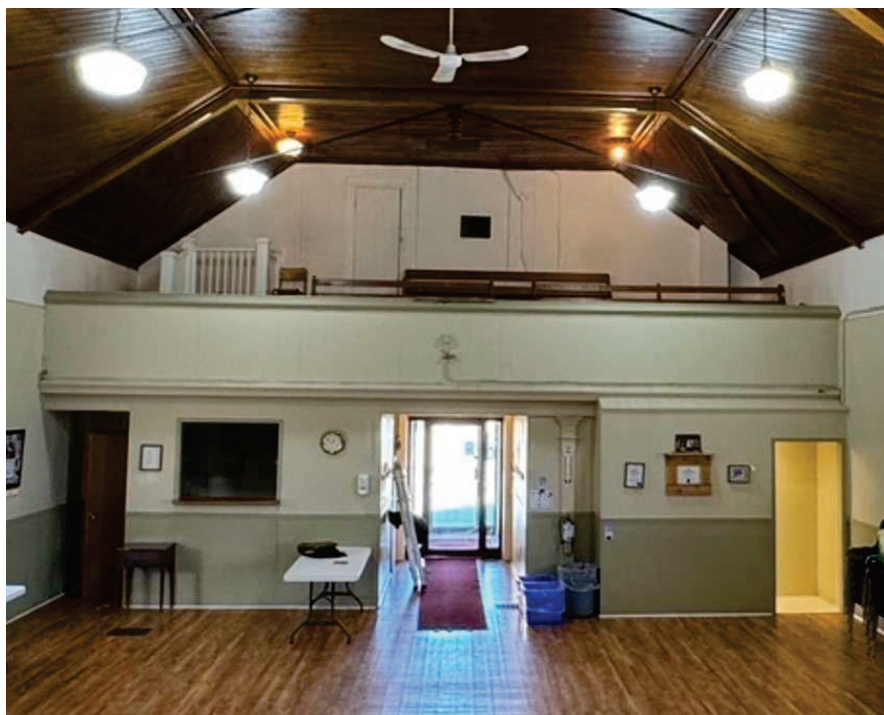
Photo #34

Interior View of Hall with Bleacher/Mezzanine Support System Showing Kitchen (West) and Washrooms (East), Supported by Brick Walls, Structural Columns, and Beams with No Visible Defects

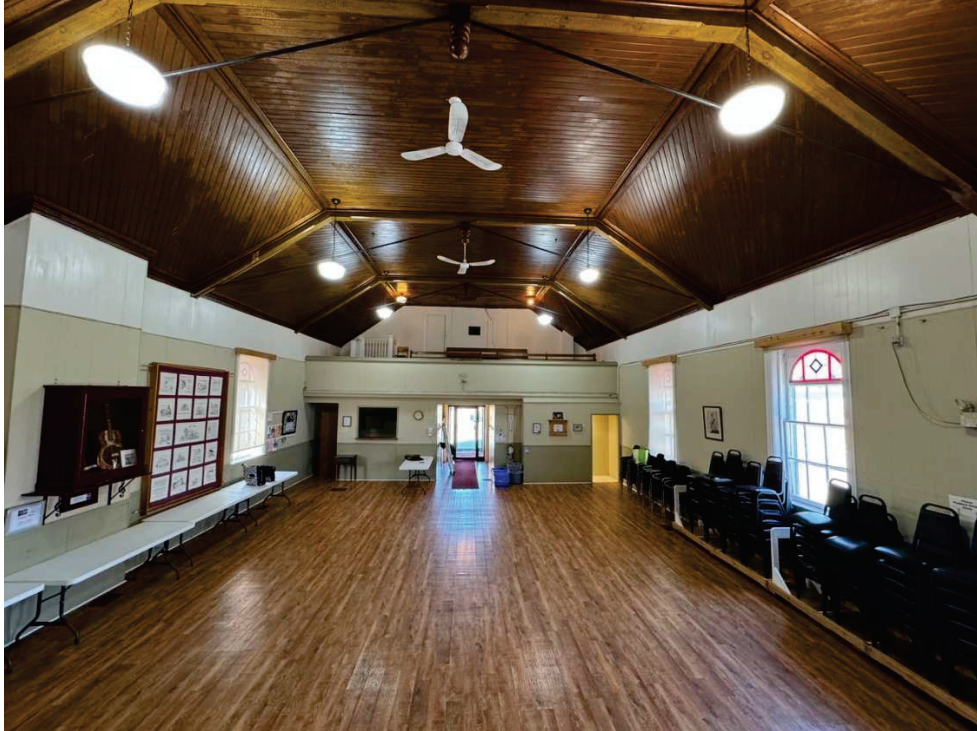
Photo #35

Interior View of Town Hall Looking North, Showing Roof Structure, Walls, and Mezzanine with No Visible Signs of Distress, Misalignment, Deflection, or Structural Irregularities

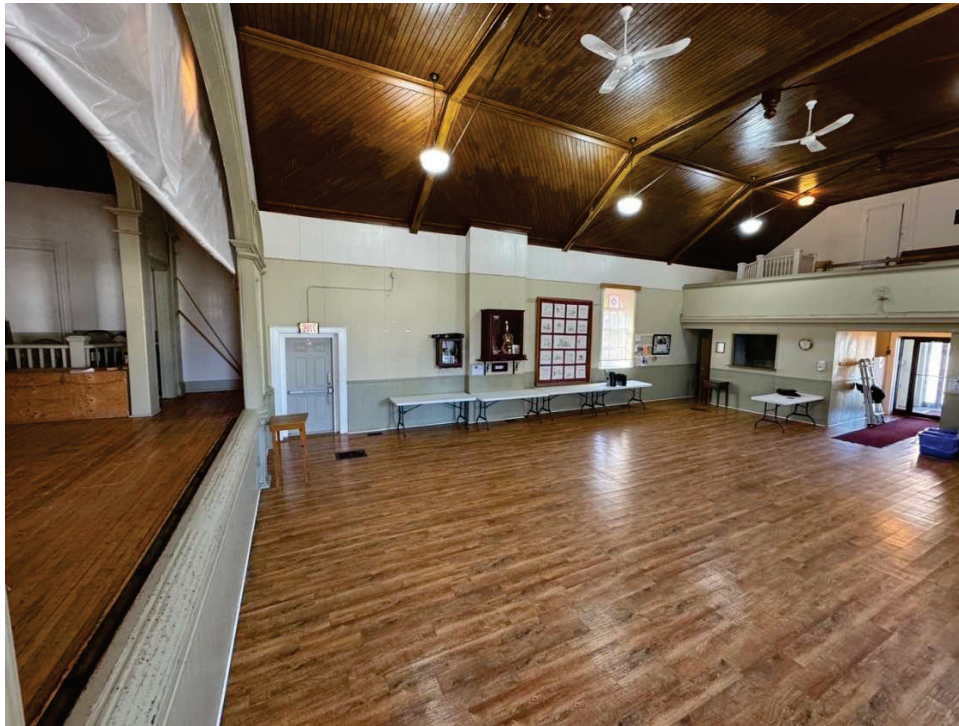
Photo #36

Interior View of Town Hall Capturing South-West-North Sides, Including Stage Area, Roof Structure, and Walls with No Visible Signs of Distress, Misalignment, Deflection, or Structural Irregularities

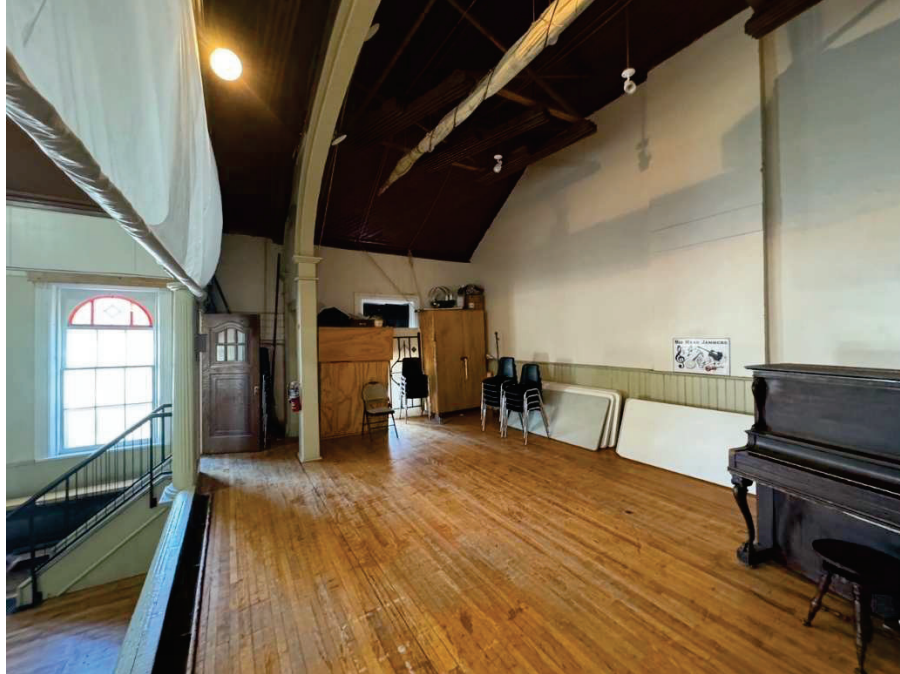
Photo #37

Photographs #37, #38, #39, & #40 show a raised wooden stage area that occupies the south end of the hall, designed for performances, presentations, or other community activities. The stage features a polished wooden floor in good condition, showing visible signs of historical use. A six-step wooden staircase with aluminum railings is located on the east side, providing easy access to the stage. Both the staircase and railings are in good condition.

Stage Area, Looking East, Highlighting Structural Integrity of the Supporting Architectural Arch below the Roof Truss, Walls, and Roof with No Visible Signs of Distress, Misalignment, or Structural Defects

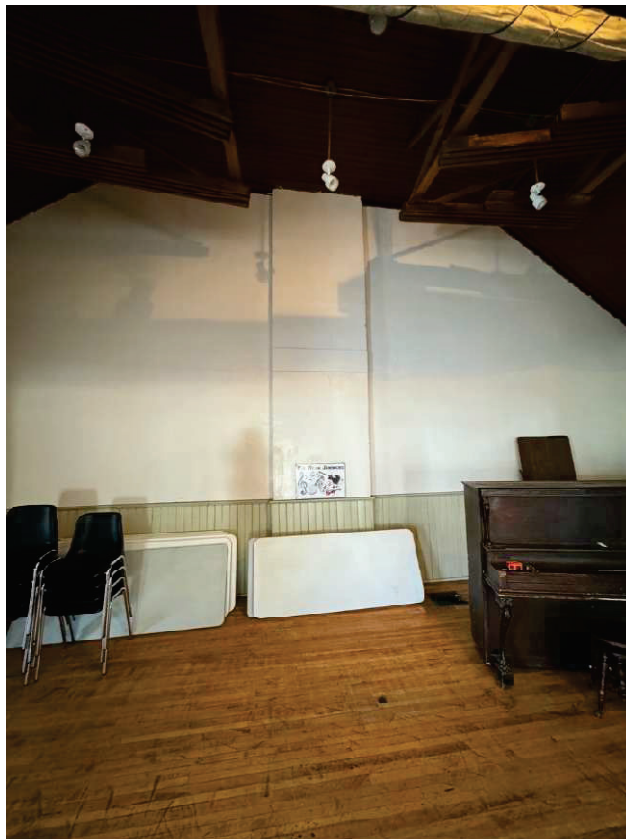
Photo #38

Stage Area, Looking South, Showing the South Building Bearing Brick Wall Finished with Drywall and Paint, with a Brick Column in the Middle Supporting the Roof Structure

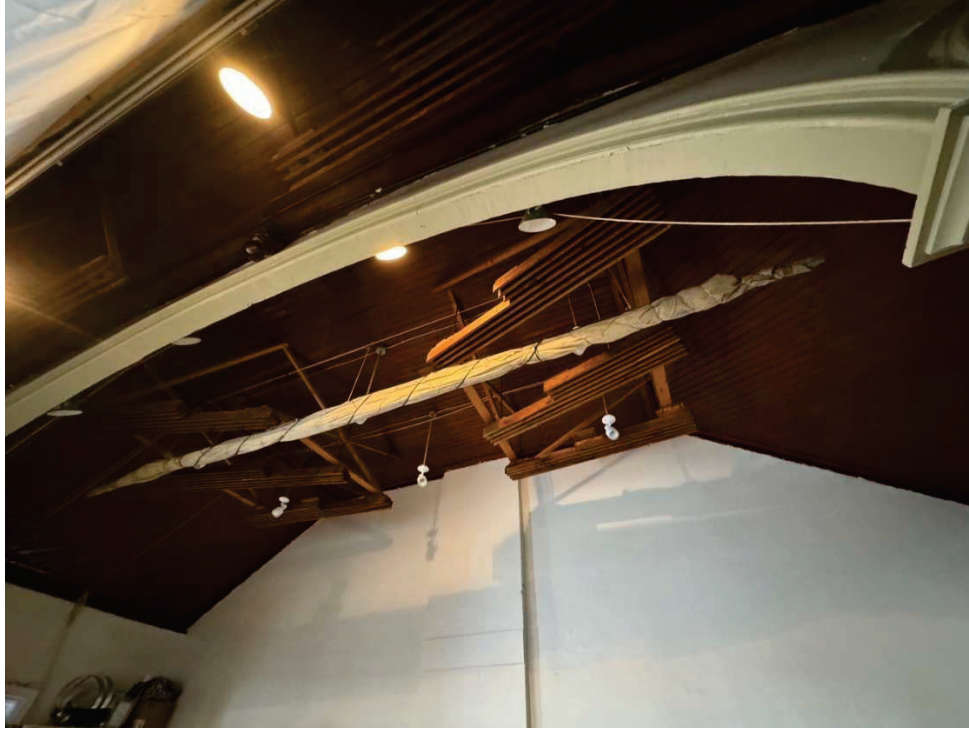
Photo #39

Ceiling View at the Stage Area, Highlighting Architectural Arches and Roof Trusses;
Possible Hidden Tension Cables within the Arch or Structural Function of the Arch
Unconfirmed; No Visible Signs of Structural Irregularities

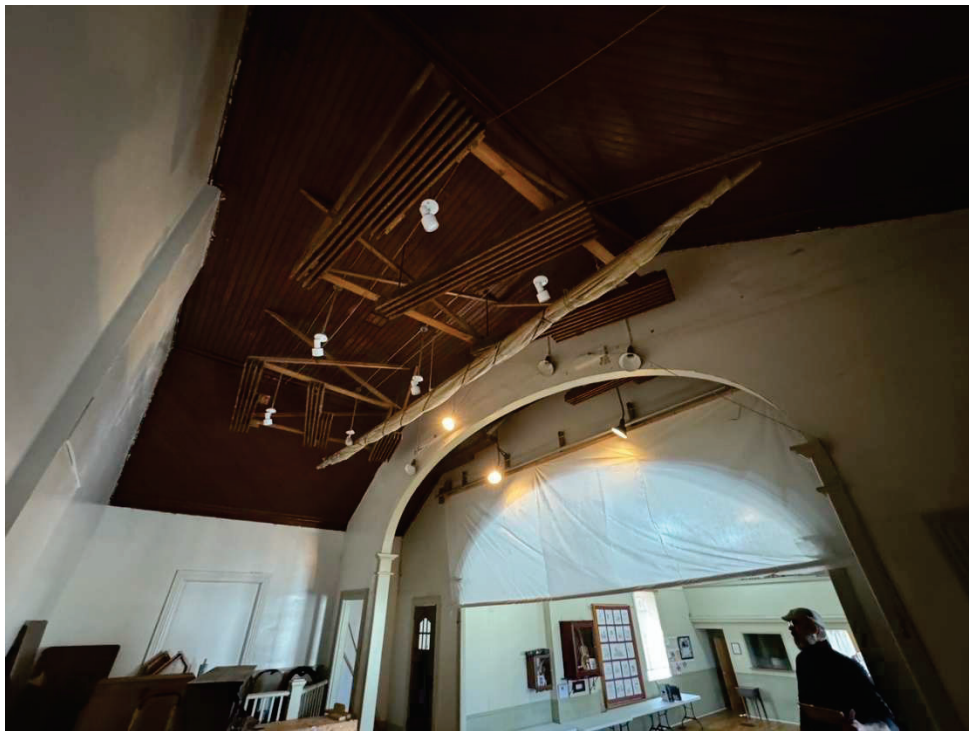
Photo #40

Double Arches at the Stage Area, Looking North, Highlighting Ceiling and Roof Truss
Details; No Visible Signs of Structural Irregularities or Defects

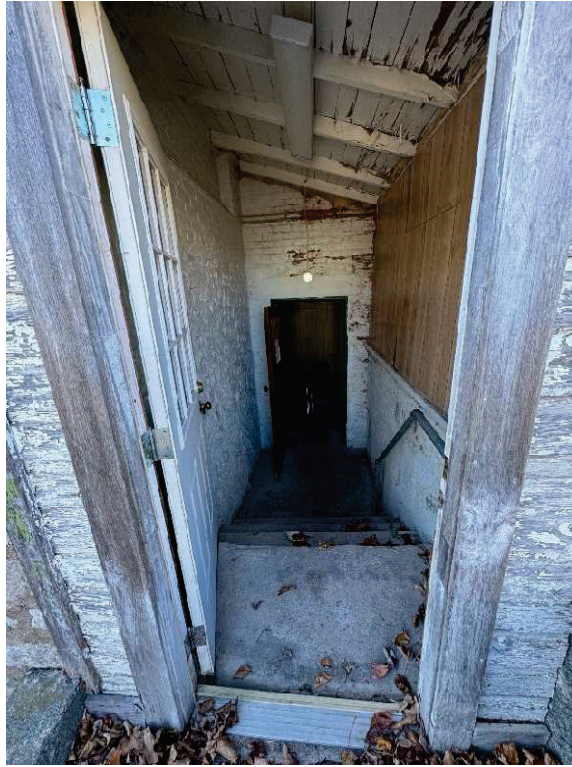
Photo #41

The basement has multiple access doors located on the east side of the building foundation wall. The basement north access door and its roof structure as shown on the Photographs #41, #42 & #43 appear to be later additions to the original building design, as they are not seamlessly integrated with the main structure. The materials and design of the additions contrast with the older masonry and finish of the original building. The wooden framing and siding around the door show significant weathering, peeling paint, and possible decay. The roof covering this entrance shows signs of deterioration, particularly the boards, which display peeling paint and potential water damage. The overall structure seems functional but may require repair or replacement in the near future to ensure safety and durability. The concrete stairs (4-steps+ Landing + 5-steps) leading to the basement appear in fair conditions but with minor discoloration, likely due to moisture and lack of regular cleaning. The interior brick walls near the basement access appear painted but exhibit signs of water stains or efflorescence, suggesting moisture infiltration. This could be a concern for long-term durability if not addressed.

Basement North Access Doors with Concrete Stairs and Landings, featuring a Single Metal Railing on the North Side; No Visible Structural Defects, Misalignment, or Distress in the Stairs, Landings, or Surrounding Masonry

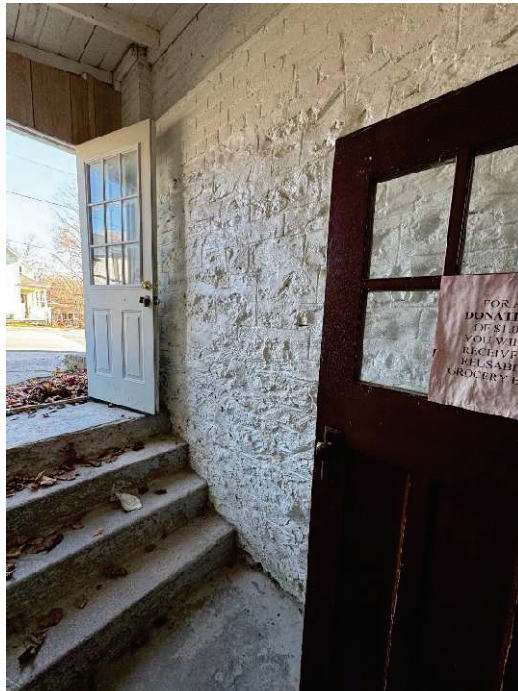
Photo #42

Basement North Access Doors and Concrete Stairs, Looking East; The Wall is Composed of Two Portions. No Visible Structural Defects, Misalignment, or Deterioration Observed in the Stairs, Landings, or Surrounding Wall Structure.

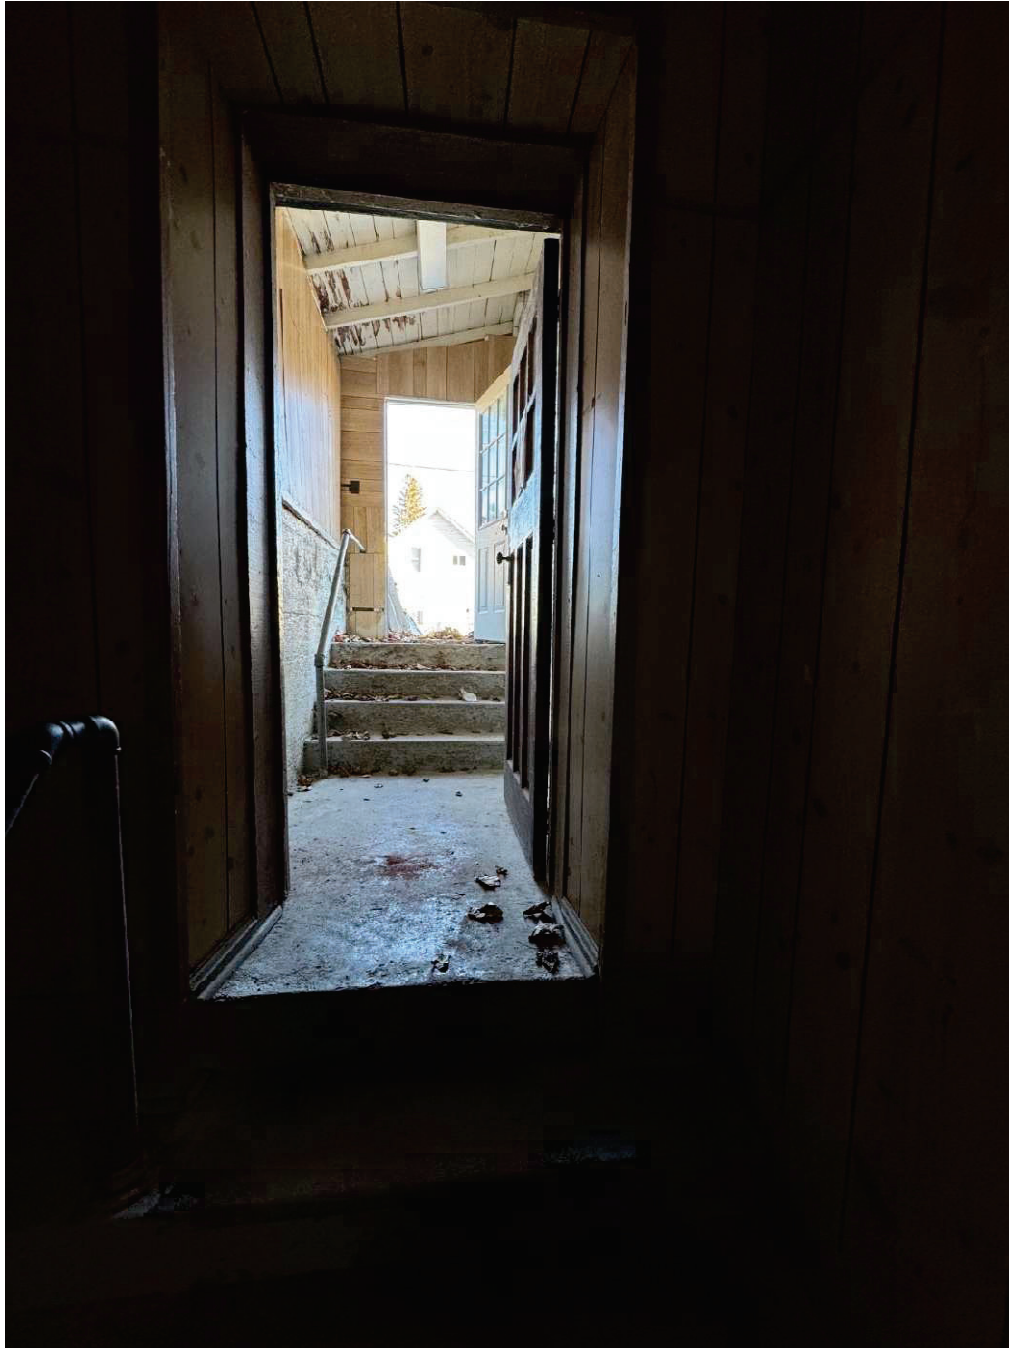
Photo #43

View from Inside Looking East at the Basement Access on the North Side of the Building, Showing the Covering Structure Including the Wall Above the Original Stone Foundation Wall, Roof, and Access Door. The Roof of the Added Structure is in Fair Condition and May Require Replacement. No Visible Structural Defects or Deterioration Observed in the Surrounding Components.

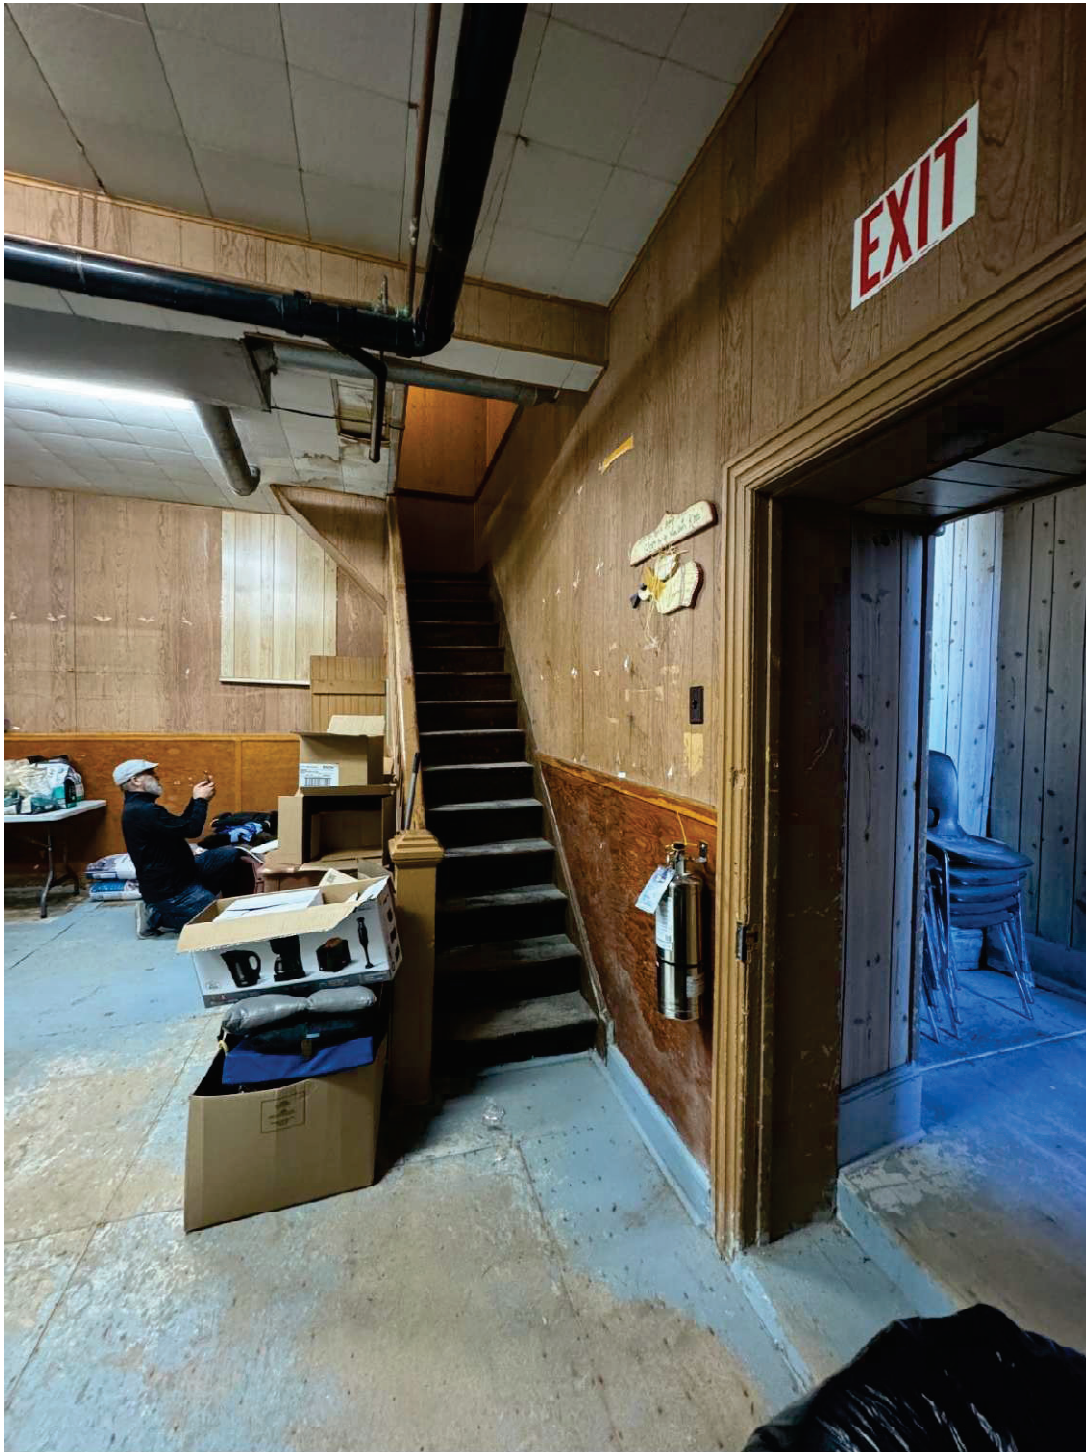
The photograph #44 & #45 show the basement north exit / access door with the stairs leading to the ground floor above. The wooden staircase shows visible signs of wear and tear, including scuffed and worn treads. This indicates frequent use over time without significant maintenance or refinishing. There appear to be no obvious structural issues, such as cracking or splitting in the wood, but the surface condition suggests the need for sanding and repainting or sealing.

Photo #44
Basement North Exit/Access and North Stairs Leading to Ground
Floor, Looking West

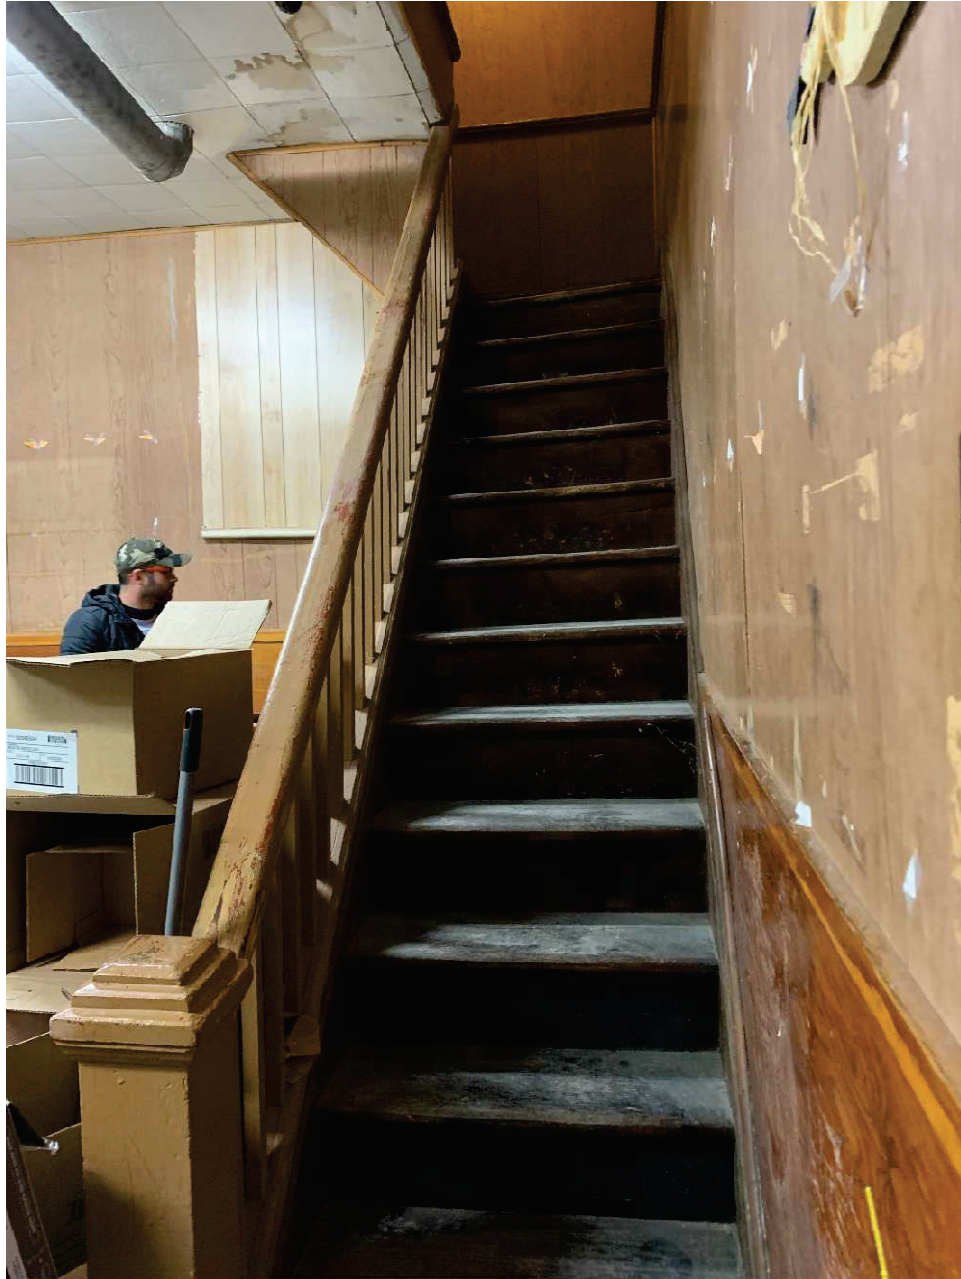
Photo #45
View of Basement North Stairs Leading to Ground Floor, Looking West

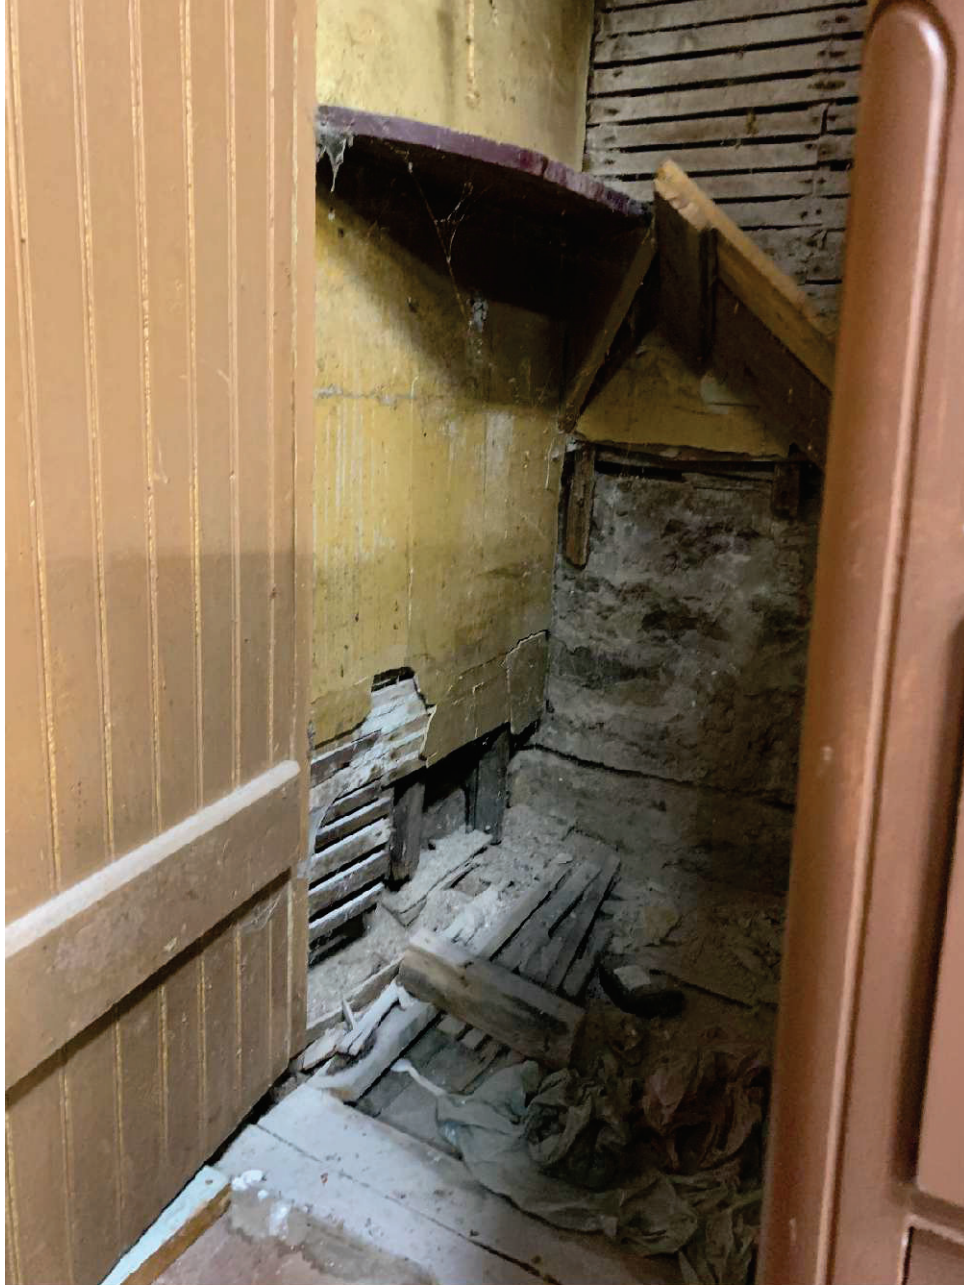
Photo #46

Photographs #46 & 47 show the storage room located below the north basement stairs. The north and east walls are constructed with masonry stone and have finishing layers consisting of wood framing a cementitious grout or plaster applied over lath. Portions of the interior finish are deteriorated, exposing the wooden lath beneath. Significant wear is visible in the interior finishes, particularly along the lower portions of the wall. This includes cracked and missing plaster, exposing the underlying wood lath and parts of the stone masonry. The floor consists

Storage Room Below North Basement Stairs at Northeast Corner, Looking North. Interior wall finishes are deteriorated, exposing the wooden lath beneath.

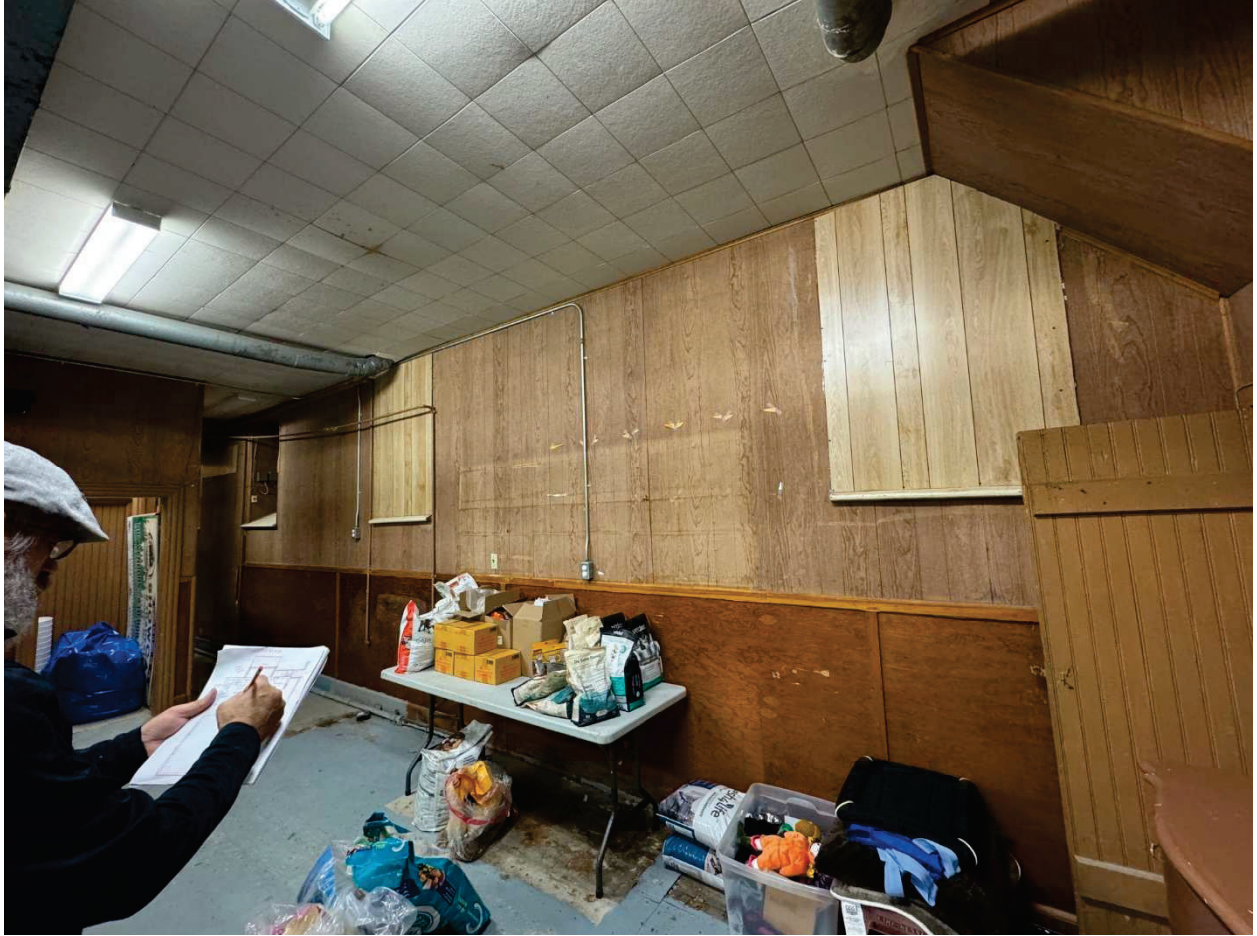
Photograph #49 shows the basement's east foundation wall from the inside, looking west.

Photo #49
Basement east wall, looking west.

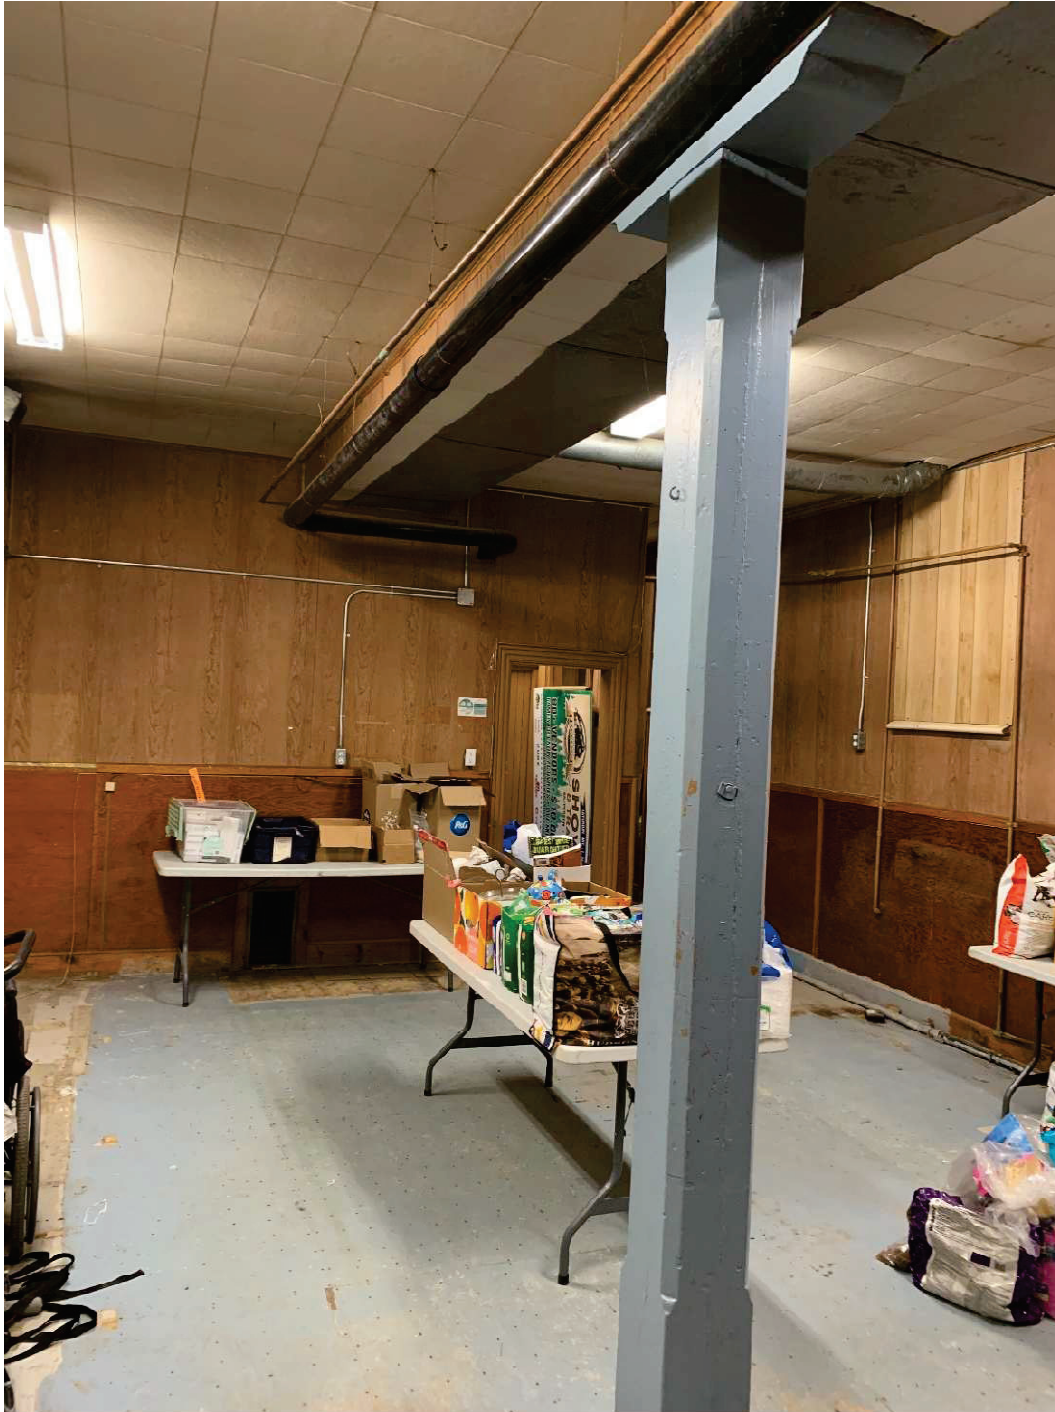
Photo #50

Photographs #50, & #51 show the food bank area in the basement, with a structural column and overhead beam, looking southwest: The column appears to be constructed of wood and is painted gray. It includes a capital-like detail at the top where it meets the overhead beam. The column shows no visible signs of damage, cracking, or instability. The overhead beam is hidden in the ceiling finishes and spans horizontally north- south and appears to be made either of steel or wood. It is well-integrated with the column and other structural elements, supporting the ground floor structure above. The ceiling consists of acoustic tiles, which display discoloration and staining in certain areas, possibly indicating previous water damage or leaks. A portion of the ceiling near the beam appears uneven or slightly sagging, warranting further inspection to ensure it is secure and supported properly.

Food bank area with a structural column with capital and overhead beam, looking southwest.

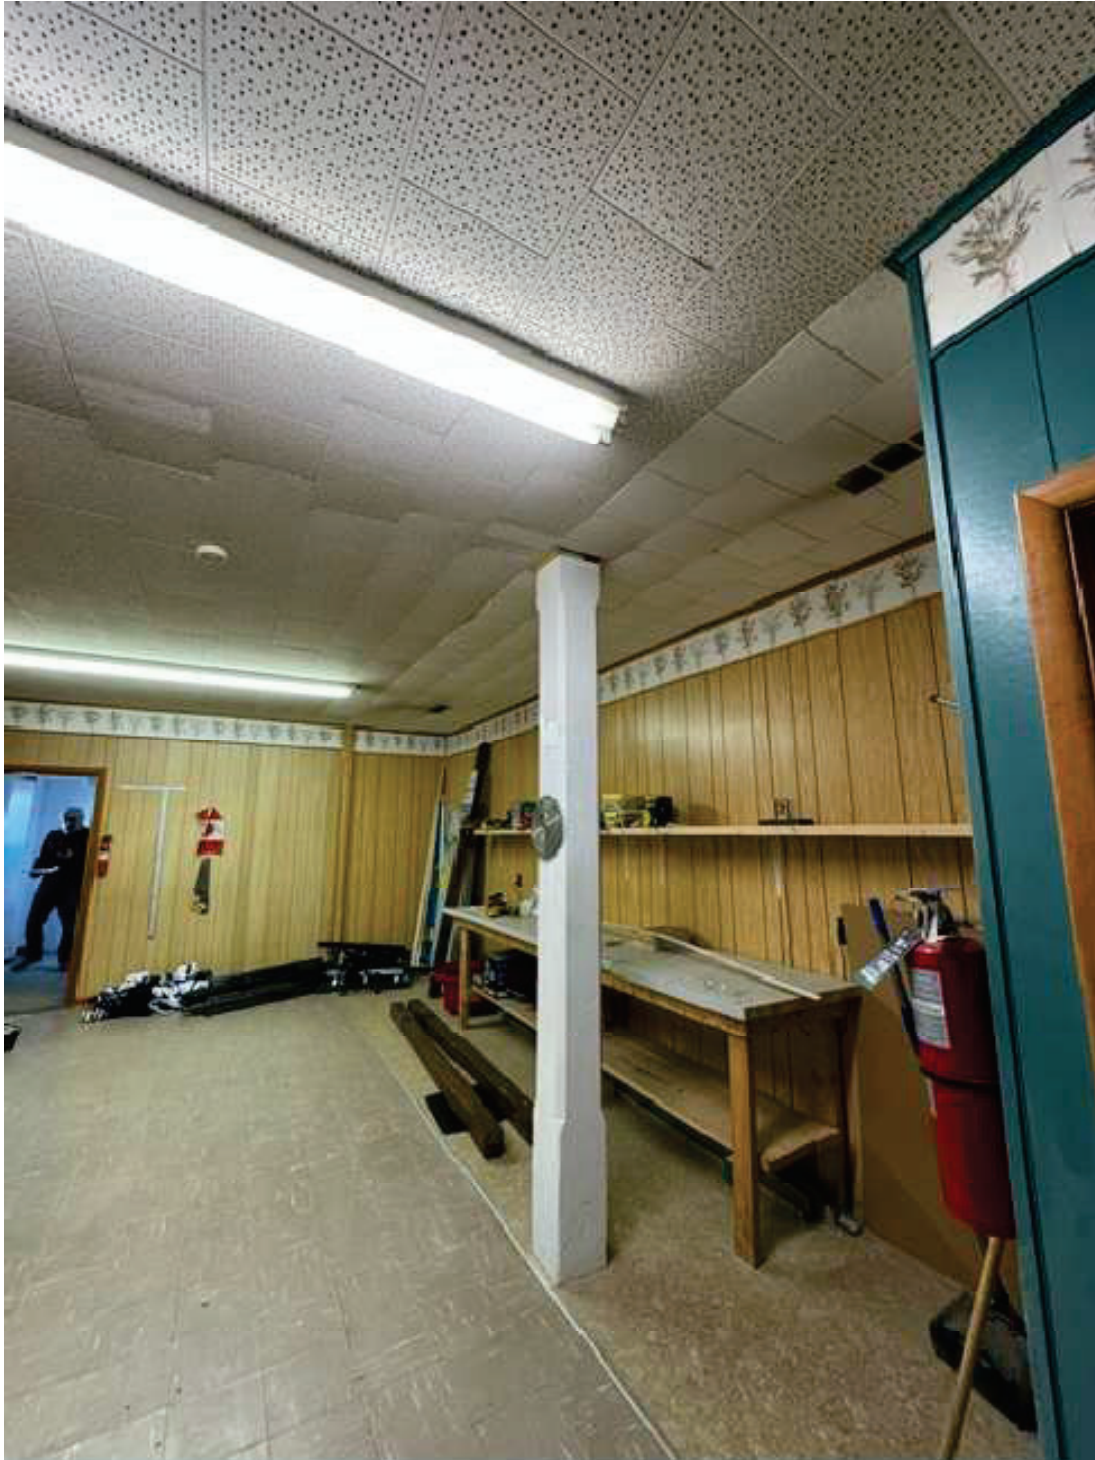
Photo #61

Photograph #61 shows the Carpentry Shop, Looking North from the Entrance Door

General view of the carpentry shop, looking north.
A structural wood column is visible in the space.

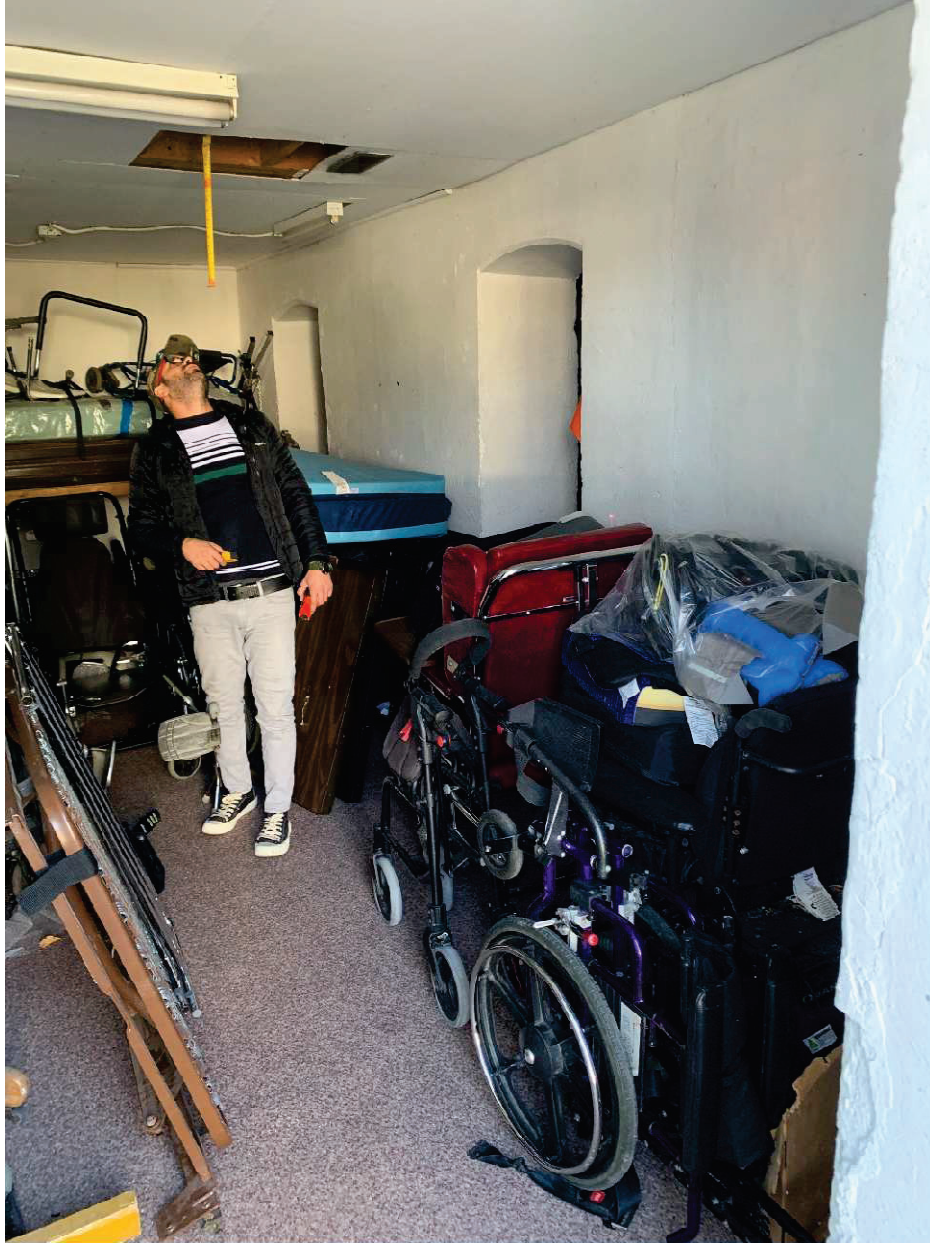
Photo #62

General View of the Carpentry Shop, Looking Southwest
A structural wood column is visible in the space.
No structural irregularities or signs of distress were observed.

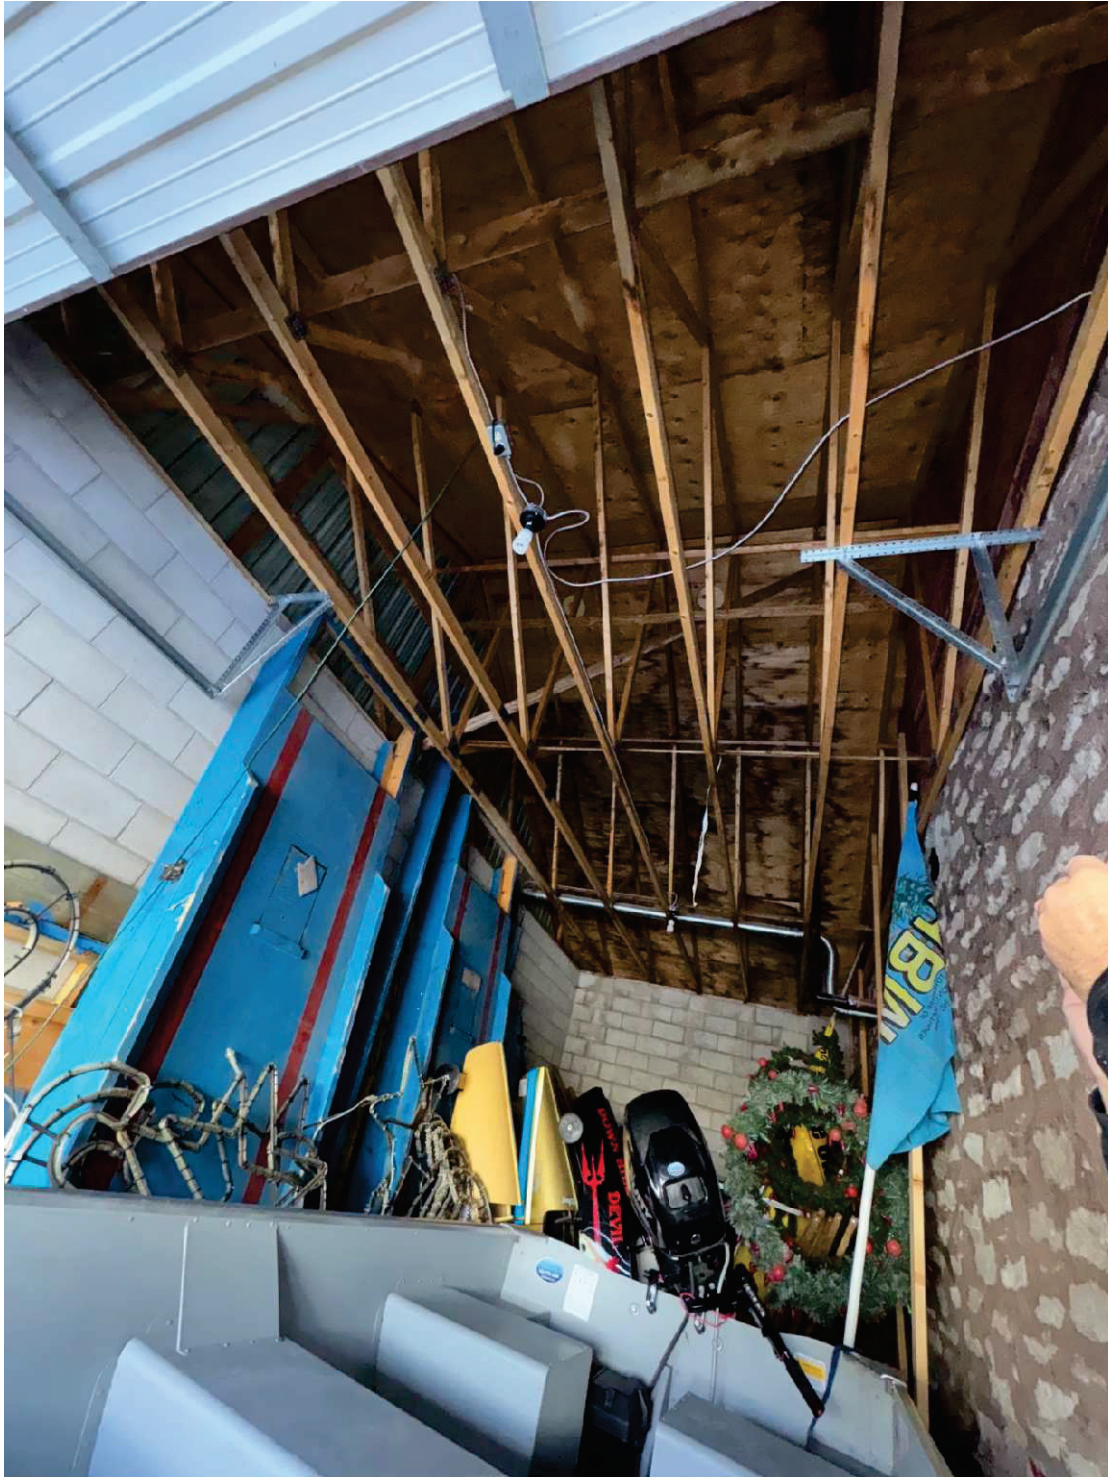
Photo #64

General View of One of the Two Storage Rooms (Former Jail Compartments, Looking North)

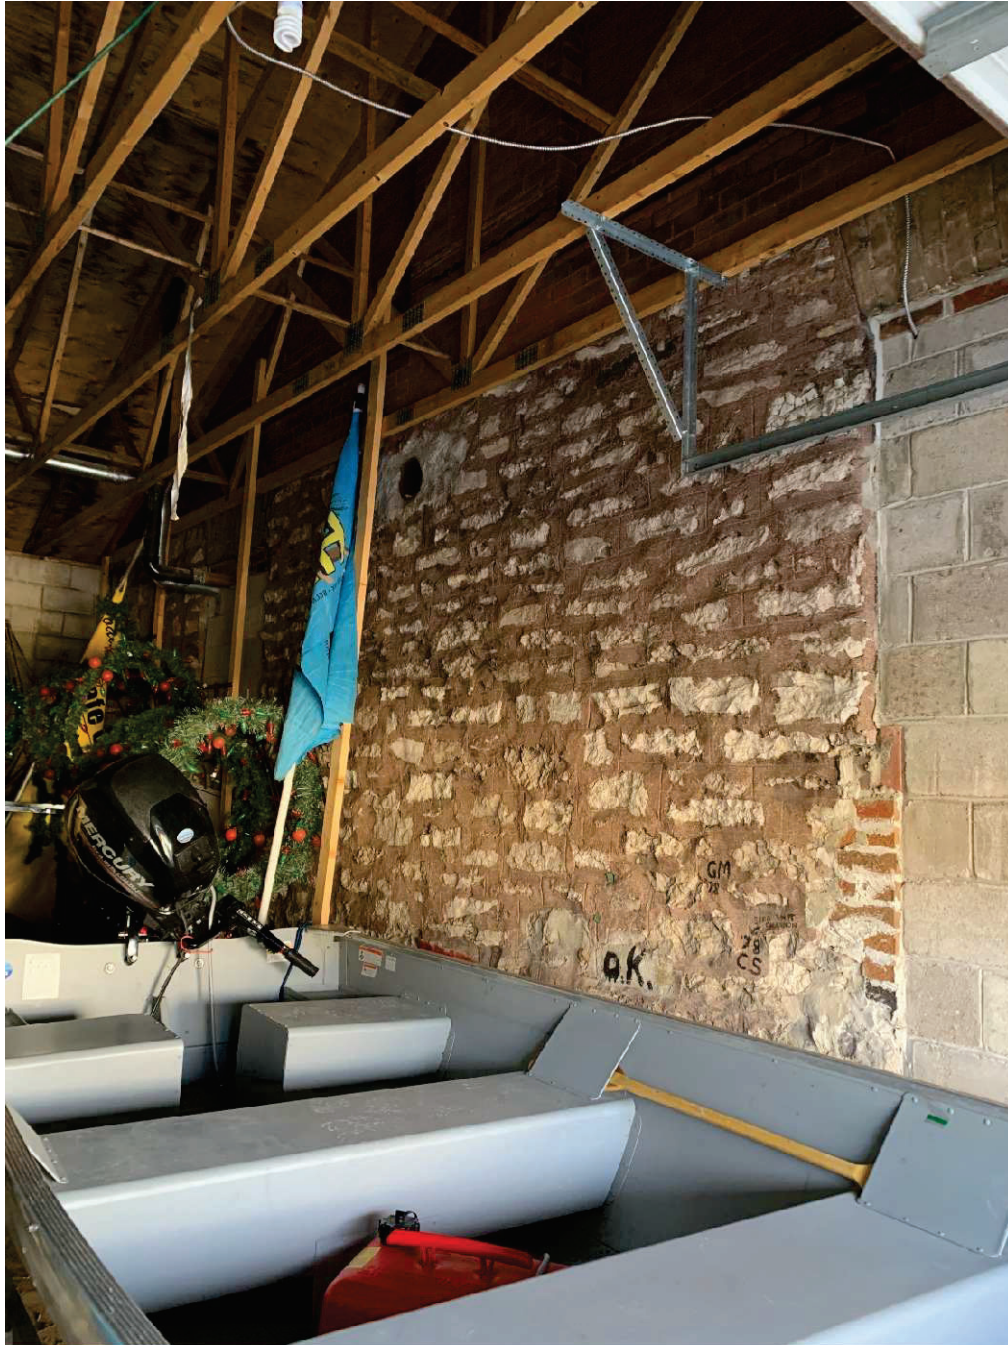
Photo #65
General View of the Garage Interior, Looking West

Photograph #65 shows the general view of the garage addition to the main town hall building looking from the garage door to the west.

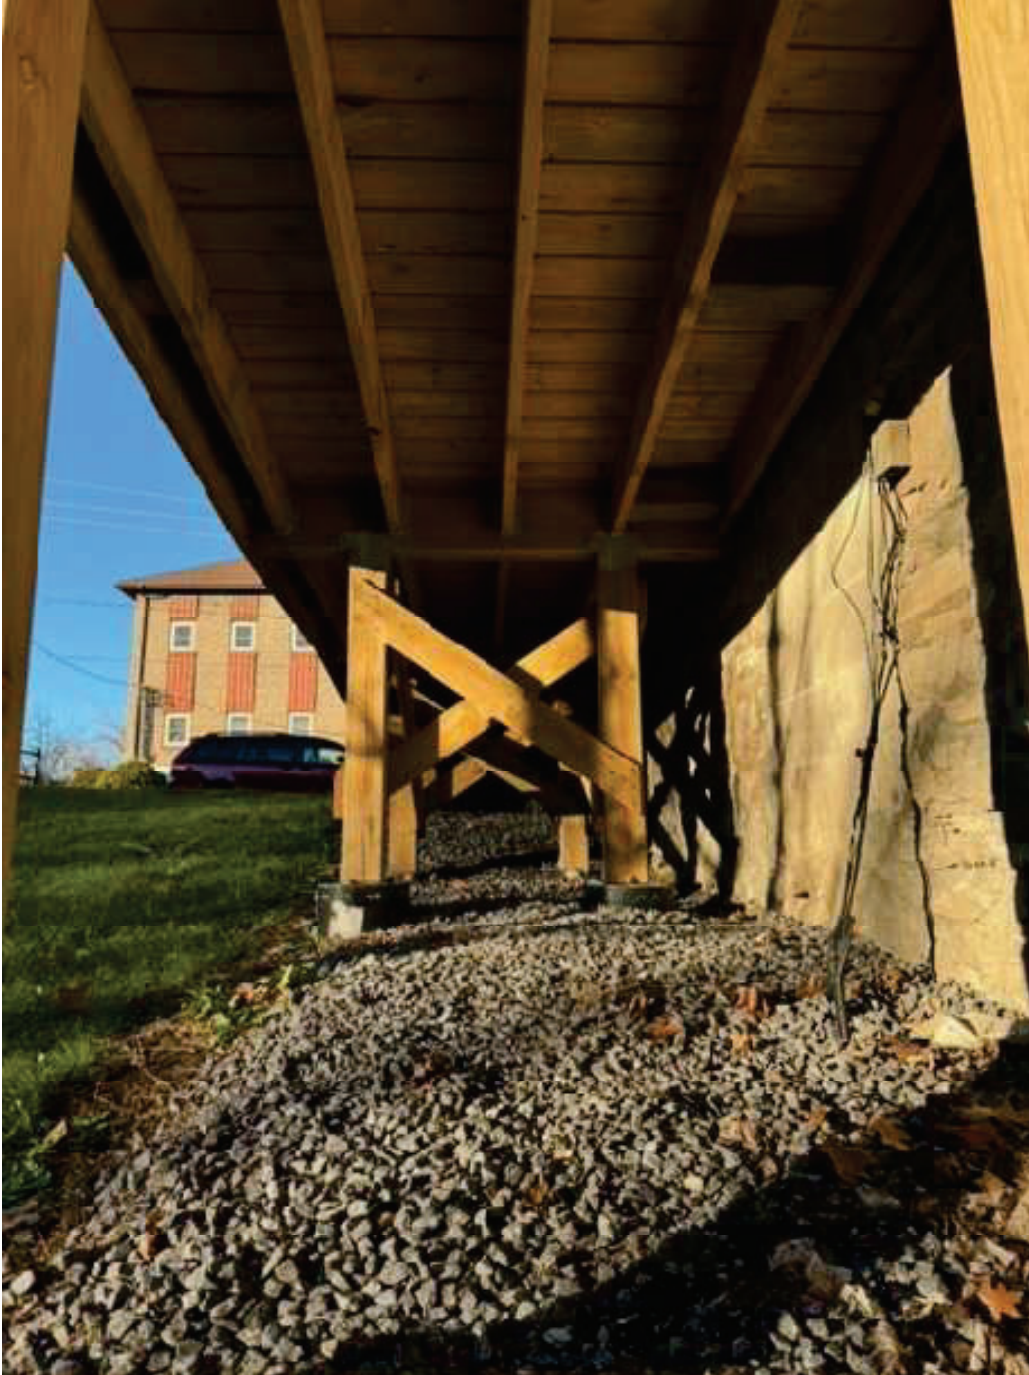
Photo #69

The access ramp addition on the west side of the building is in good condition. The ramp features a wooden deck and concrete landings, with steel railings installed on both sides for safety and support. The construction appears to meet accessibility requirements, with no visible signs of structural defects or wear.
