TOWNSHIP OF HAVELOCK-BELMONT-METHUEN

To: Mayor Martin and Members of Council
From: Bob Angione, Chief Administrative Officer/Clerk
Meeting Date: March 4, 2025
Subject: Repairs to Old Town Hall (1 Mathison Street West)

Building Envelope Condition Assessment (BECA) Report

RE: Building Envelope & Roof Condition Assessment for Old Town Hall, 1 Mathison Street West, Havelock ON

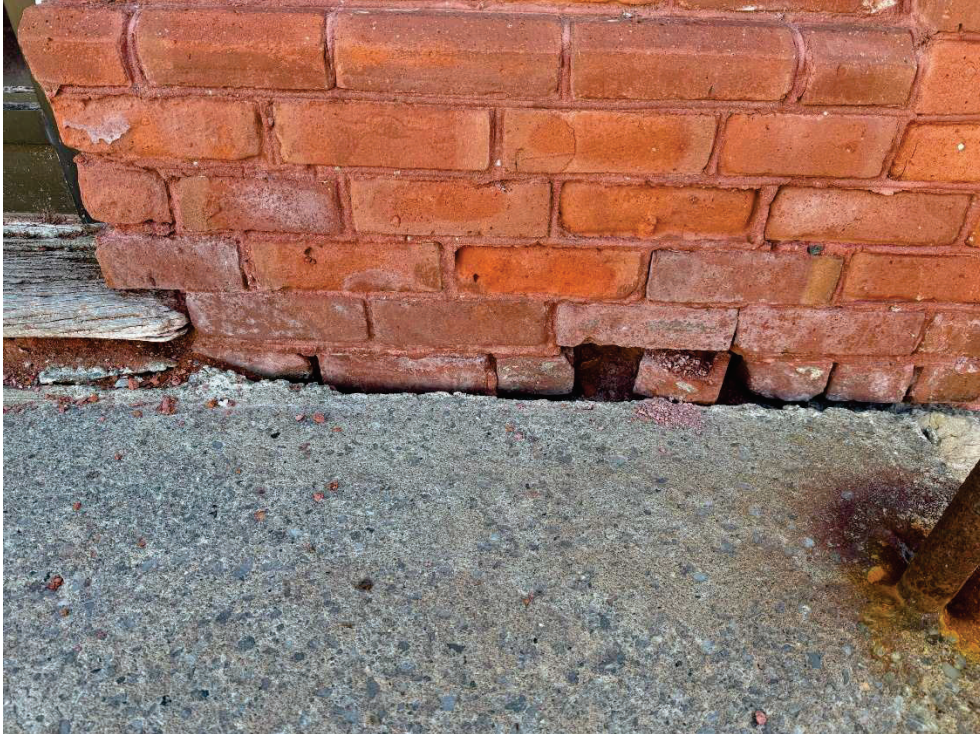
Entrance door threshold exhibits signs of settlement, with visible gaps and crumbling materials. The wooden threshold is weathered and misaligned.

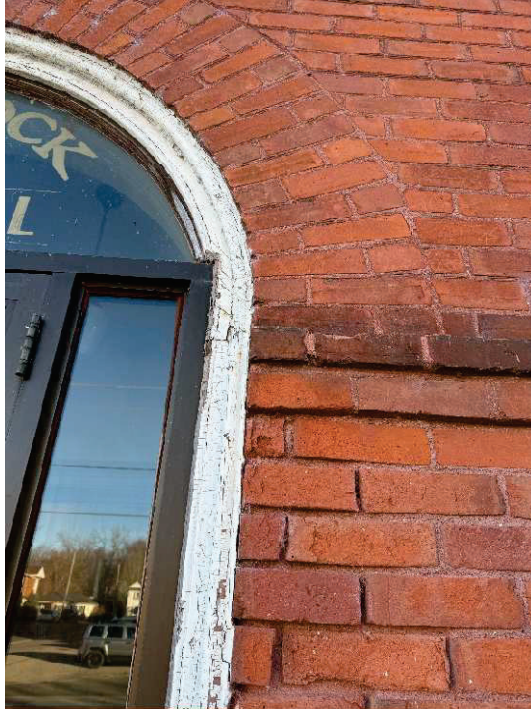
Photo #76

The north brick wall adjacent to the door entrance shows cracks, separation from the door frame, and gaps in the mortar joints. The paint on the frame is peeling.

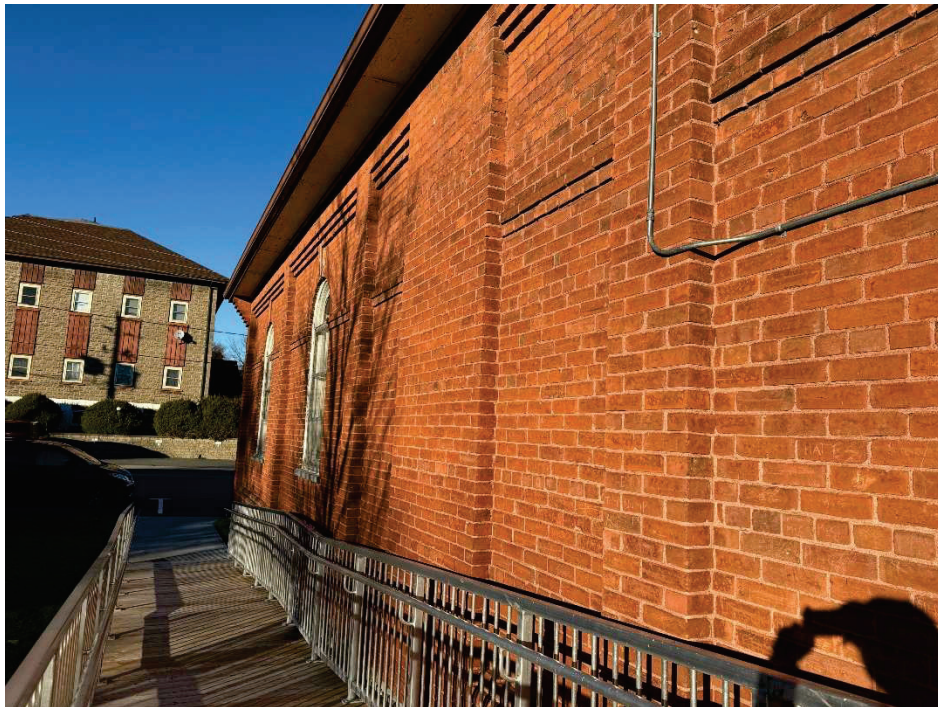
Photo #79

WEST: The west elevation of the building, looking southeast in photograph #79 and looking northeast in photograph #80 shows a general view of the historical brick wall with arched windows in good condition. The brickwork appears well-maintained, and the structural integrity of the wall is visually satisfactory. The newly added accessibility ramp is visible in the foreground, supported by timber posts. The west elevation window in photograph #81 shows a deteriorated wooden sill and cracking in the adjacent brickwork. Cracks in the masonry suggest potential structural settlement or material degradation in this area. Repairs are needed to address these issues and prevent further deterioration.

The west building elevation looking southeast. Show general view of historical brick wall with arched windows in good conditions.

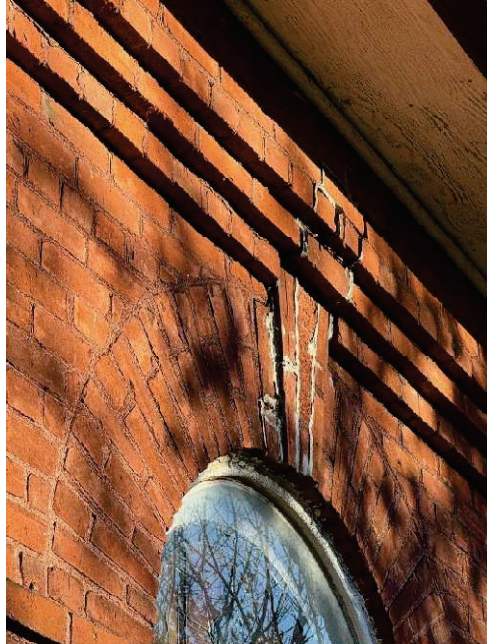
Photo #82

Photographs #82 & #83 show the window crown where cracks and gaps have been poorly sealed with sealant or mortar that does not match the original color. Discolored bricks are also visible in the brick masonry, indicating potential water damage or material degradation.

The window crown at the north elevation where cracks and gaps have been poorly sealed with sealant or mortar that does not match the original color. Discolored bricks are also visible in the brick masonry, indicating potential water damage or material degradation.

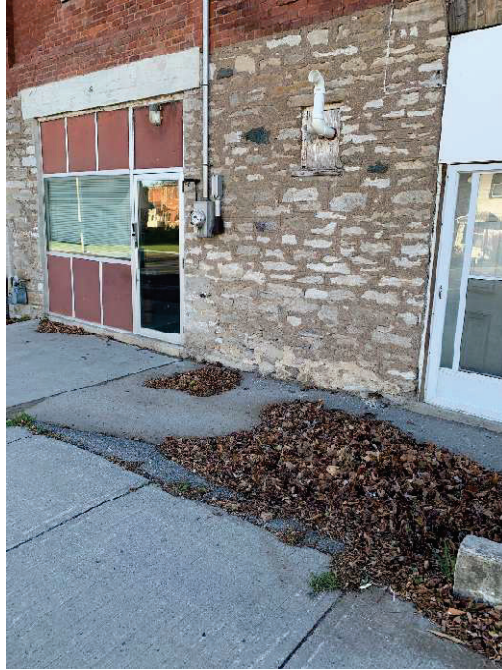
Photo #88

EAST: Photograph #88 shows the east elevation of the building, looking northwest. The elevation comprises brick masonry on the upper section and stone masonry on the lower section. The brickwork shows signs of cracking and inconsistent mortar repairs, indicating potential structural movement or aging materials. The wooden door at the basement level, likely for the carpentry shop, appears weathered and deteriorated. Additionally, the retaining concrete curbs and the slab-on-grade are in poor condition and require repairs to address water infiltration and prevent further deterioration.

Est elevation looking Northwest. The brickwork shows signs of cracking and inconsistent mortar repairs. The wooden door at the basement level (for the carpentry shop) appears weathered and deteriorated. The retaining concrete curbs and the slab-on-grade are in poor condition.

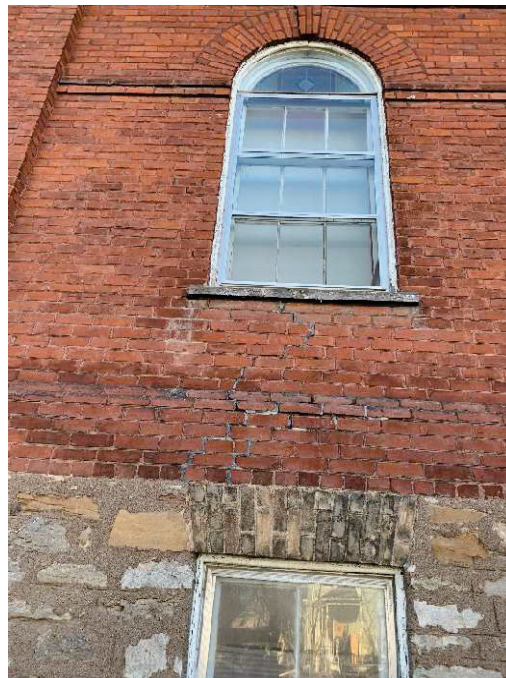
Photo #89

Photograph #89 shows the south section of the east elevation, looking southwest. The foundation wall at the police office has been partially demolished to accommodate a door with a metal façade. The original window

East Elevation South Section Renovations and Structural Concerns. Renovations, including a new door with a metal façade, reinforced concrete lintel, and an opening with PVC pipes. The concrete slab adjacent to the sidewalk shows mixed conditions, with one portion deteriorated due to water infiltration and poor drainage.

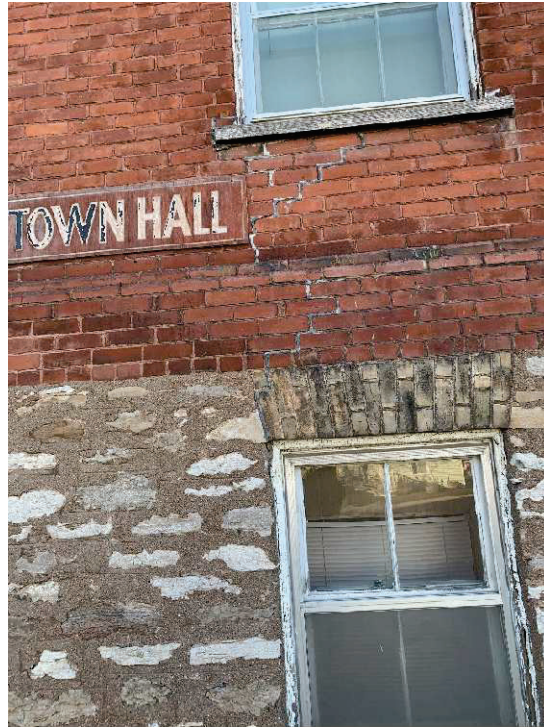
Photo #90

Cracks and settlement at east elevation windows are observed in the brick masonry located between the upper arched window and the basement-level window see photograph#90 & #91. The cracks suggest structural settlement or movement. The wooden sills of the upper windows show weathering.

Cracks at east elevation windows are observed in the brick masonry located between the upper arched window and the basement-level window. The wooden sills of the upper windows show weathering.

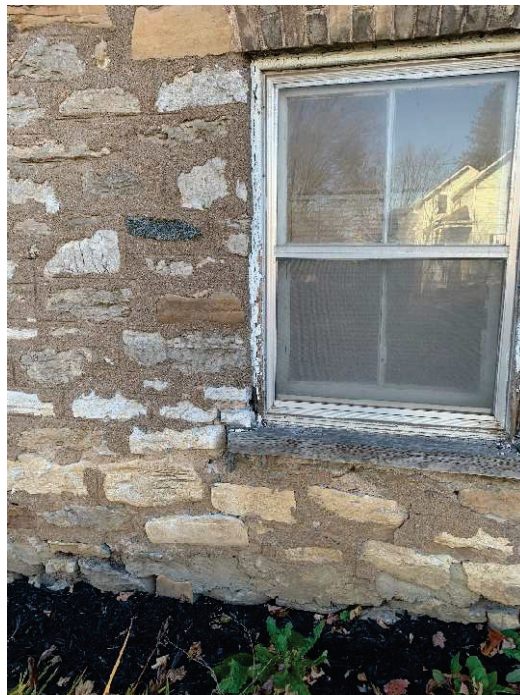
Photo #91

Cracks at east elevation windows are observed in the brick masonry located between the upper arched window and the basement-level window. The wooden sills of the upper windows show weathering

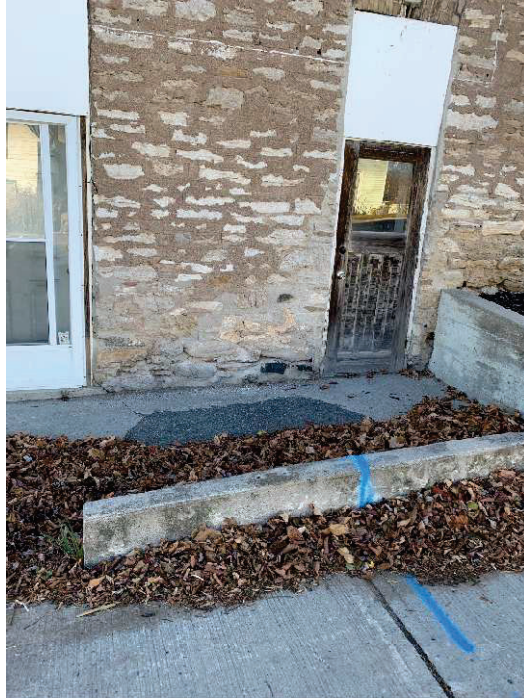
Photo #92

The photograph #92 shows the east elevation basement wall and window conditions. The basement wall is constructed of stone masonry with signs of weathering and inconsistent mortar repairs. The window frame exhibits peeling paint and deterioration, while the wooden sill is weathered and splitting. The overall condition suggests a need for maintenance to address aging materials and prevent further structural or water damage. The photograph #93 shows the east elevation at the carpentry shop entrance, with a weathered wooden door and a stone masonry wall exhibiting inconsistent mortar repairs. The adjacent concrete curb and the slab on grade are in poor condition, displaying cracks, uneven surfaces, and accumulated debris. Repairs are necessary to restore the functionality and aesthetic of the area.

East elevation and basement wall and window condition. Stone masonry with signs of weathering and inconsistent mortar repairs. Window frame exhibits peeling paint and deterioration, while the wooden sill is weathered and splitting. A need for maintenance.

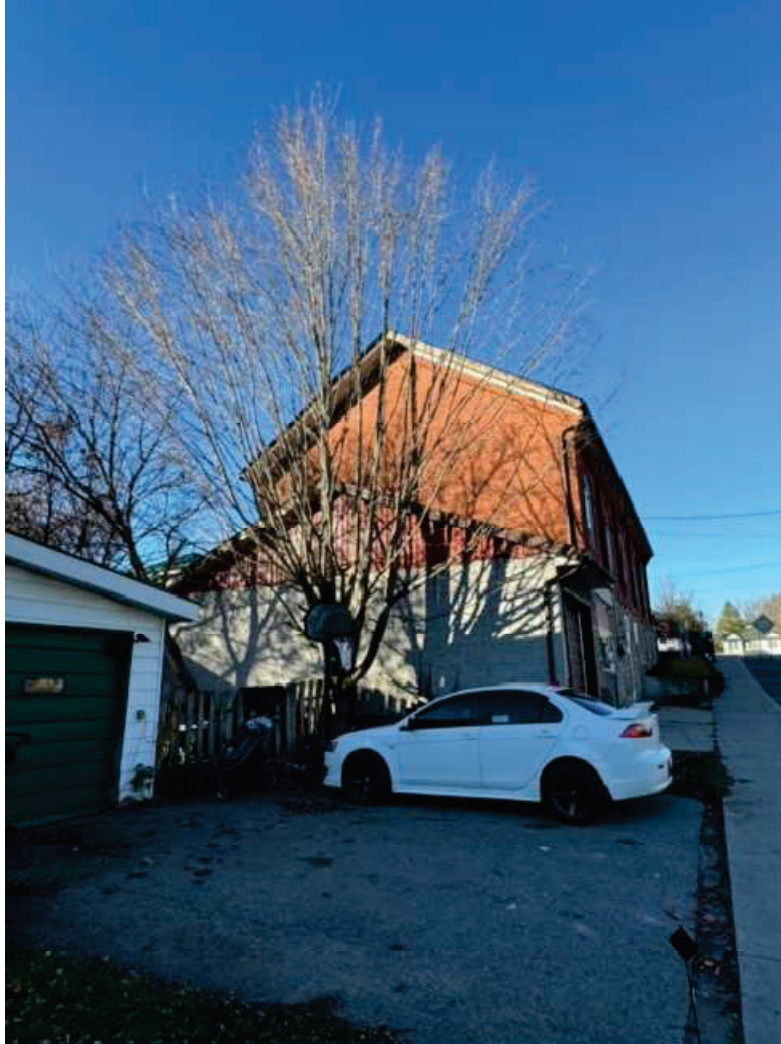
Photo #94

The garage door on the east elevation is shown on the photograph #94. It set within a concrete block wall and appears functional. The adjacent concrete slab on grade shows visible cracks, uneven surfaces, and signs of deterioration, indicating inadequate drainage and potential water infiltration. Repairs are recommended to improve durability and restore the structural integrity of the slab.

East Elevation Garage Door and Concrete Slab Condition
The garage door appears functional. The adjacent concrete slab on grade shows visible cracks, uneven surfaces, and signs of deterioration

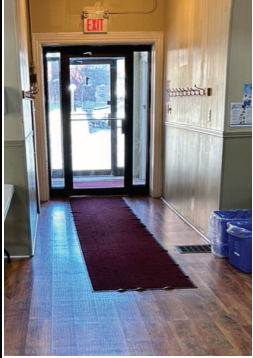
Community Hall	Flooring	Floor entrance mats may present a trip hazard.	<p>Ensure edges of mats lay flat. Replace mats that have lifted edges.</p> <p>Out of scope</p>	Better Practice Recommendation

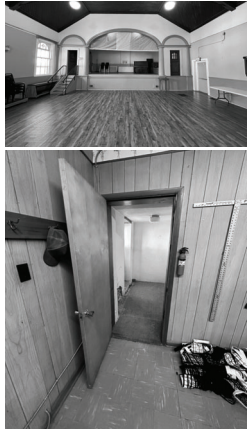
Community Hall and Basement	Colours and Finishes	Colour contrast between walls and floors, doors and walls, and furnishings/millwork and surroundings could be improved.	<p>Contrast can be helpful for wayfinding. When selecting colours and finishes, provide contrast between floors and walls, doors and walls, and furnishings or cabinetry and their surroundings.</p> <p>Painting budget: \$2.75 ft²</p>	Better Practice Recommendation
